Then / Now Photo Comparison

Scanned Photos of Park Synagogue from the Western Reserve Historical Society Archive Compared to Present Day Photos to Identify Alternations over time for the Historic Preservation.

By David Craun, AIA, Cleveland Planning Advisors, LLC, Owner Representative Services

Park Synagogue
Mendelsohn Restoration

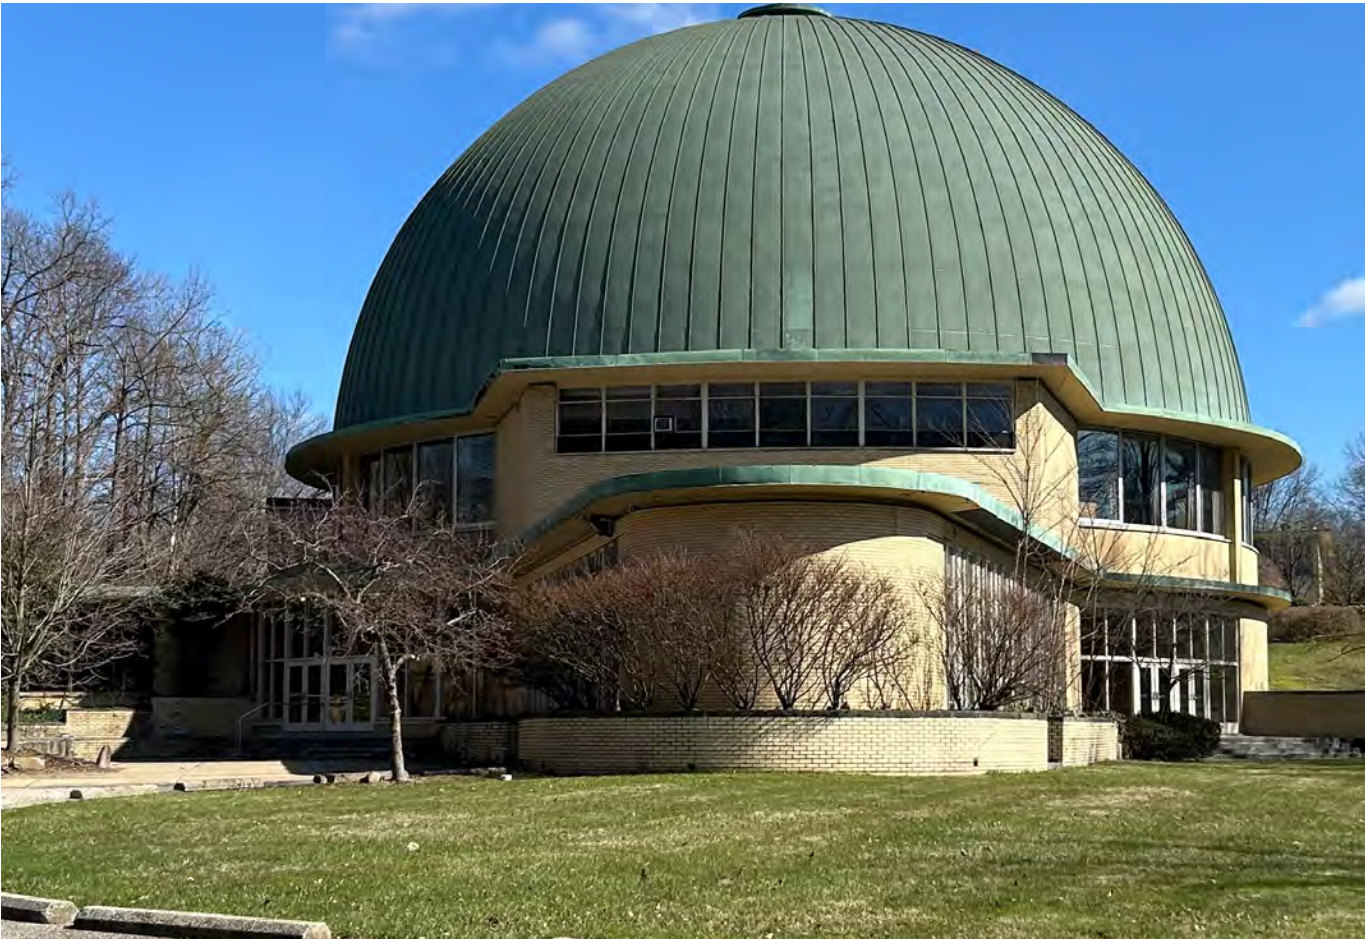
Present Day Photo

HISTORIC ALTERATIONS

- 1. Added Site Walls for Ramp
- 2. Bridge Addition*
- 3. Elevator Addition
- 4. Non-Period Window Replacement
- 5. Facade Lighting
- 6. AC Unit in Window
- 7. Thickened Fascia

*1968 Bridge and Kangesser Hall addition.
Note: landscape alternations not included.

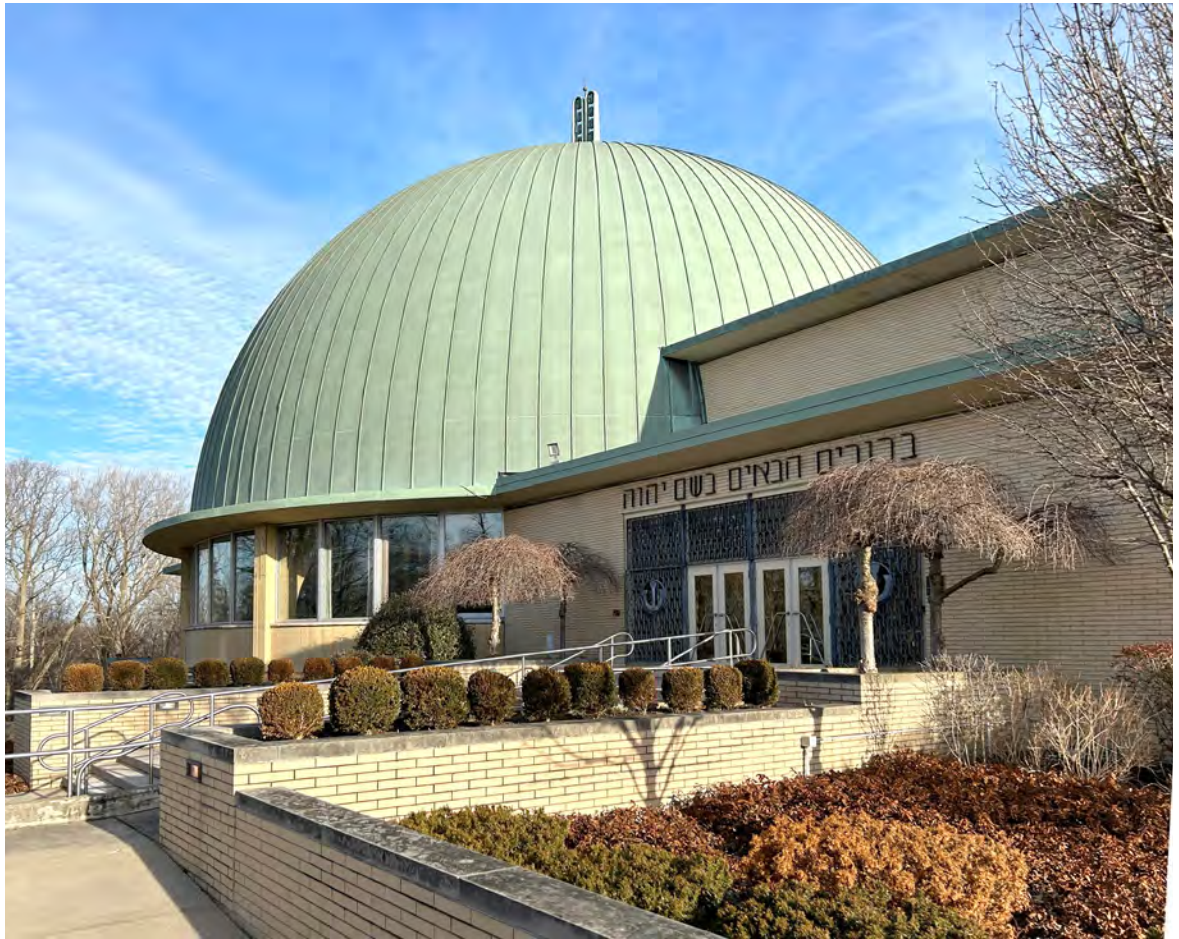
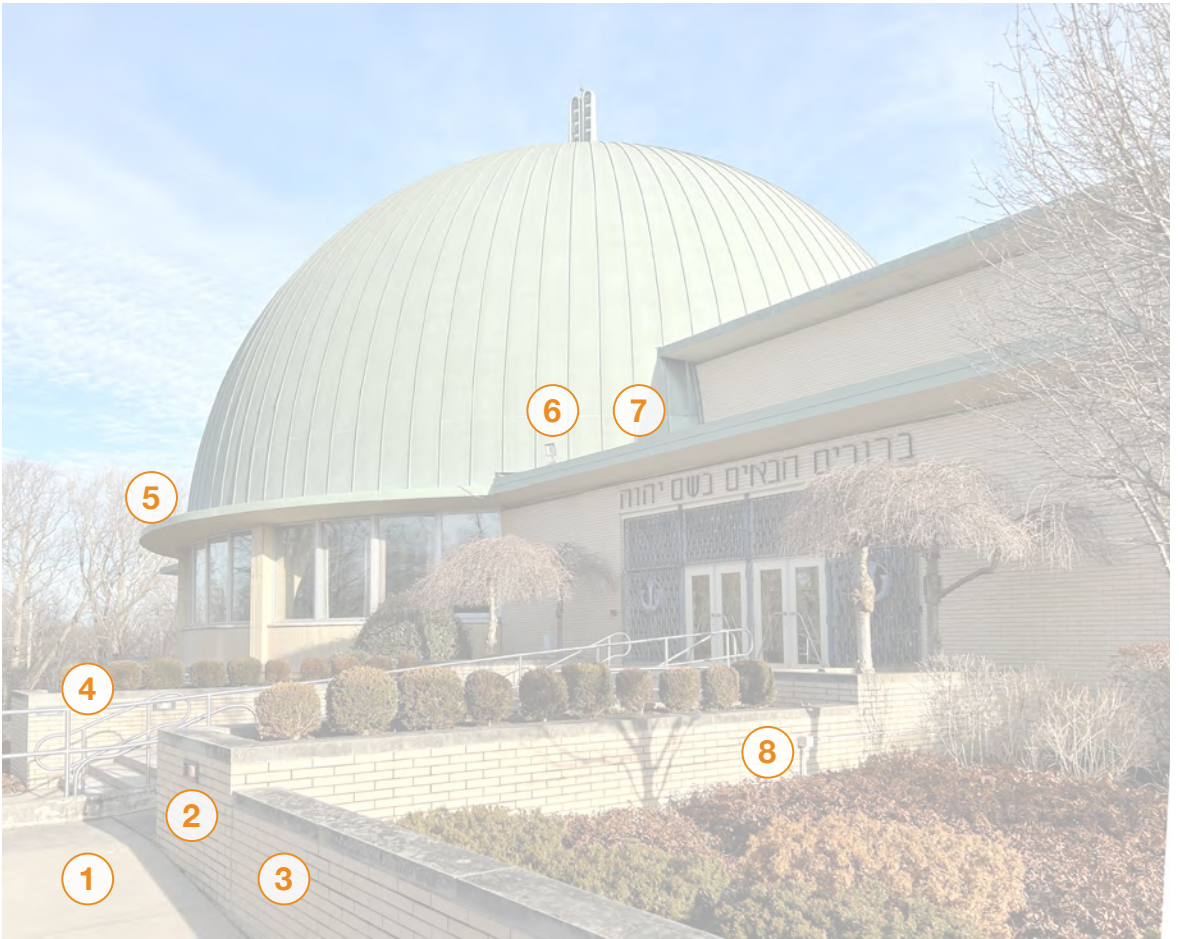
Present Day Photo

HISTORIC ALTERATIONS

- 1. ADA Ramp Over Stairs
- 2. Step Lighting
- 3. Ramp/Garden Wall
- 4. Stair Handrails
- 5. Thickened Fascia
- 6. Roof lighting
- 7. Double-Thick Fascia
- 8. Exposed Electrical

Note: landscape alternations not included.

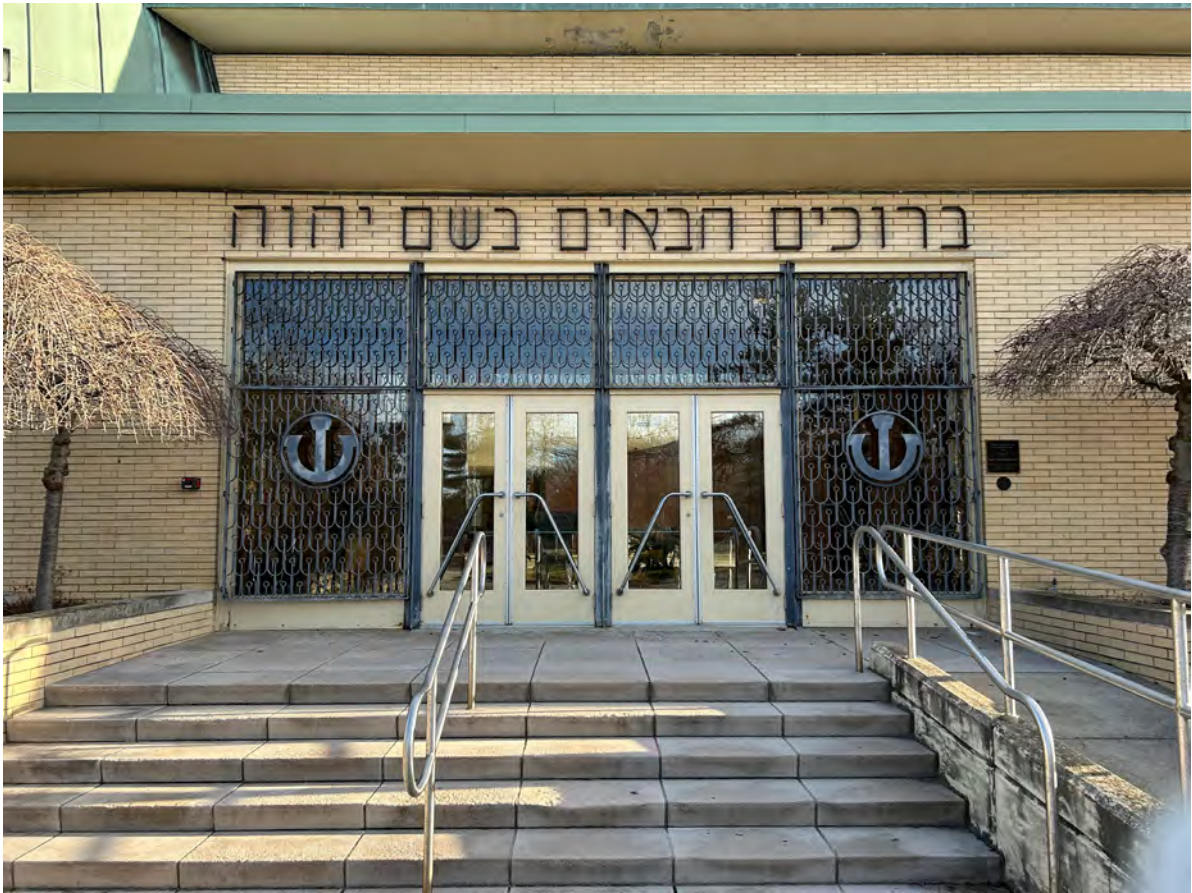
Present Day Photo

HISTORIC ALTERATIONS

- 1. Ramp Over Stairs
- 2. Stair/Ramp Handrails
- 3. Knox Box for CHFD
- 4. Historic Building Marker
- 5. Double-Thick Fascia

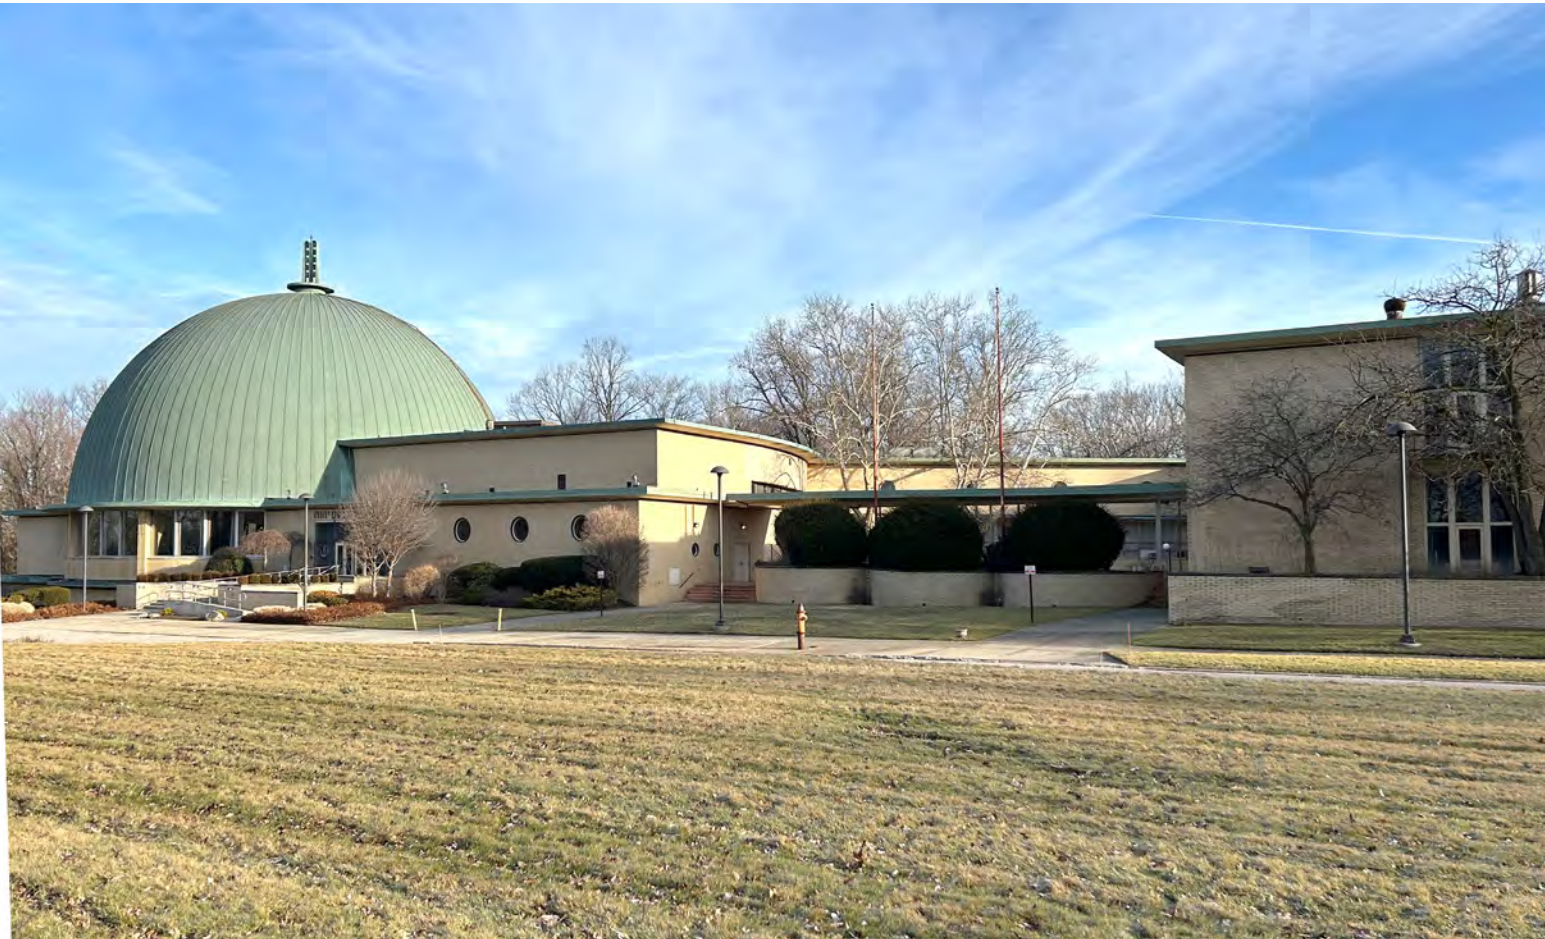
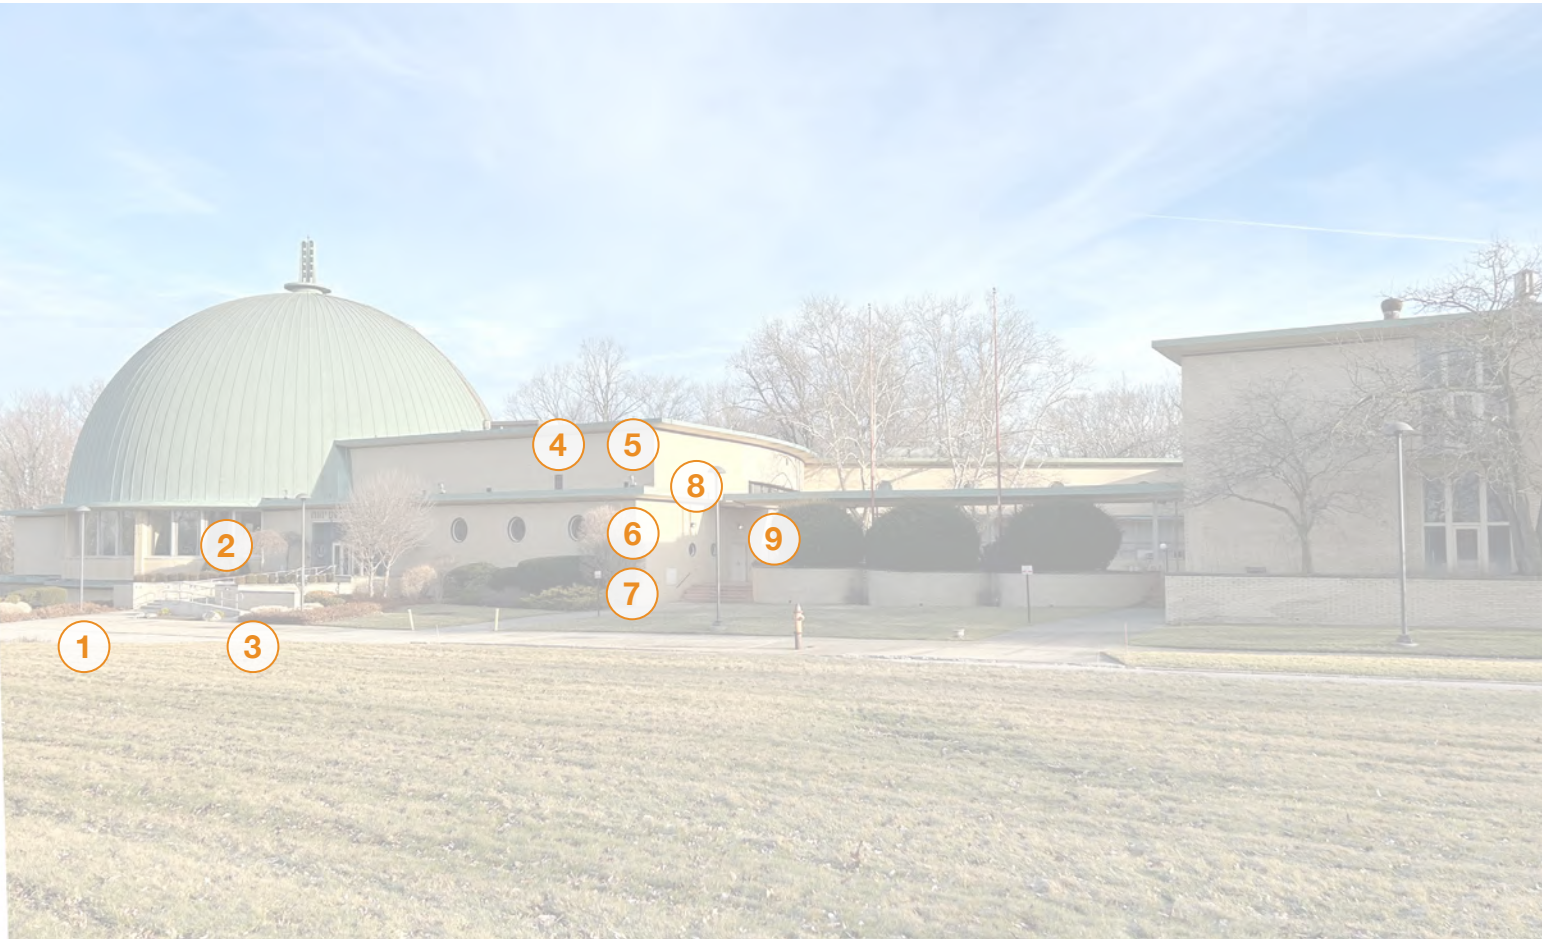
Present Day Photo

HISTORIC ALTERATIONS

- 1. Site Lighting Poles
- 2. Stair Handrails
- 3. Ramp Over Entry Stairs
- 4. Enlarged Facade Vent
- 5. Roof lighting
- 6. Double-Thick Fascia
- 7. Enlarged Service Panel
- 8. Facade Lighting
- 9. Chase Under Roof

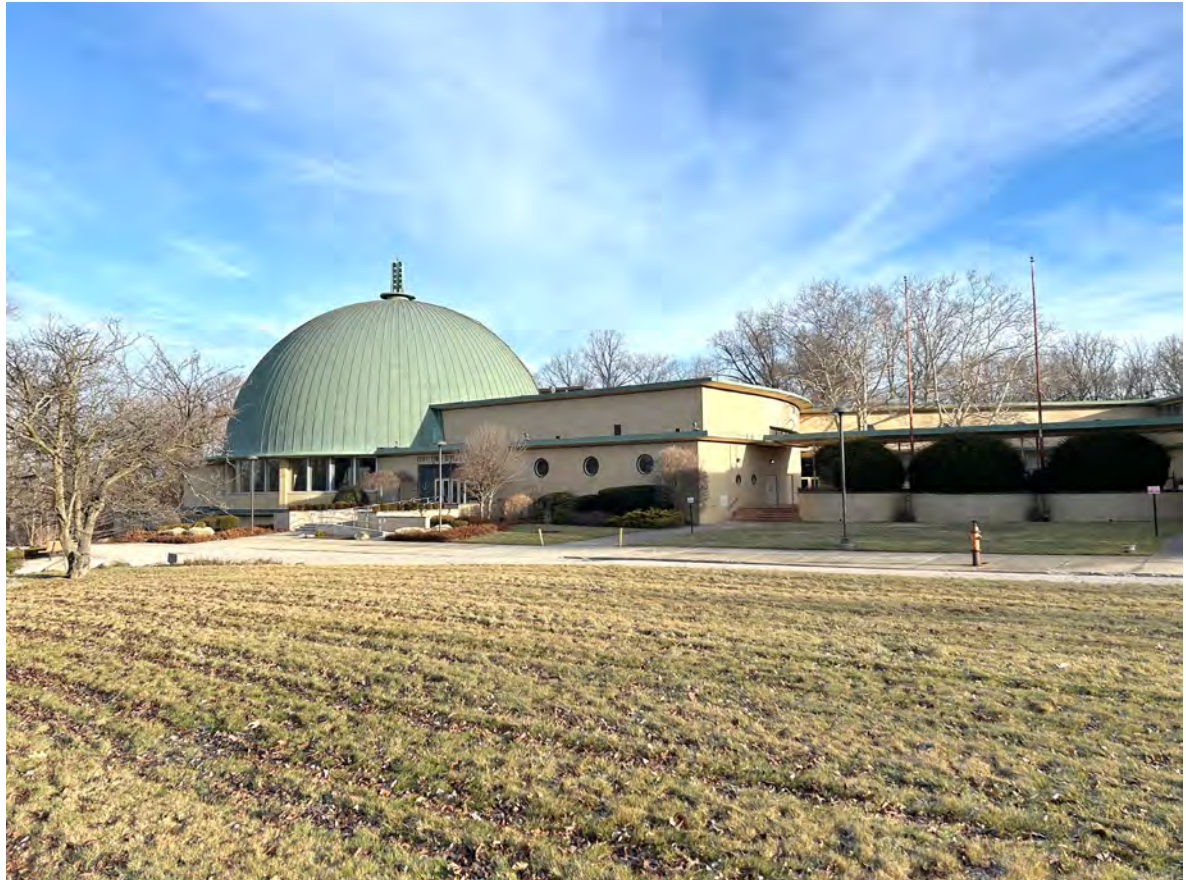
Present Day Photo

HISTORIC ALTERATIONS

- 1. Site Lighting Poles
- 2. Ramp Over Entry Stairs
- 3. Double-Thick Fascia
- 4. Facade Lighting
- 5. Chase Under Roof
- 6. Courtyard Storage Addition*

*2003 Storage addition removed large window and converted a public connection to courtyard into a janitorial/service entry.

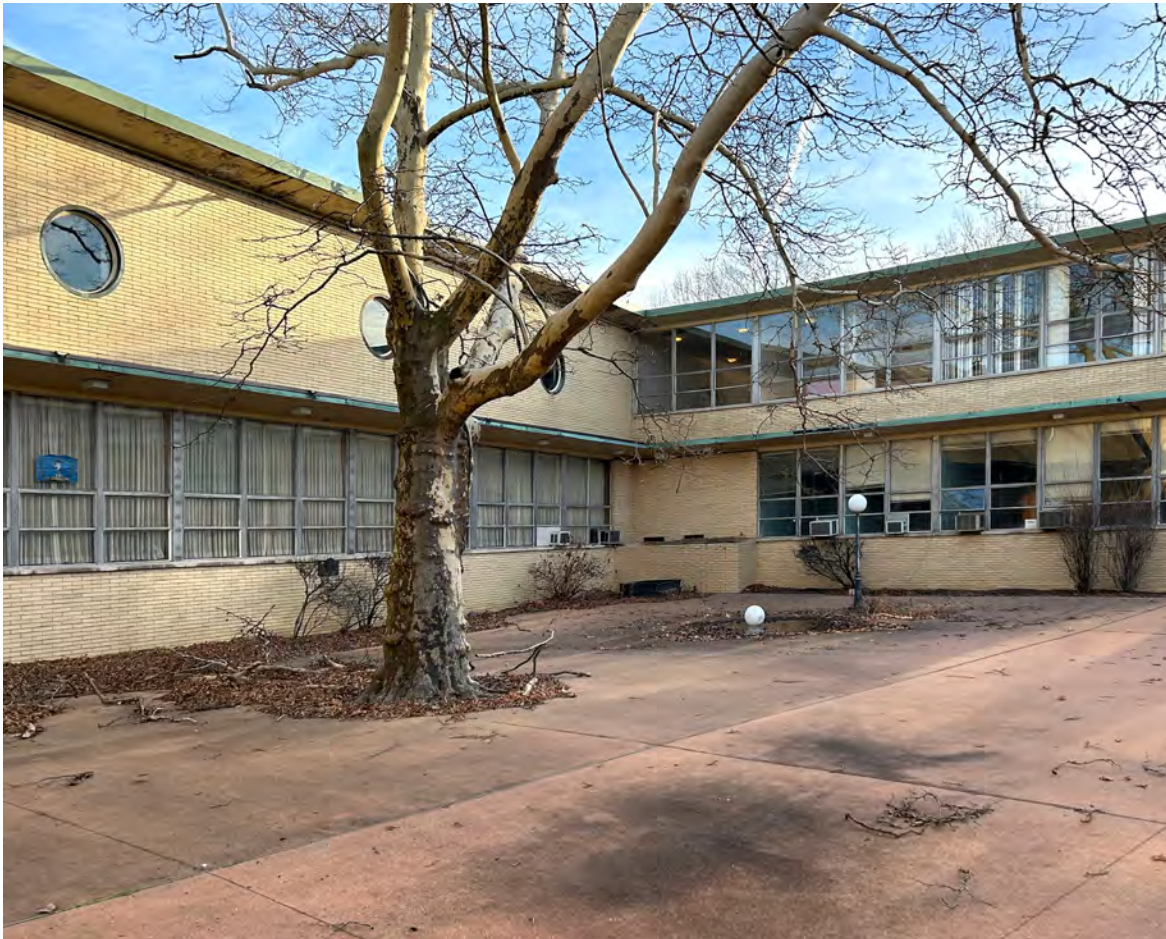
Present Day Photo

HISTORIC ALTERATIONS

- 1. Paving Infill of Circular Lawn Area
- 2. Removal of Existing Trees*
- 3. Addition of Non-period Fixtures
- 4. Change in Concrete Pattern/Shape
- 5. Inconsistent Perimeter Plantings
- 6. Thickened Fascia

*According to Mendelsohn’s design drawings, existing trees were to remain at random locations in the courtyard. The two remaining trees appear to be original.

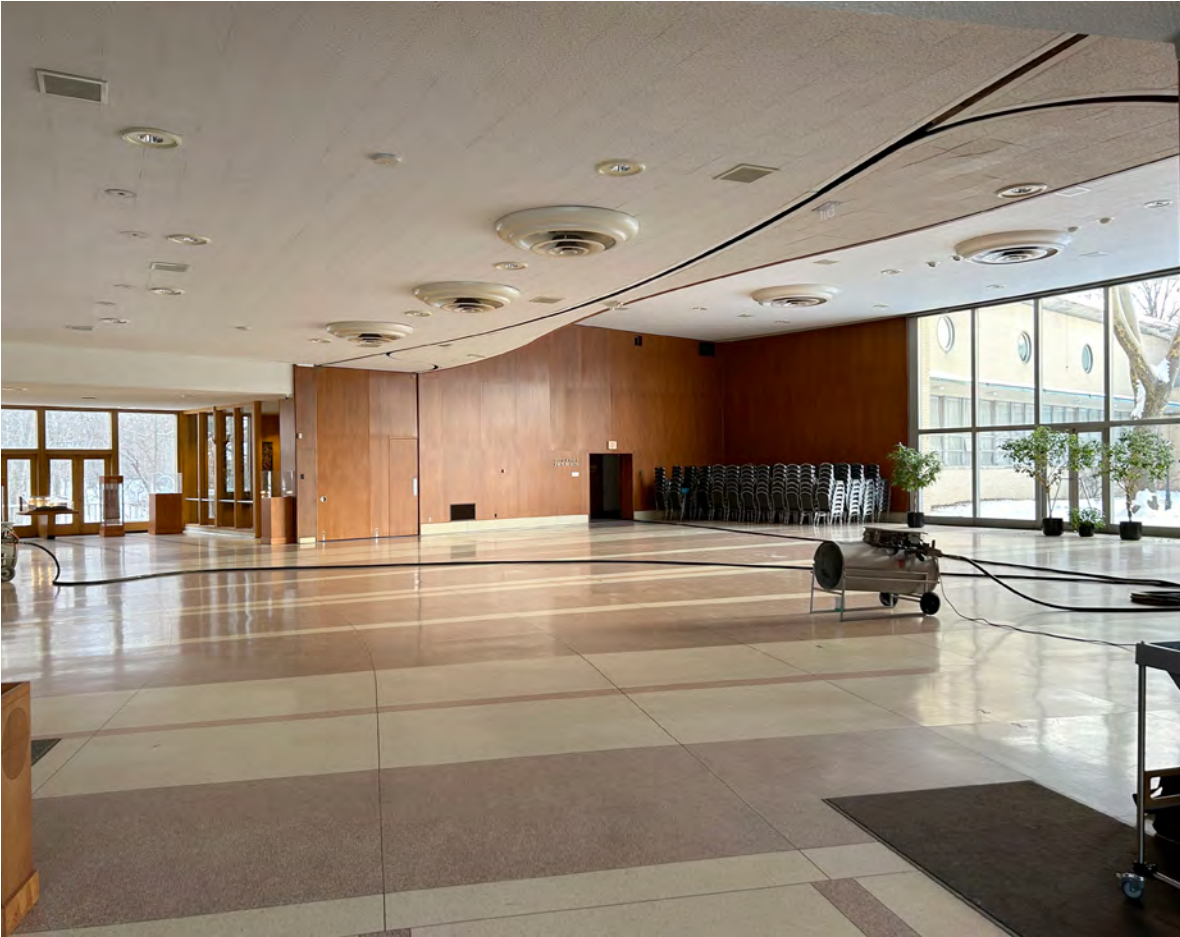
Present Day Photo

HISTORIC ALTERATIONS

- 1. Removal of Curtains
- 2. Non-Period Lighting Fixtures
- 3. Enlarged HVAC Diffusers
- 4. Repositioned Flush Doors
- 5. Removal of Projection Windows

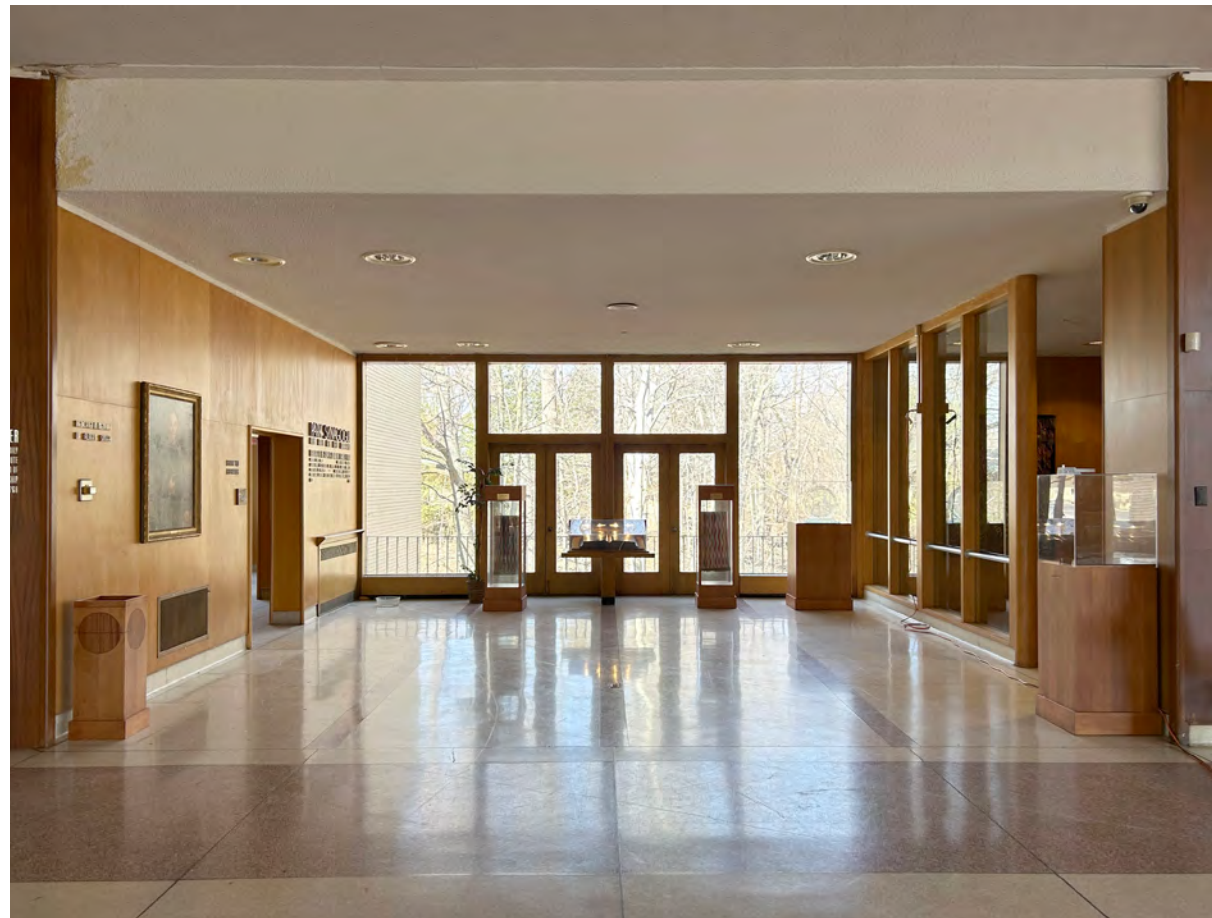
Present Day Photo

HISTORIC ALTERATIONS

1. Added Floor Outlet
2. Enlarged Opening to Elevator Lobby*
3. Added Hood Over Wall Heater
4. Original Signage Moved from Entry
5. Removal of Curtains
6. Non-Period & Added Lighting Fixtures
7. Added HVAC Diffuser
8. Added Exposed Electrical
9. Added Security Camera

*1998 Renovation of former men's restroom to lobby for elevator addition.

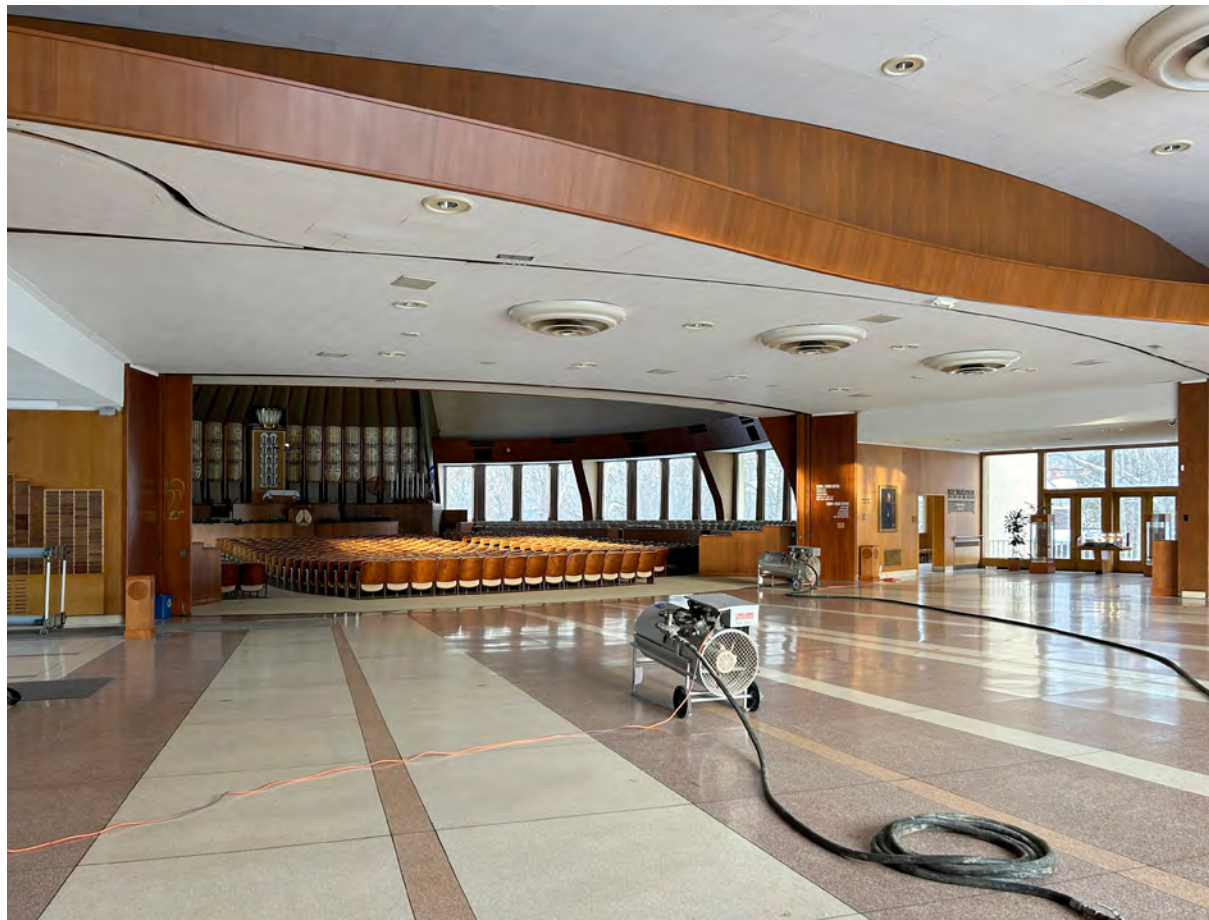
Present Day Photo

HISTORIC ALTERATIONS

1. Original Signage Moved for Memorial
2. Removal of Curtains
3. Non-Period Lighting Fixtures
4. Enlarged HVAC Diffusers
5. Removal of Speaker [Organ Tone Box]
6. Enlarged Opening to Elevator Lobby

Note: the original ceramic tile artwork shown on the wall of the historic photo has been relocated to the lobby of the administration wing.

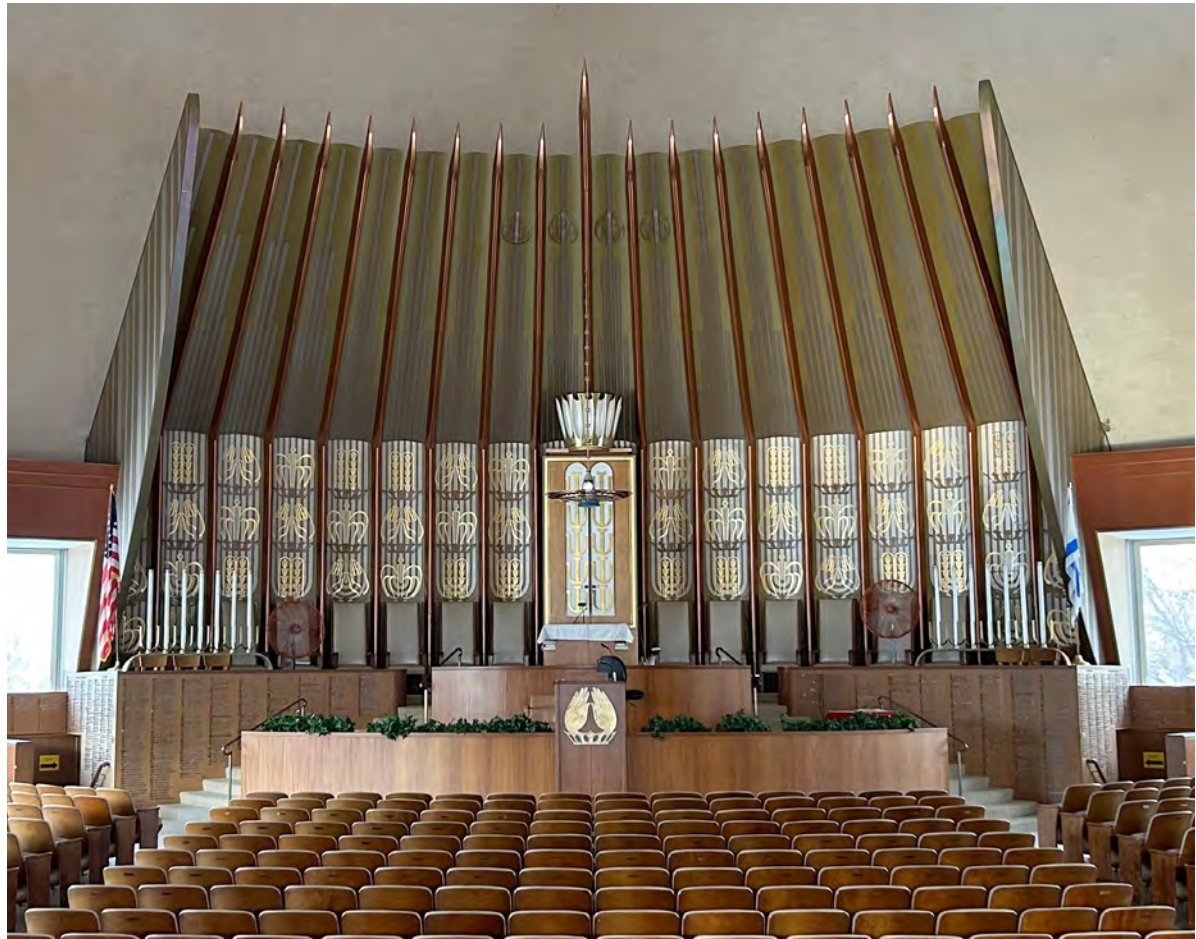
Present Day Photo

HISTORIC ALTERATIONS

1. Expanded List of Names in Memoriam

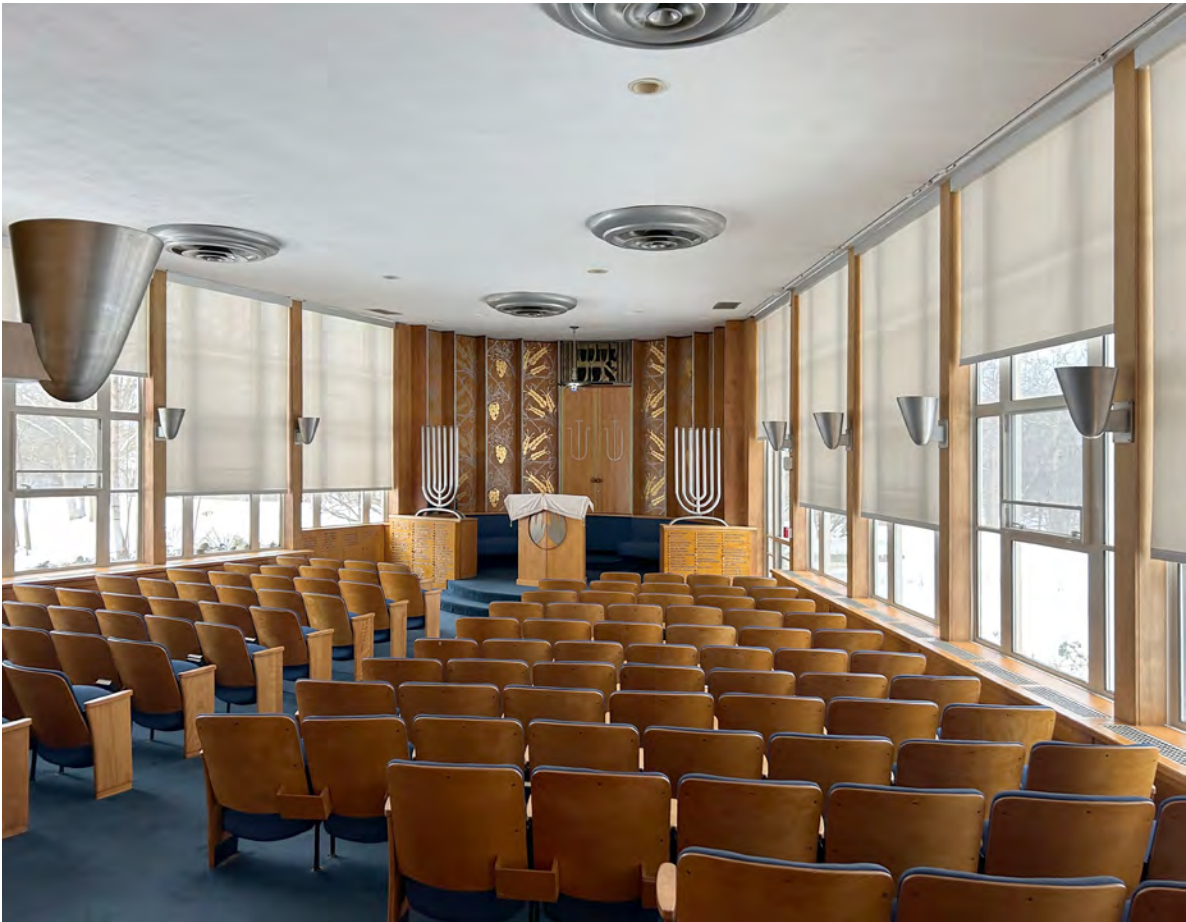
Present Day Photo

HISTORIC ALTERATIONS

- 1. Non-Period Replacement Windows
- 2. Former Door Closed In
- 3. Enlarged HVAC Diffusers
- 4. Added Return Air Vents
- 5. Added Non-Period Lighting Fixtures

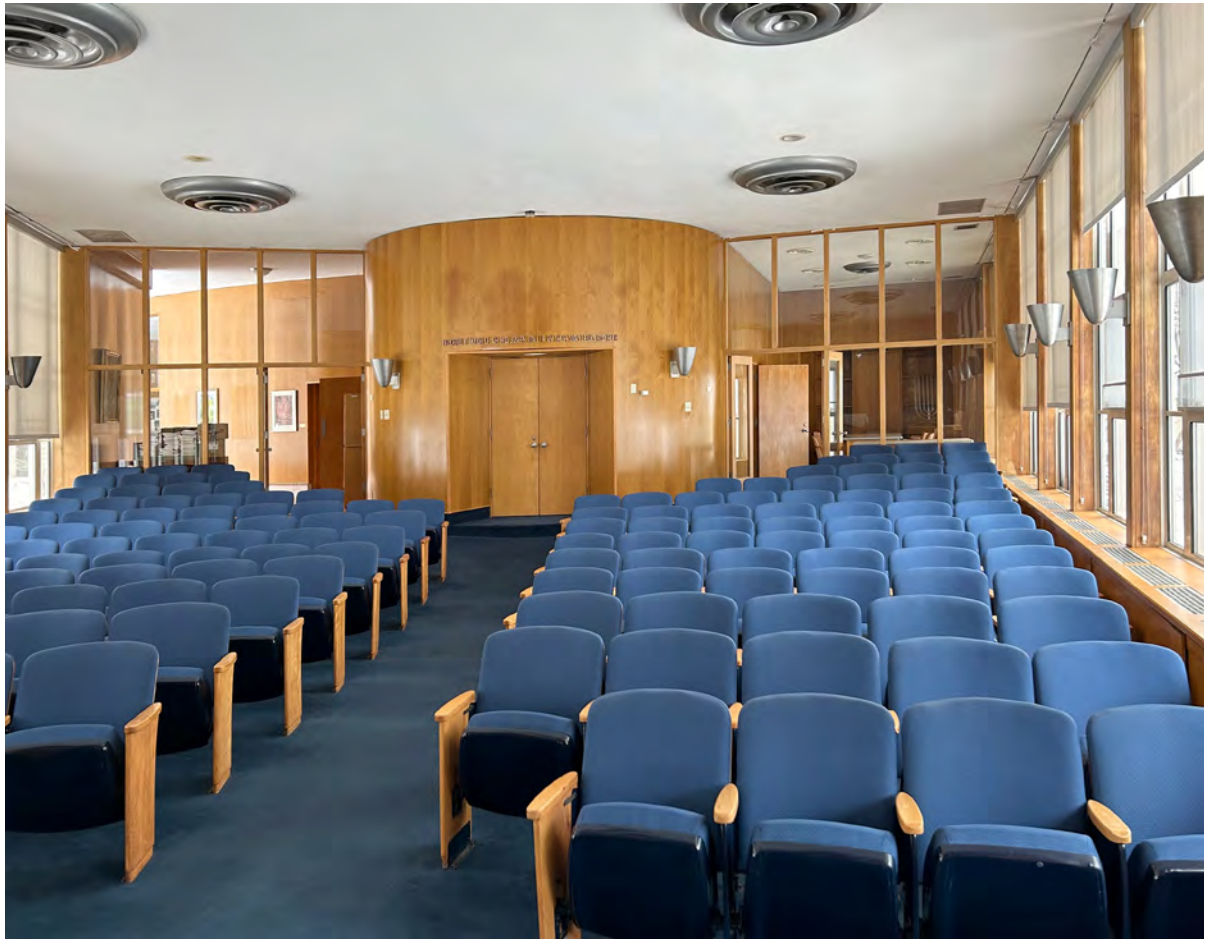
Present Day Photo

HISTORIC ALTERATIONS

- 1. Added Window Shades
- 2. Removal of Privacy Curtains
- 3. Added Return Air Vents
- 4. Enlarged HVAC Diffusers
- 5. Added Non-Period Lighting Fixtures
- 6. Added Dedication Signage
- 7. Added Wall Switches/Controls

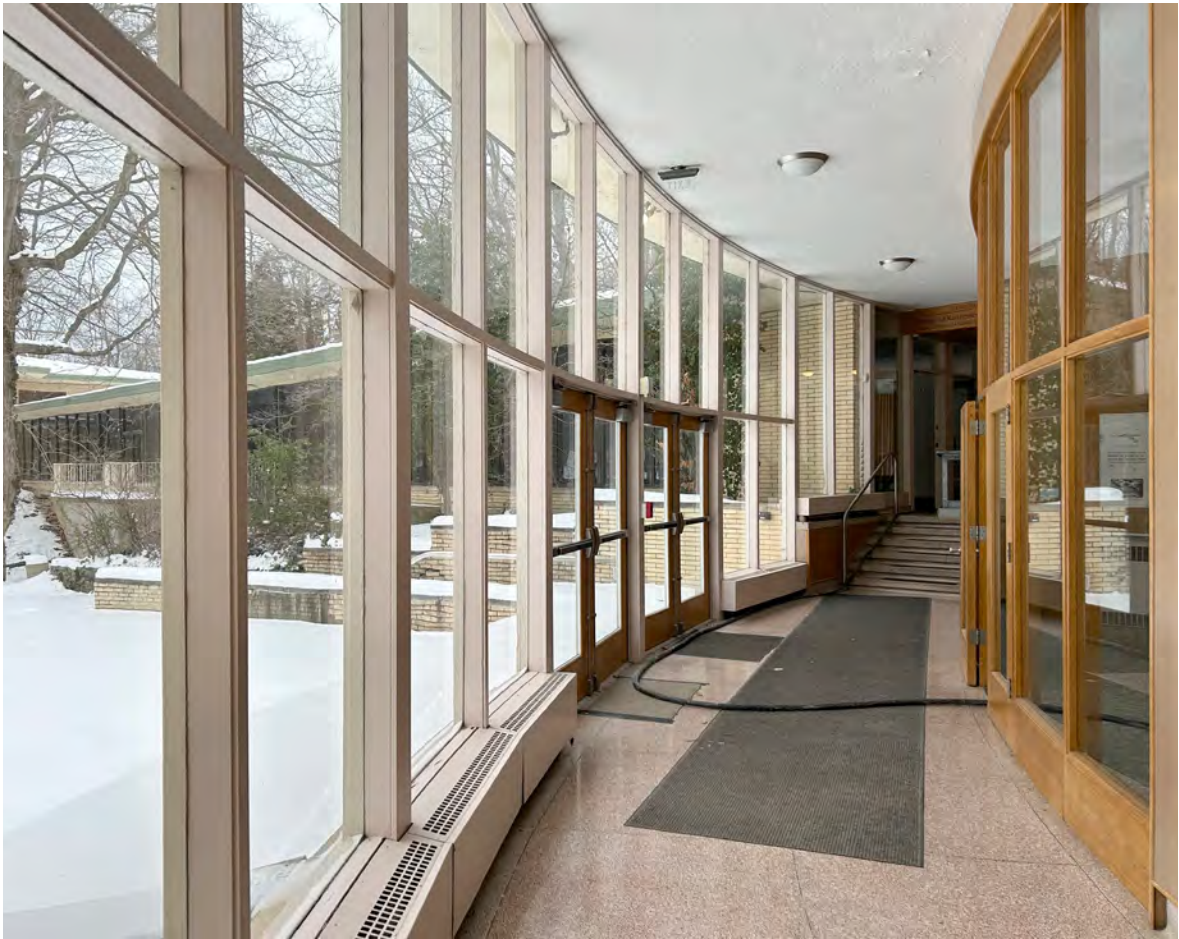
Present Day Photo

HISTORIC ALTERATIONS

- 1. Bridge Addition*
- 2. Added Site Walls for Ramp
- 3. Panic Hardware on Exit Doors
- 4. Ceiling Painted Lighter Color**
- 5. Non-Period Lighting Fixtures
- 6. Added Stair Handrail

*1968 Bridge and Kangesser Hall Addition.

**Ceiling color appears to have originally matched between exterior and interior.

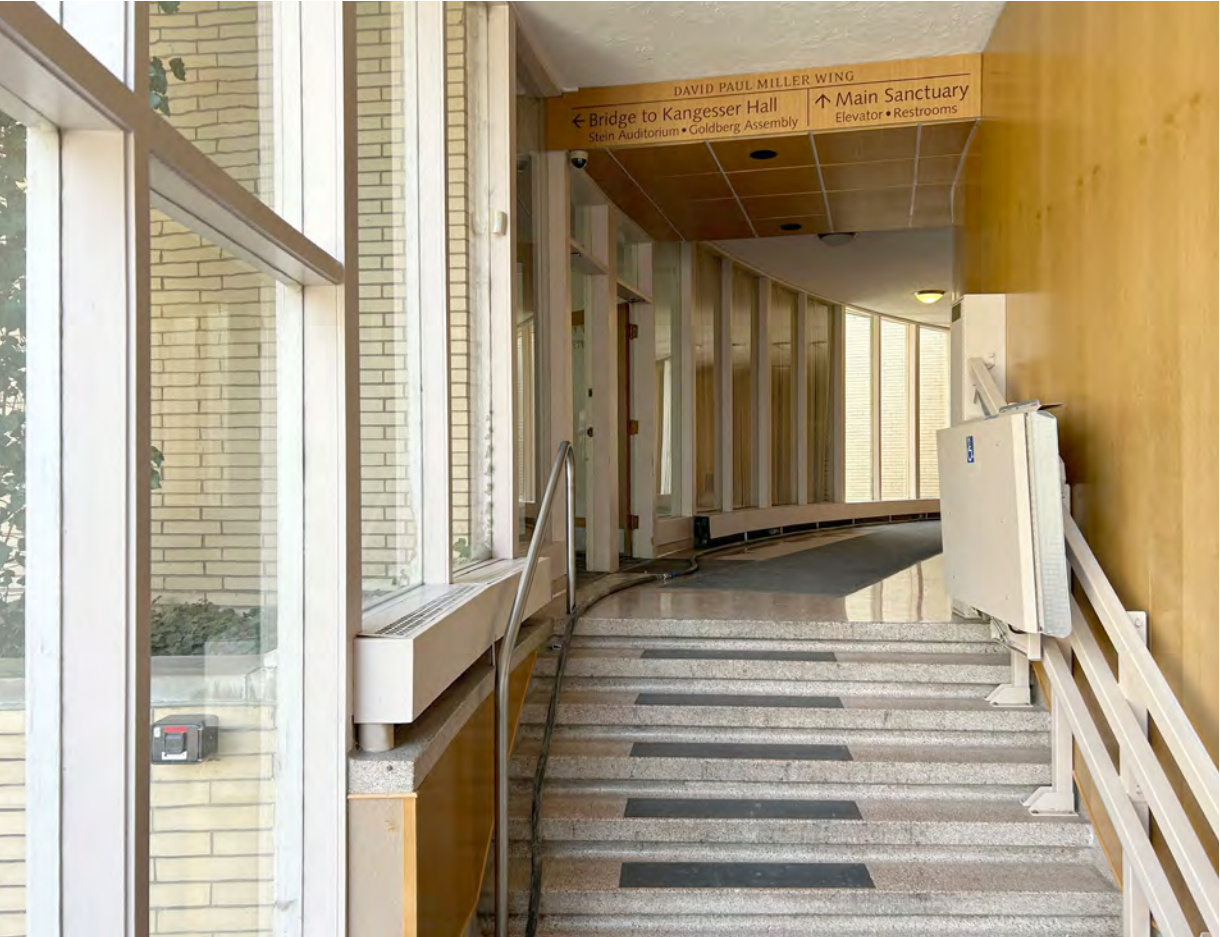
Present Day Photo

HISTORIC ALTERATIONS

- 1. Knox Box for CHFD
- 2. Bridge Addition*
- 3. Discolored Wood Panel
- 4. Added Handrail
- 5. Motion Detector & Security Camera
- 6. Non-Period Ceiling Signage Feature
- 7. Non-Period Lighting Fixtures
- 8. Window System Altered for Doors
- 9. Curtains of Office in Bridge
- 10. Elevator Addition**
- 11. Slip-Resistant Pads on Stairs
- 12. Handrail Replaced with ADA Lift

*1968 Bridge and Kangesser Hall Addition.

**1998 Elevator Addition

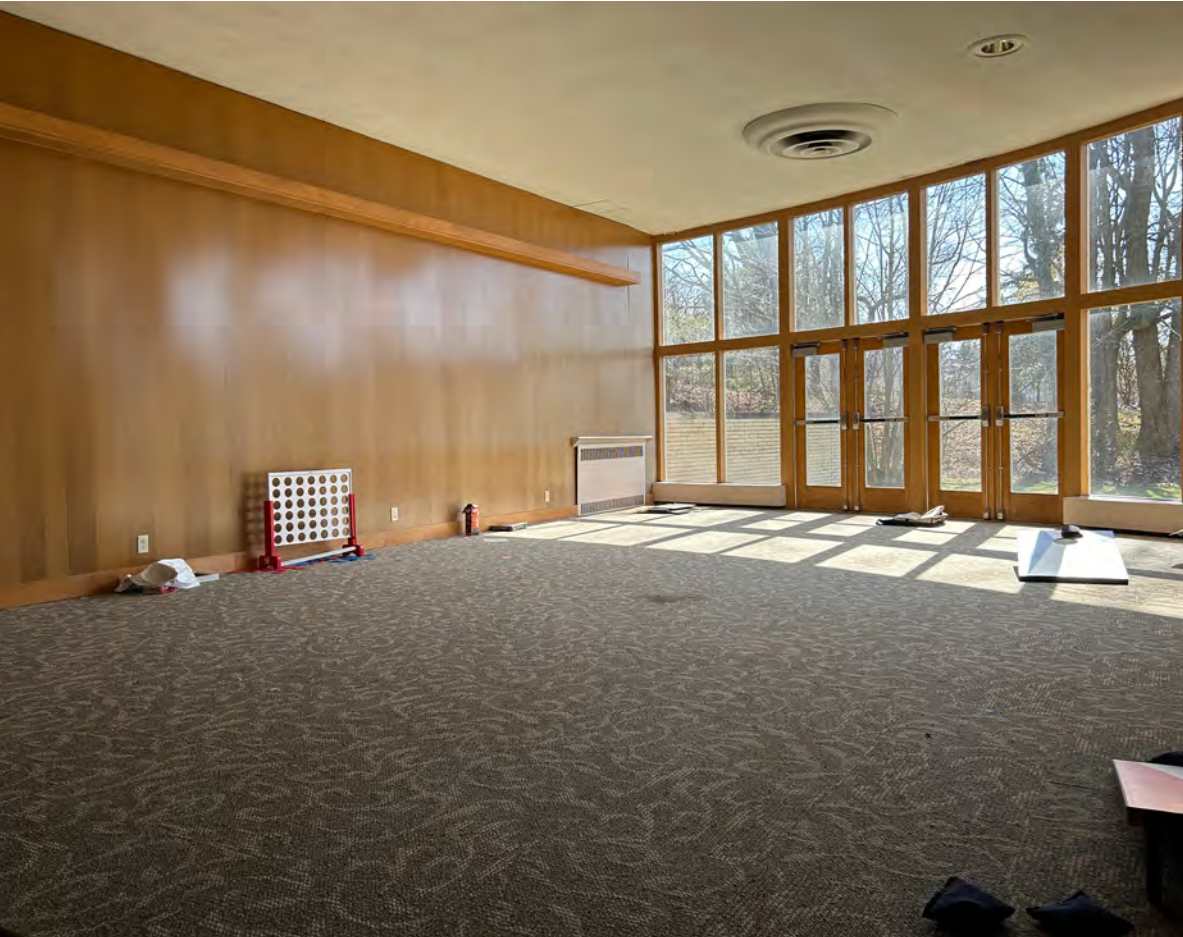
Present Day Photo

HISTORIC ALTERATIONS

- 1. Replaced Wood Paneling
- 2. Wood Cove Lighting
- 3. Added Hood Over Wall Heater
- 4. Enlarged HVAC Diffusers
- 5. Non-Period Lighting Fixtures
- 6. Removed Curtains
- 7. Panic Door Hardware

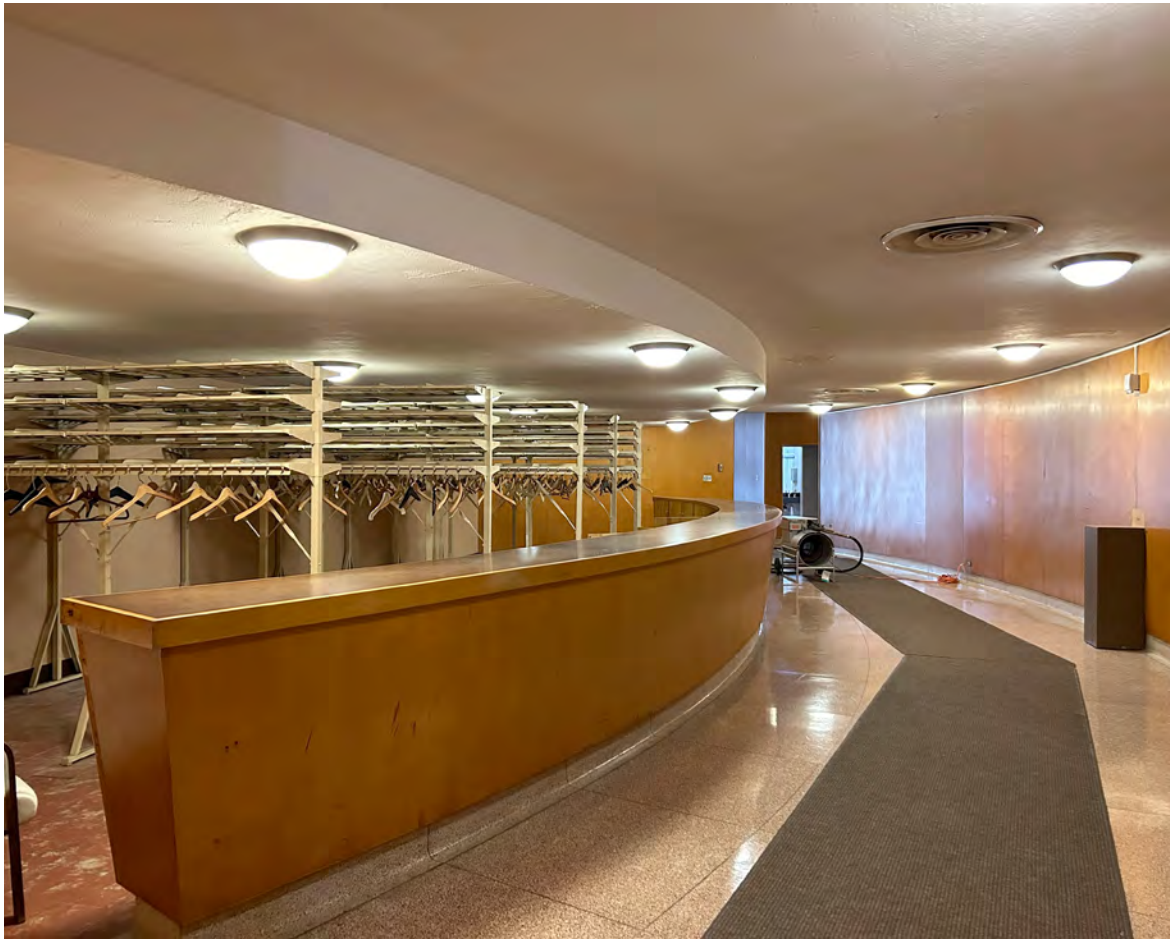
Present Day Photo

HISTORIC ALTERATIONS

- 1. Removed Millwork Doors
- 2. Non-Period Lighting Fixtures
- 3. Alarm Device with Exposed Conduit
- 4. Removed Drinking Fountain

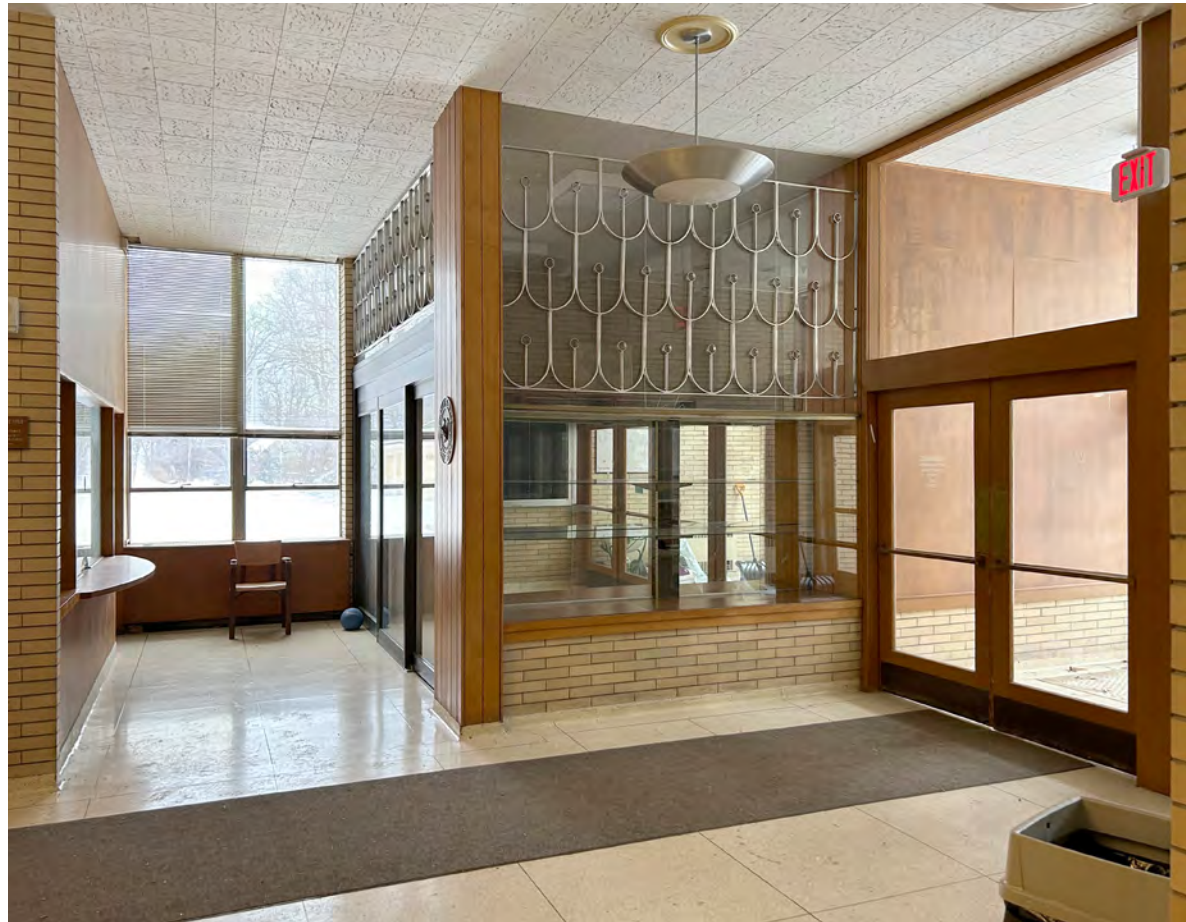
Present Day Photo

HISTORIC ALTERATIONS

- 1. Window Blinds Replaced Curtains
- 2. Added Storefront System
- 3. Added Dedication Plaque
- 4. Non-Period Lighting Fixture
- 5. Added *Shin* Decorative Grill
- 6. Added Mirror Glass at Display
- 7. Replaced Wood Paneling
- 8. Non-Period Exit Sign
