Then / Now Photo Comparison

Scanned Photos of Park Synagogue from the Western Reserve Historical Society Archive Compared to Present Day Photos to Identify Alternations over time for the Historic Preservation.

By David Craun, AIA, Cleveland Planning Advisors, LLC, Owner Representative Services

Park Synagogue
Mendelsohn Restoration

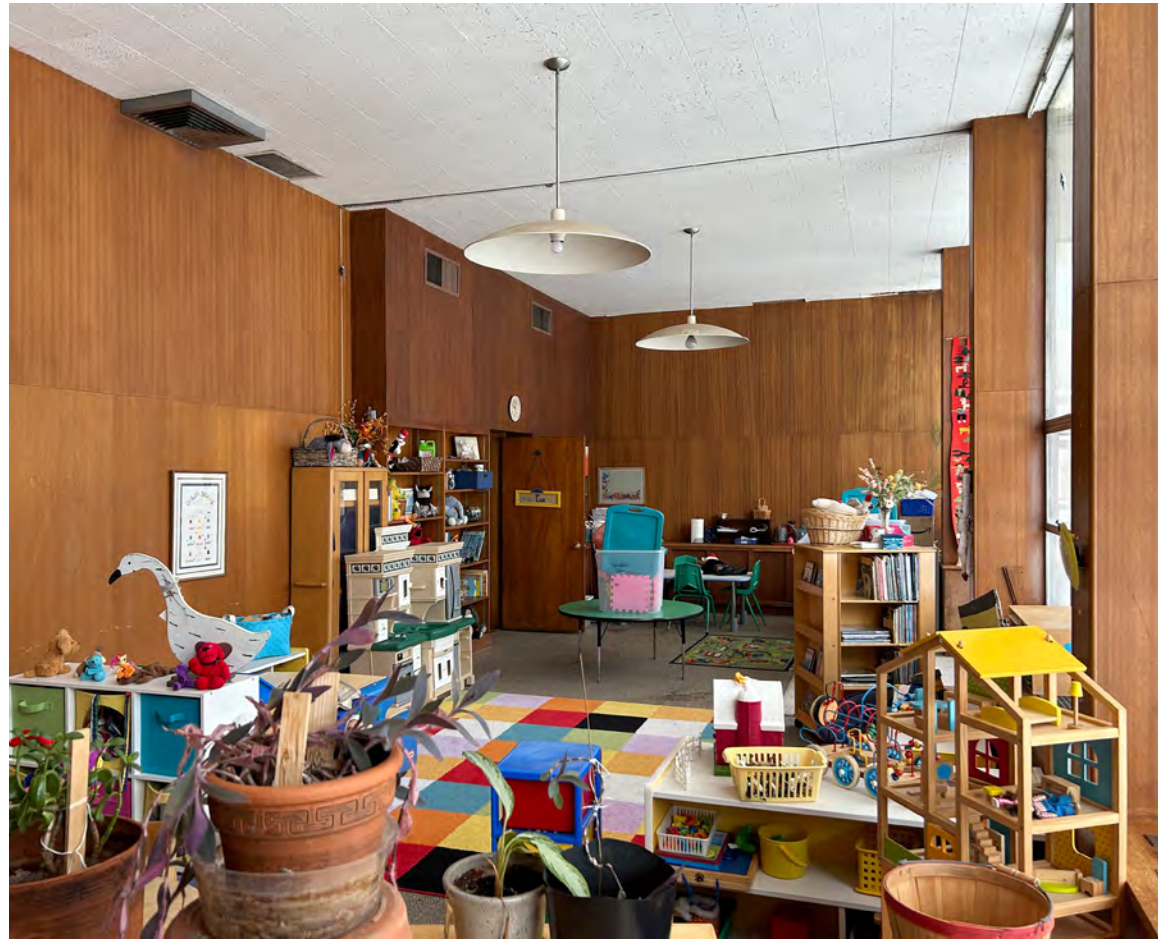
Present Day Photo

HISTORIC ALTERATIONS

- 1. Added HVAC Ceiling Return Air
- 2. Removed Privacy Curtains
- 3. Added HVAC Wall Diffuser
- 4. Removed Lighting Fixture Reflector
- 5. Removed Built-In Desk

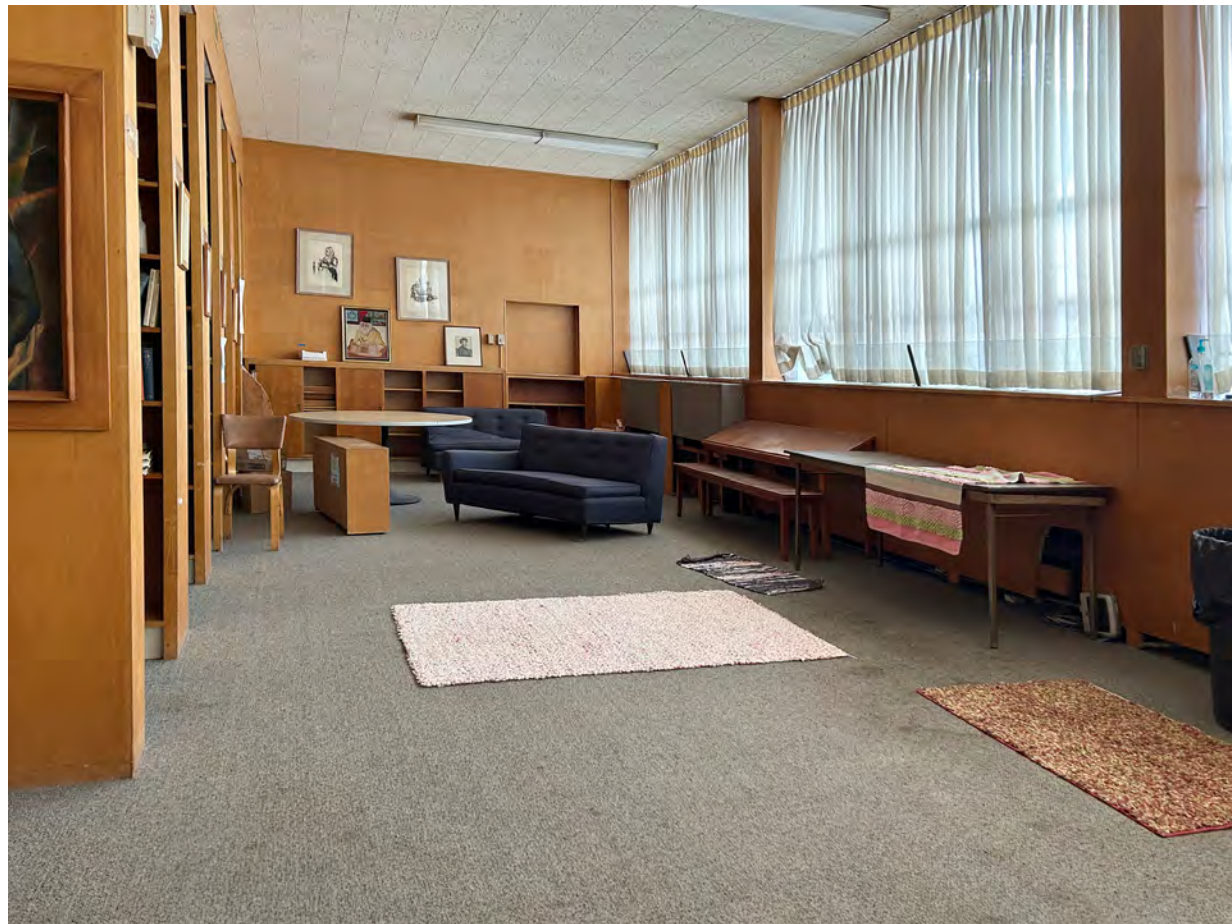
Present Day Photo

HISTORIC ALTERATIONS

1. Non-Period Lighting Fixtures
2. Casework Blocking Door
3. Added Radiators
4. Added Electrical Outlets
5. Removed Built-In Desk

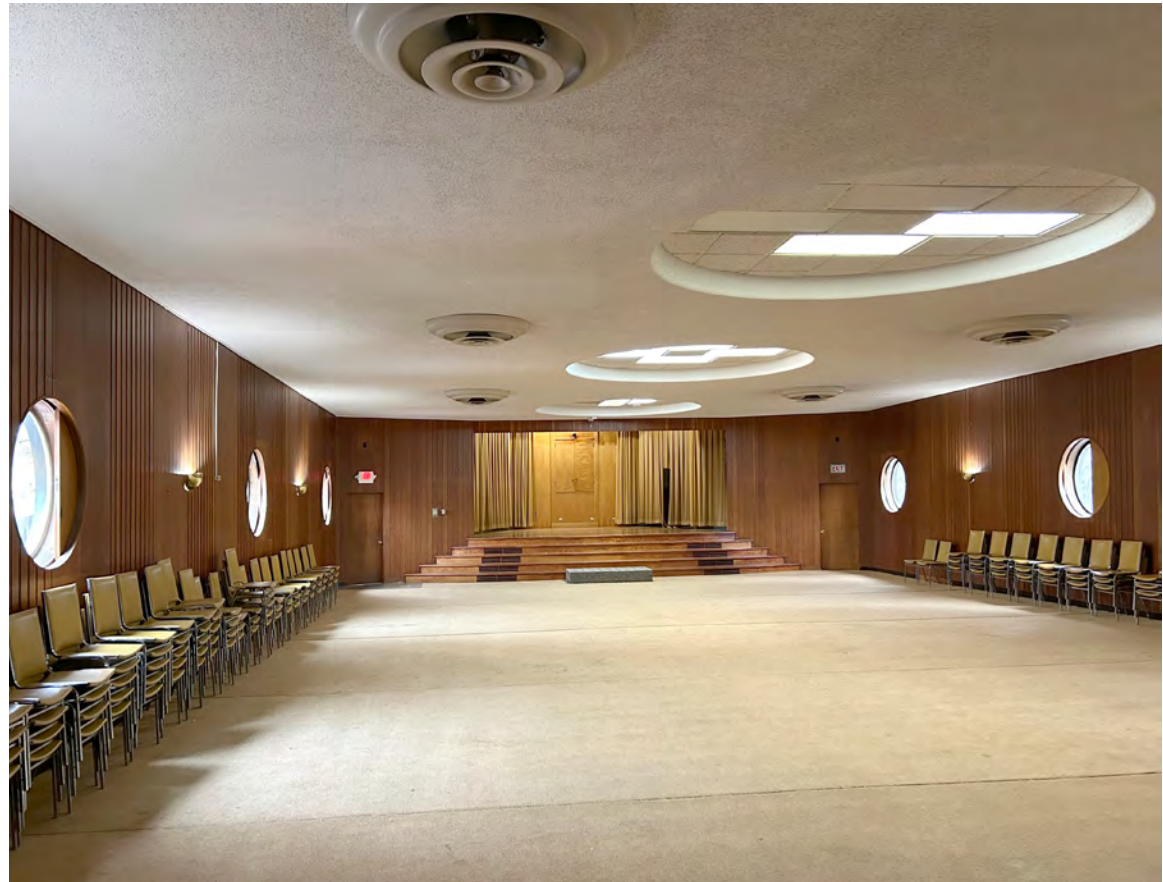
Present Day Photo

HISTORIC ALTERATIONS

- 1. Enlarged HVAC Diffusers
- 2. Added ACT Ceiling in Lighting Coves
- 3. Removed Wall-Mounted Speakers
