Then / Now Photo Comparison

Scanned Photos of Park Synagogue from the Western Reserve Historical Society Archive Compared to Present Day Photos to Identify Alternations over time for the Historic Preservation.

By David Craun, AIA, Cleveland Planning Advisors, LLC, Owner Representative Services

Park Synagogue
Mendelsohn Restoration

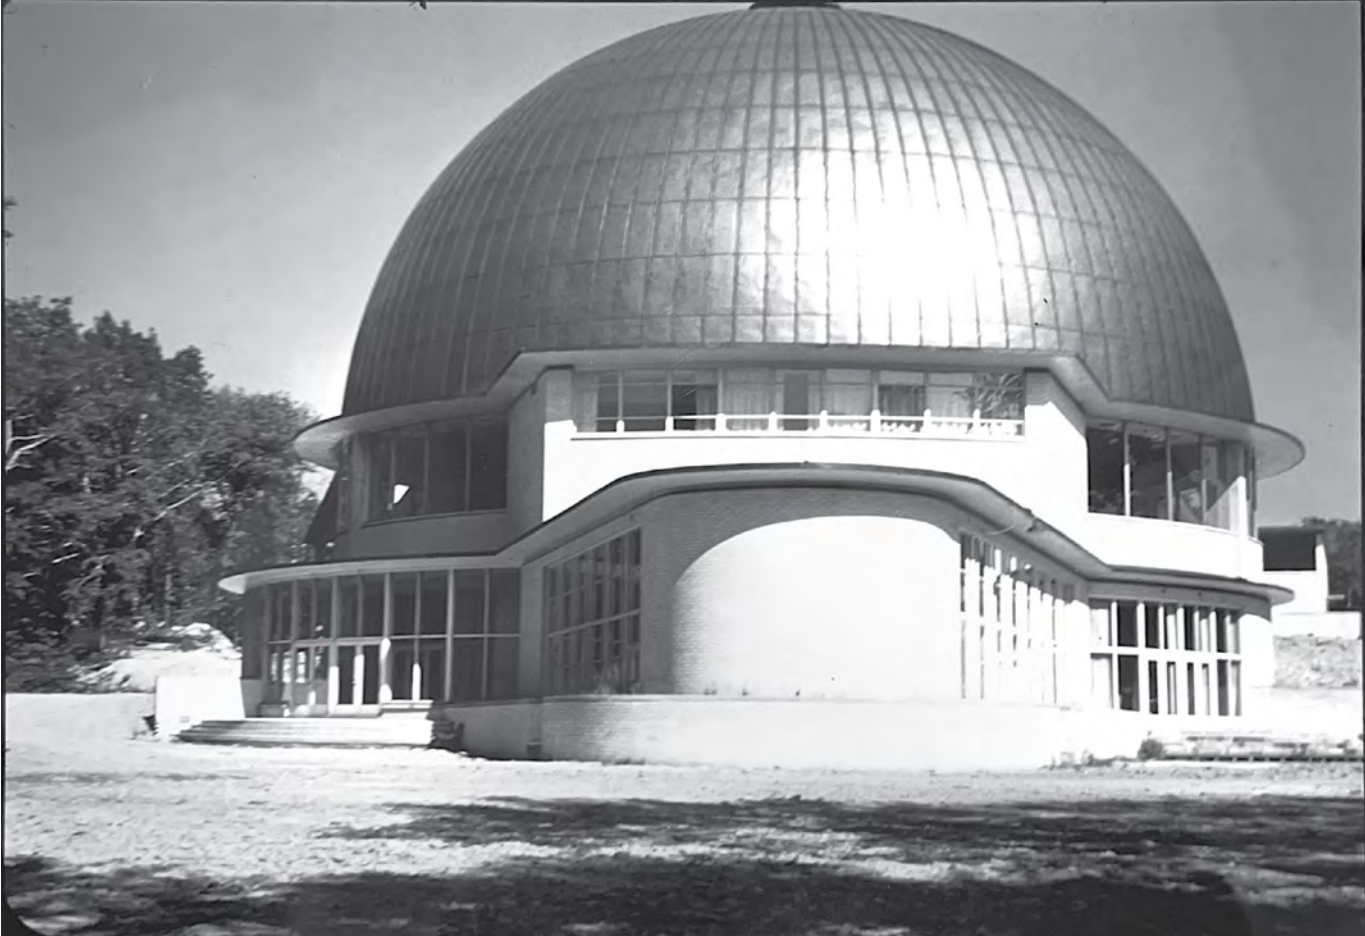
Historic Photo c.1950

HISTORIC ALTERATIONS

- 1. Added Site Walls for Ramp
- 2. Bridge Addition*
- 3. Elevator Addition
- 4. Non-Period Window Replacement
- 5. Facade Lighting
- 6. AC Unit in Window
- 7. Thickened Fascia

*1968 Bridge and Kangesser Hall addition.
Note: landscape alternations not included.

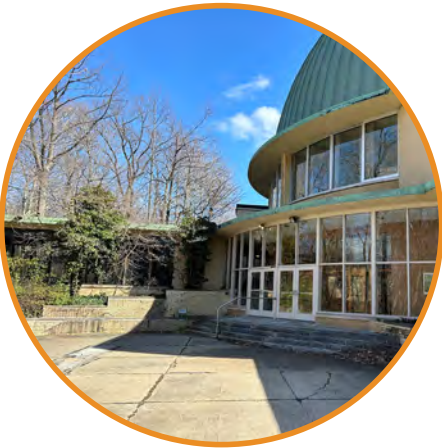
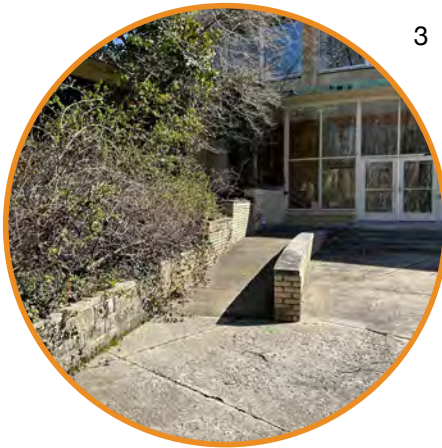
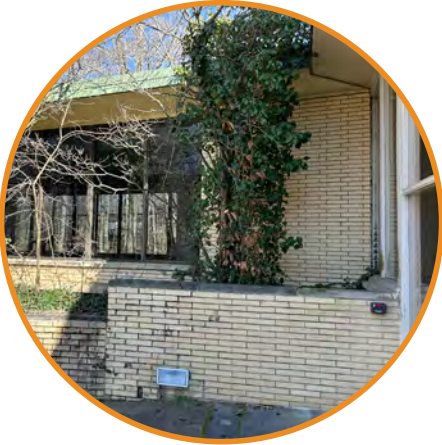
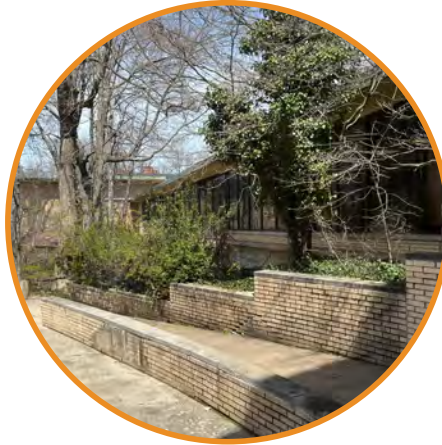
Reference photos of ramp alternation.

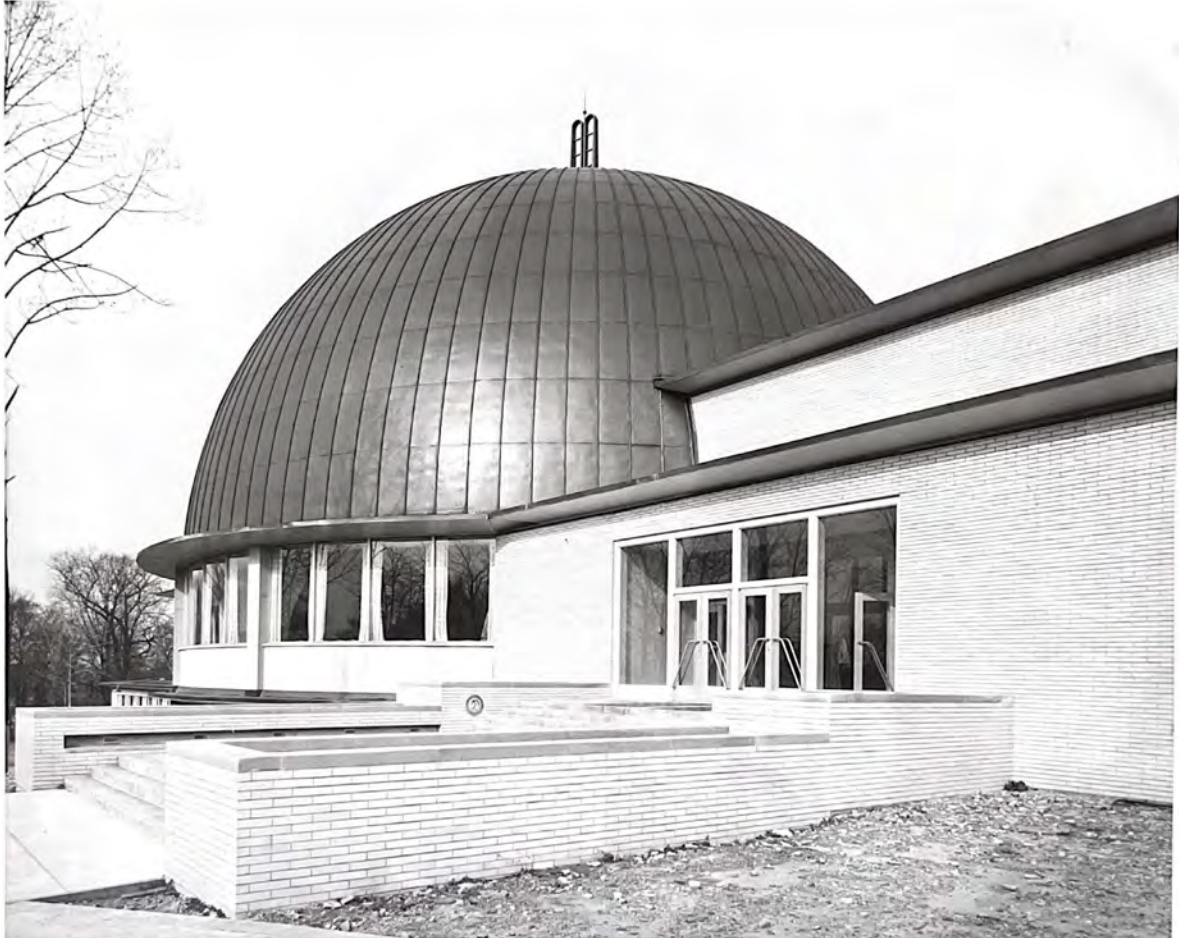
Historic Photo c.1950

HISTORIC ALTERATIONS

- 1. ADA Ramp Over Stairs
- 2. Step Lighting
- 3. Ramp/Garden Wall
- 4. Stair Handrails
- 5. Thickened Fascia
- 6. Roof lighting
- 7. Double-Thick Fascia
- 8. Exposed Electrical

Incomplete Elements In Historic Photo:

- Sacred Letters in Copula
- Sacred Words Above Entry
- Patterned Grills Over Glass

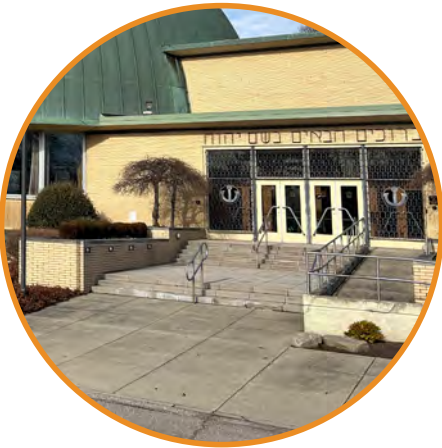
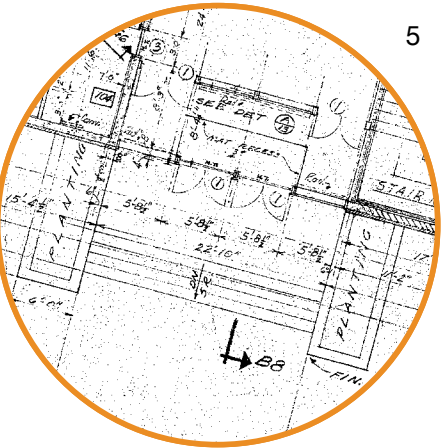
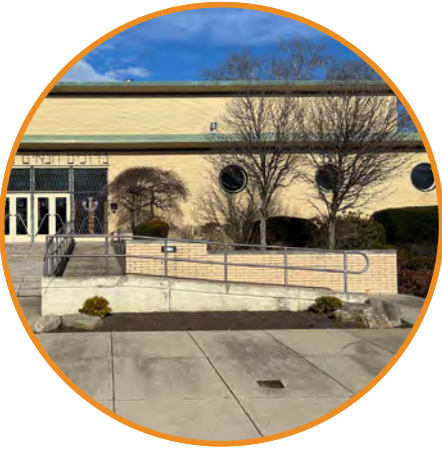
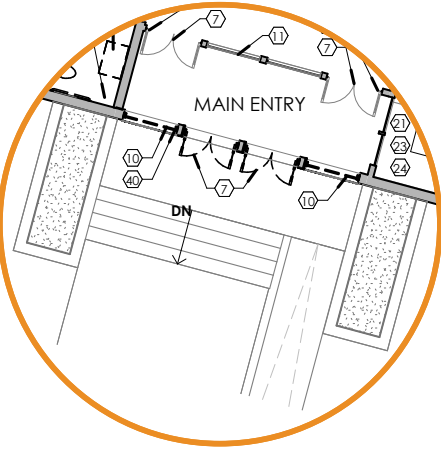
Reference drawings/photos of ADA ramp.

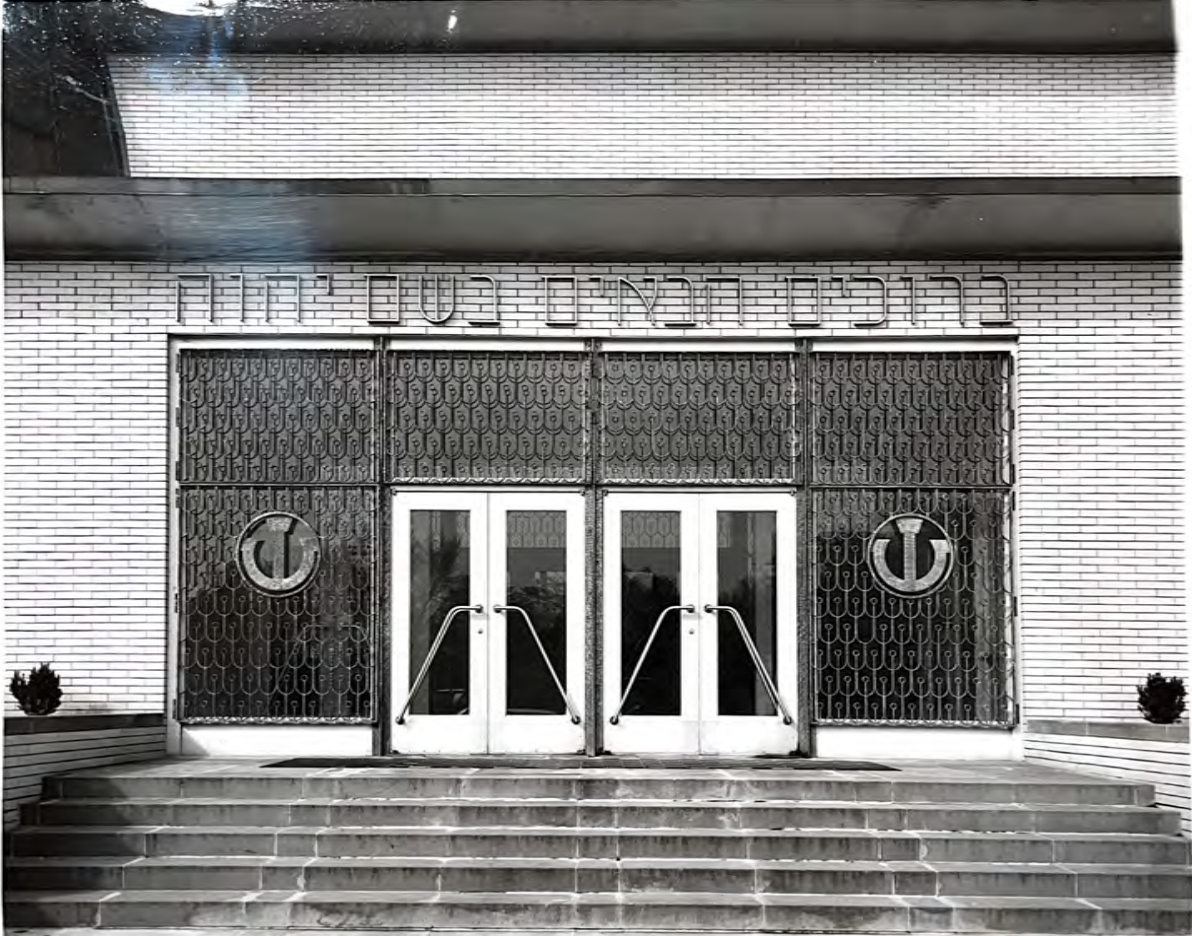
Historic Photo c.1955

HISTORIC ALTERATIONS

- 1. Ramp Over Stairs
- 2. Stair/Ramp Handrails
- 3. Knox Box for CHFD
- 4. Historic Building Marker
- 5. Double-Thick Fascia

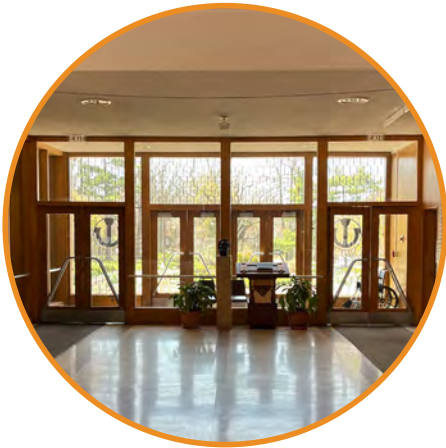
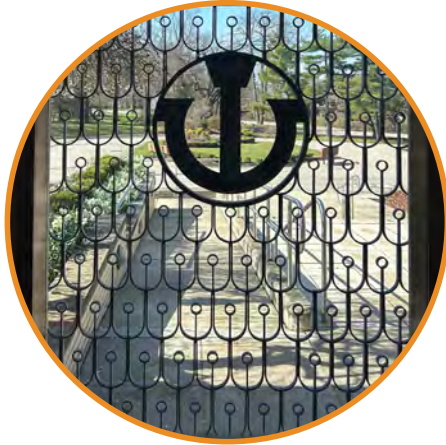
Reference photos of entry interior.

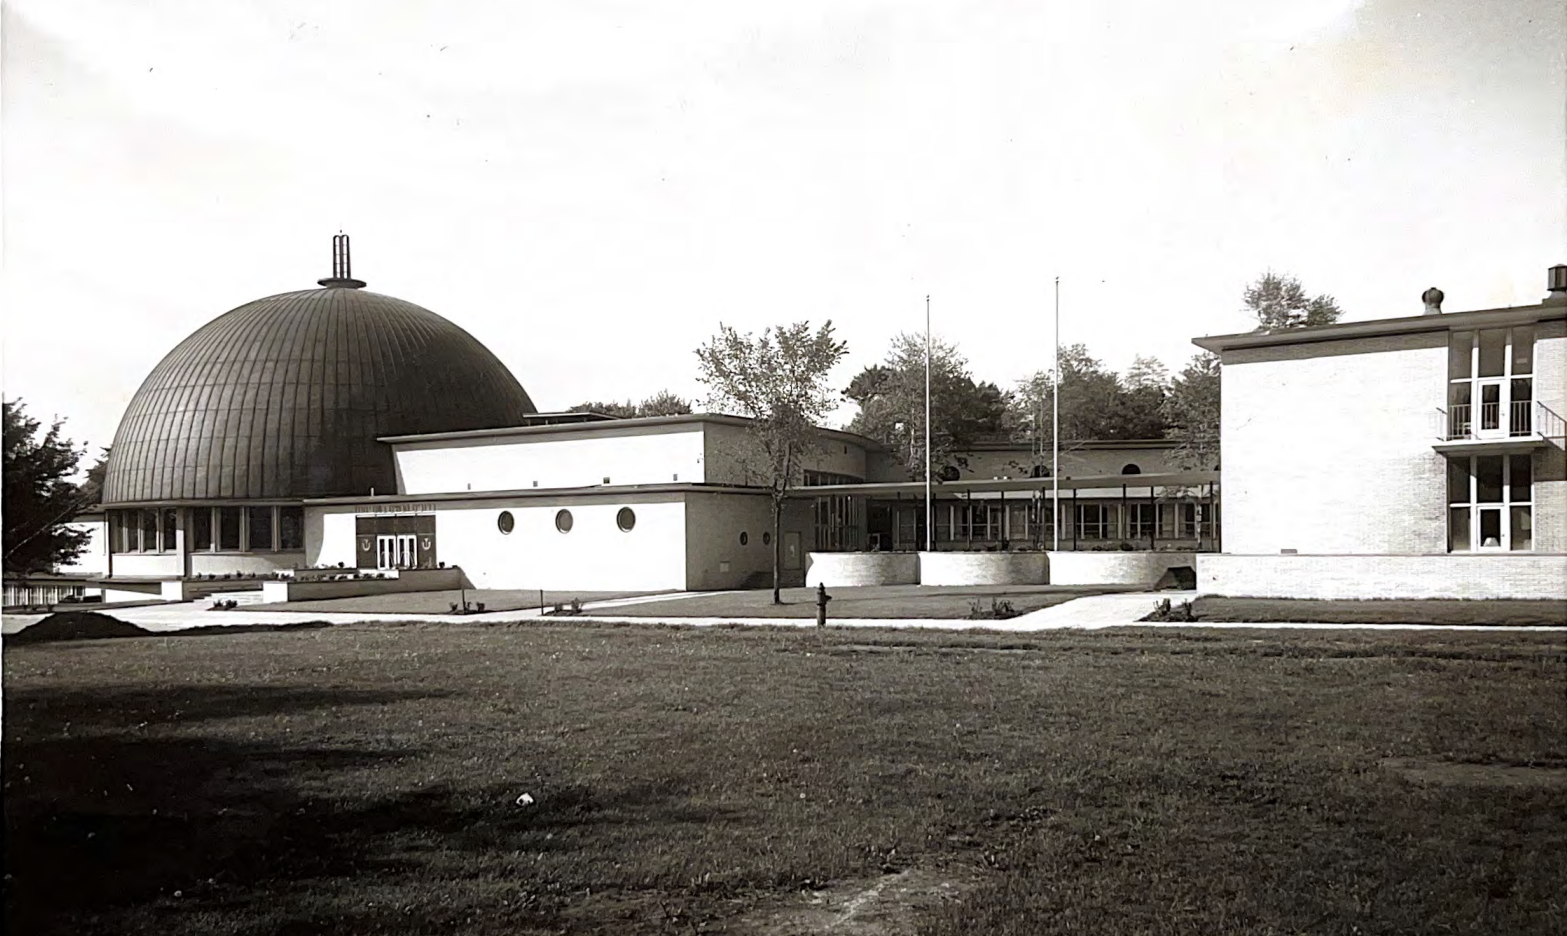
Historic Photo c.1955

HISTORIC ALTERATIONS

- 1. Site Lighting Poles
- 2. Stair Handrails
- 3. Ramp Over Entry Stairs
- 4. Enlarged Facade Vent
- 5. Roof lighting
- 6. Double-Thick Fascia
- 7. Enlarged Service Panel
- 8. Facade Lighting
- 9. Chase Under Roof

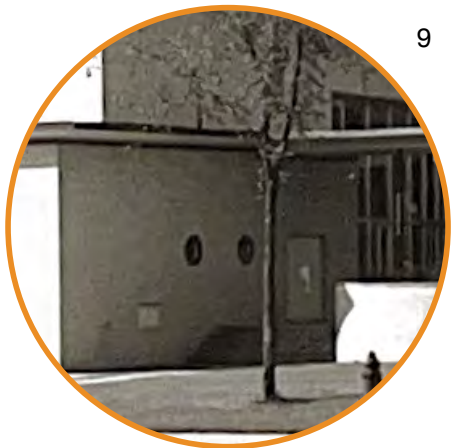
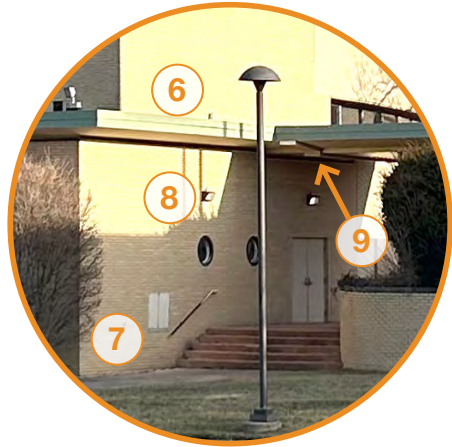
Enlarged detail photos for reference.

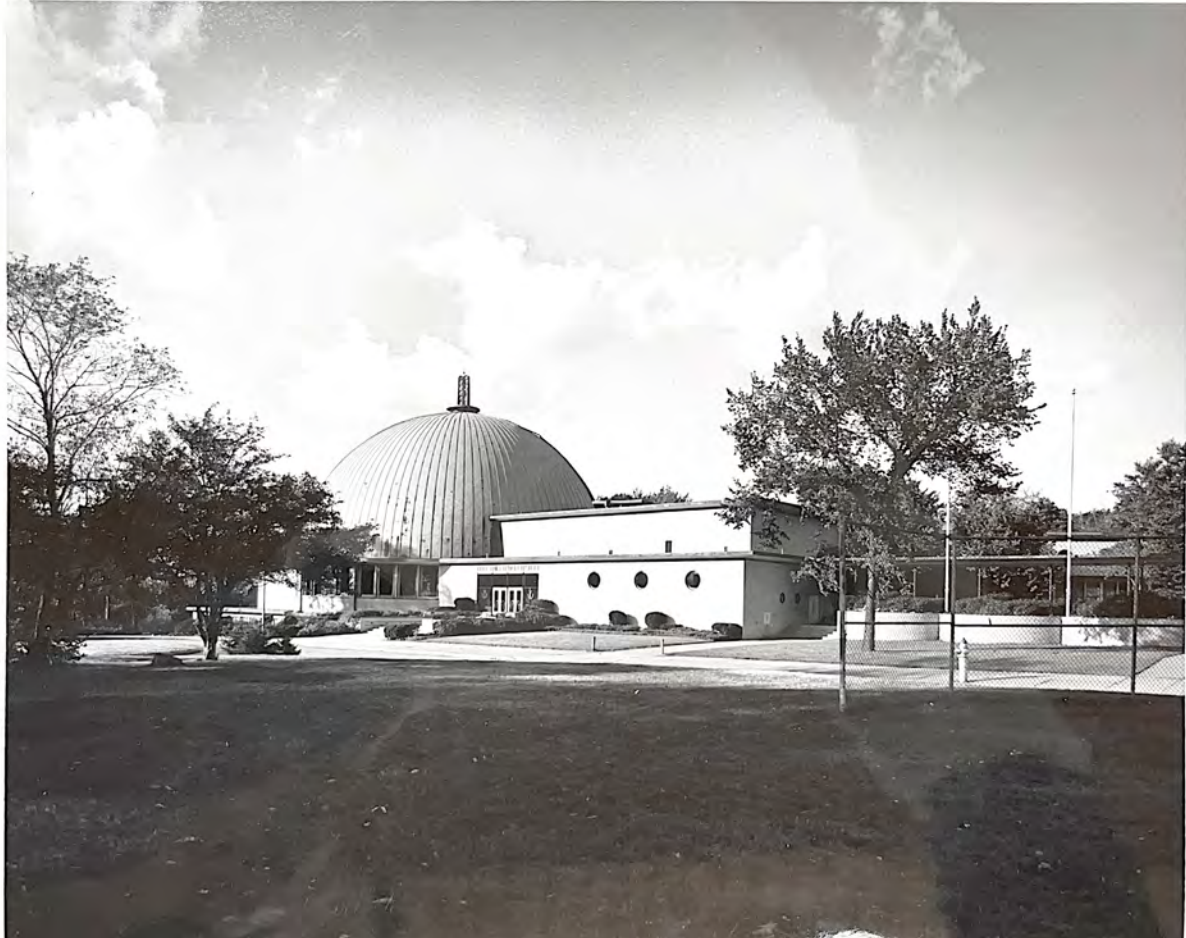
Historic Photo c.1970

HISTORIC ALTERATIONS

- 1. Site Lighting Poles
- 2. Ramp Over Entry Stairs
- 3. Double-Thick Fascia
- 4. Facade Lighting
- 5. Chase Under Roof
- 6. Courtyard Storage Addition*

*2003 Storage addition removed large window and converted a public connection to courtyard into a janitorial/service entry.

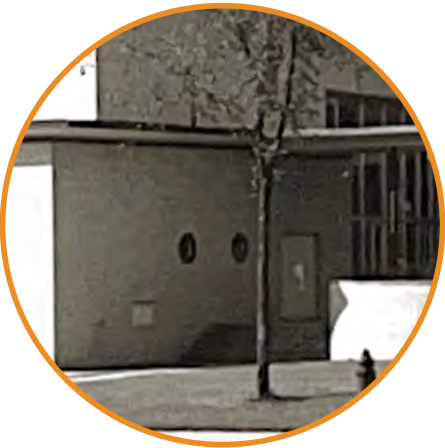
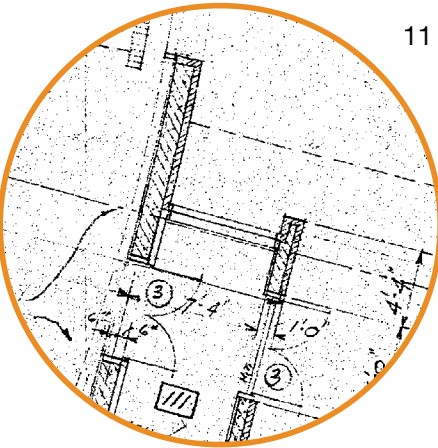
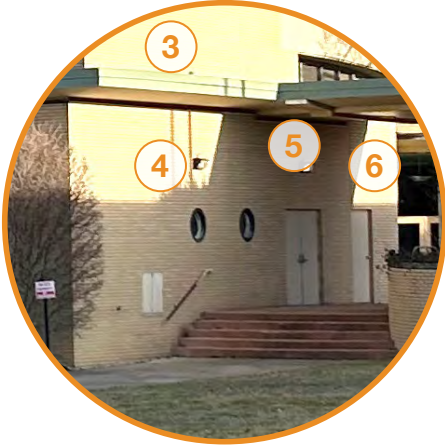
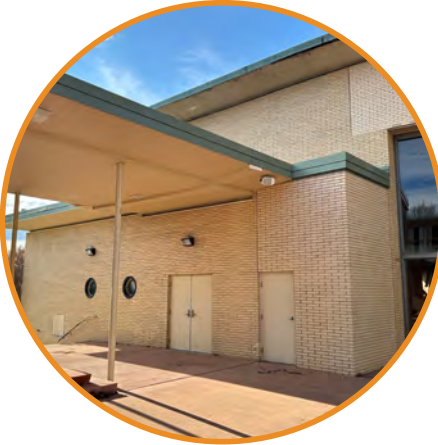
Enlarged photos and drawing/photos of storage room addition for reference.

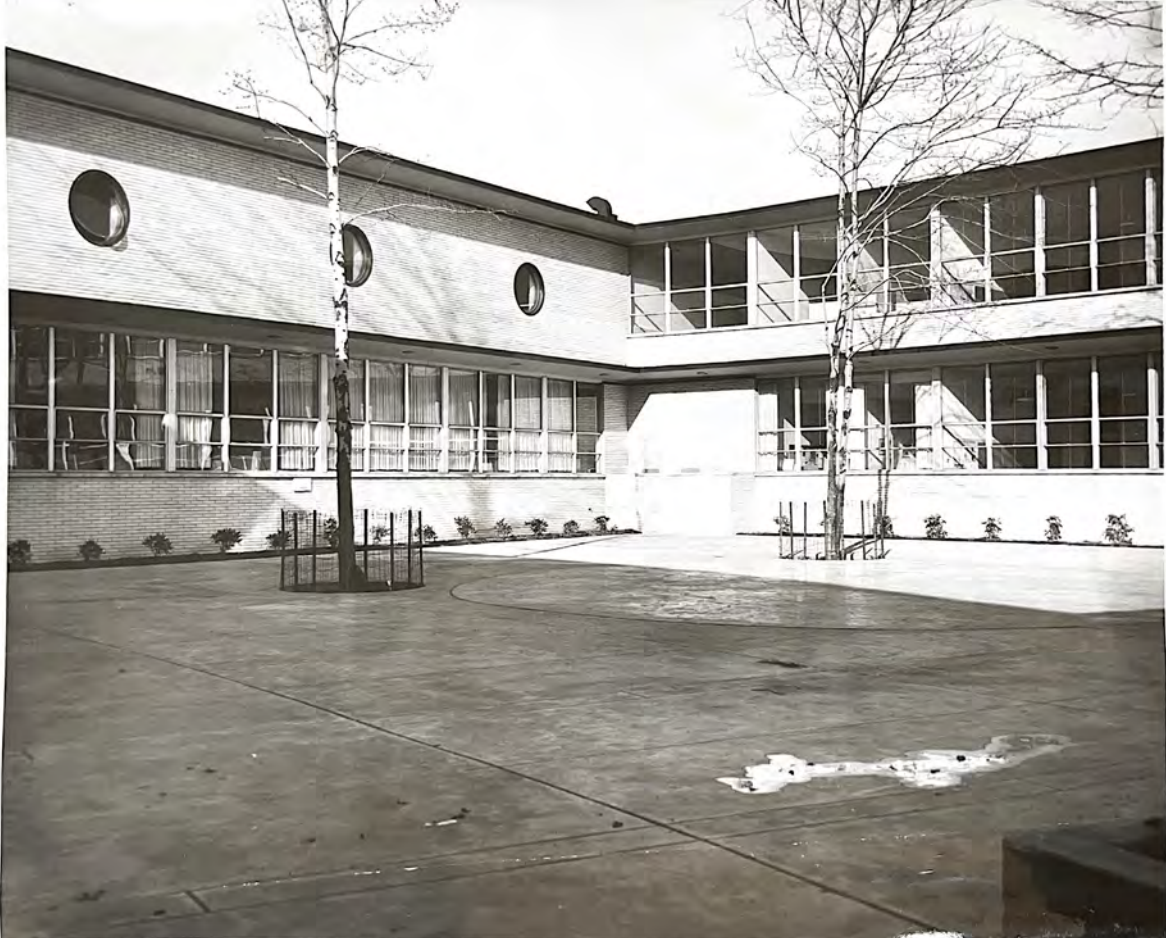
Historic Photo c.1955

HISTORIC ALTERATIONS

- 1. Paving Infill of Circular Lawn Area
- 2. Removal of Existing Trees*
- 3. Addition of Non-period Fixtures
- 4. Change in Concrete Pattern/Shape
- 5. Inconsistent Perimeter Plantings
- 6. Thickened Fascia

*According to Mendelsohn’s design drawings, existing trees were to remain at random locations in the courtyard. The two remaining trees appear to be original.

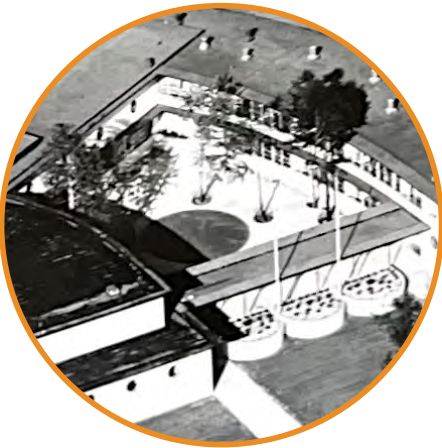
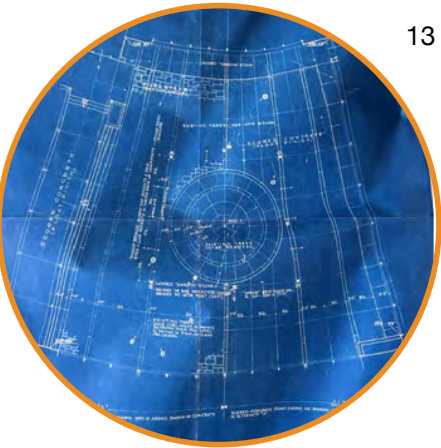
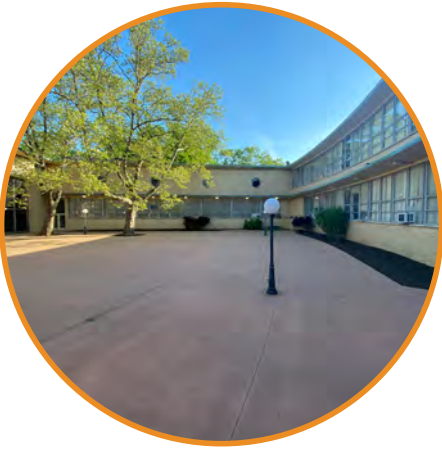
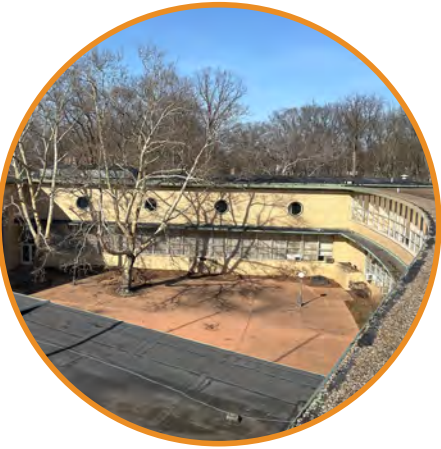
Reference drawing/photos of courtyard from c1955 to present.

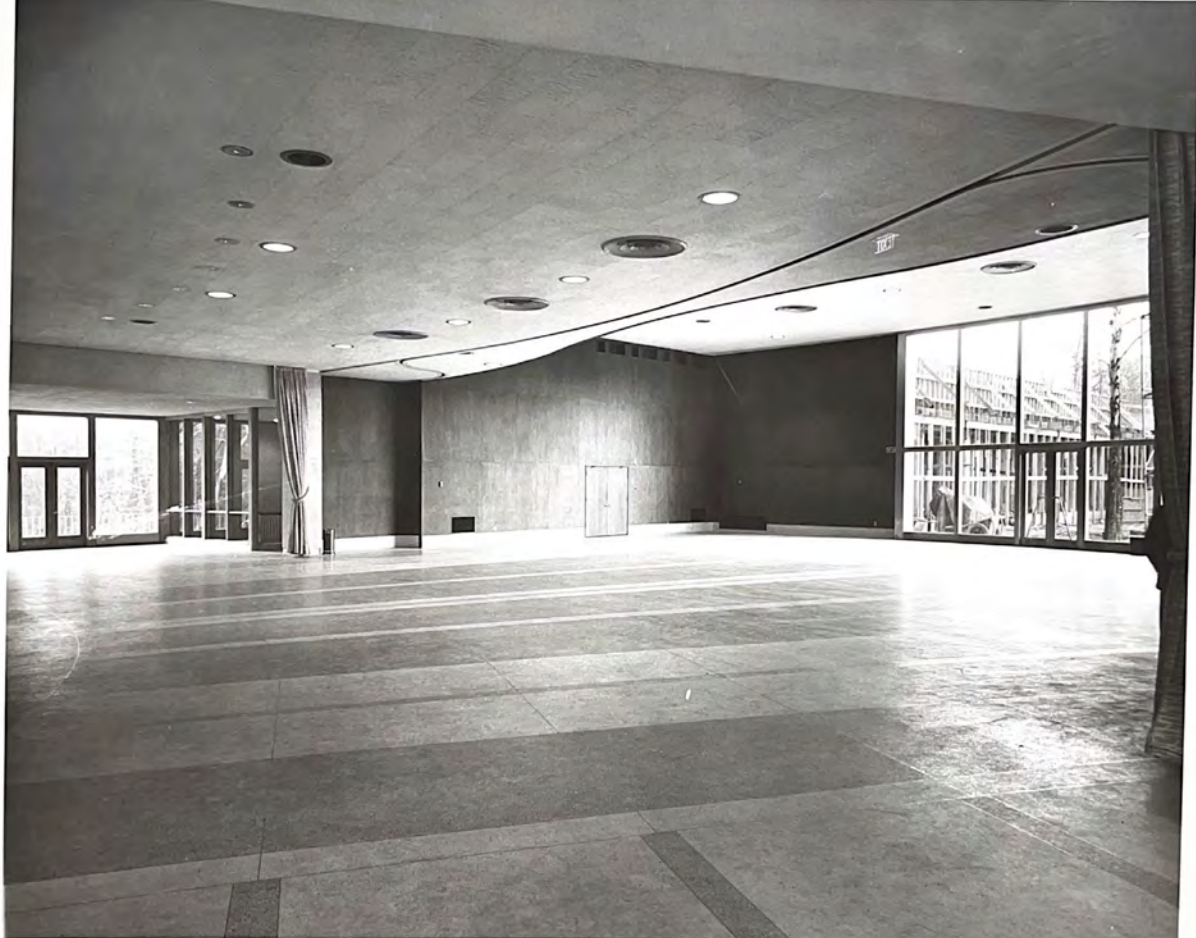
Historic Photo c.1950

HISTORIC ALTERATIONS

- 1. Removal of Curtains
- 2. Non-Period Lighting Fixtures
- 3. Enlarged HVAC Diffusers
- 4. Repositioned Flush Doors
- 5. Removal of Projection Windows

Incomplete Elements In Historic Photo:

- Sliding partition wall for ballroom
- Wood cladding at corner behind curtain
- School wing under construction

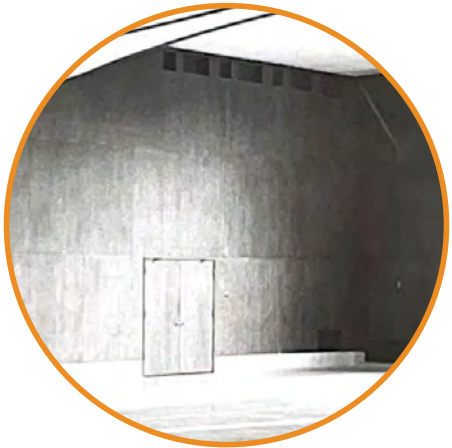
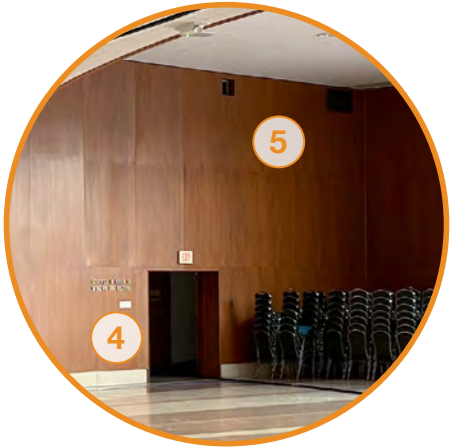
Enlarged detail photos for reference.

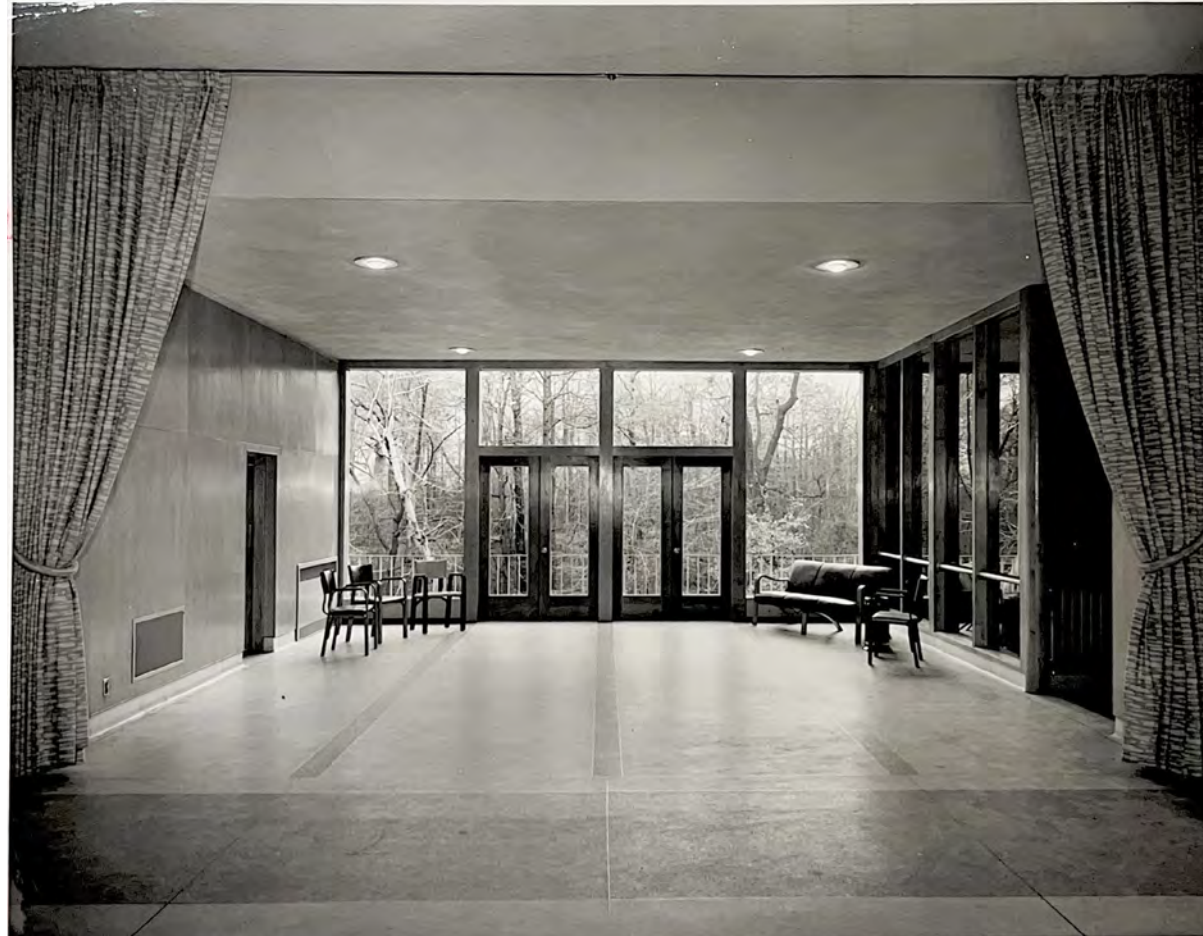
Historic Photo c.1955

HISTORIC ALTERATIONS

1. Added Floor Outlet
2. Enlarged Opening to Elevator Lobby*
3. Added Hood Over Wall Heater
4. Original Signage Moved from Entry
5. Removal of Curtains
6. Non-Period & Added Lighting Fixtures
7. Added HVAC Diffuser
8. Added Exposed Electrical
9. Added Security Camera

*1998 Renovation of former men's restroom to lobby for elevator addition.

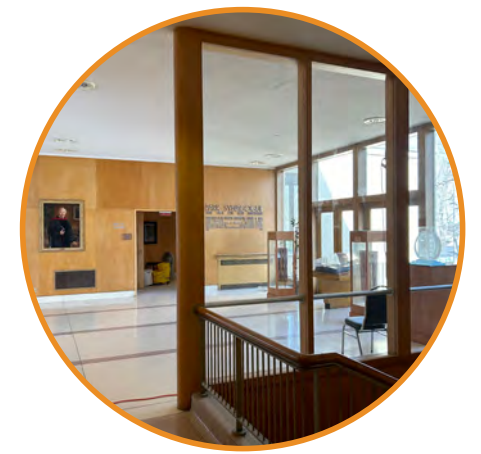
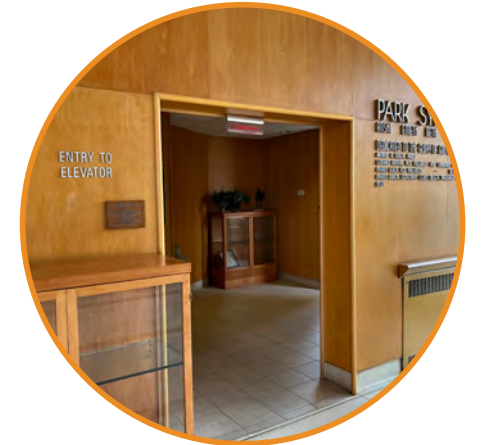
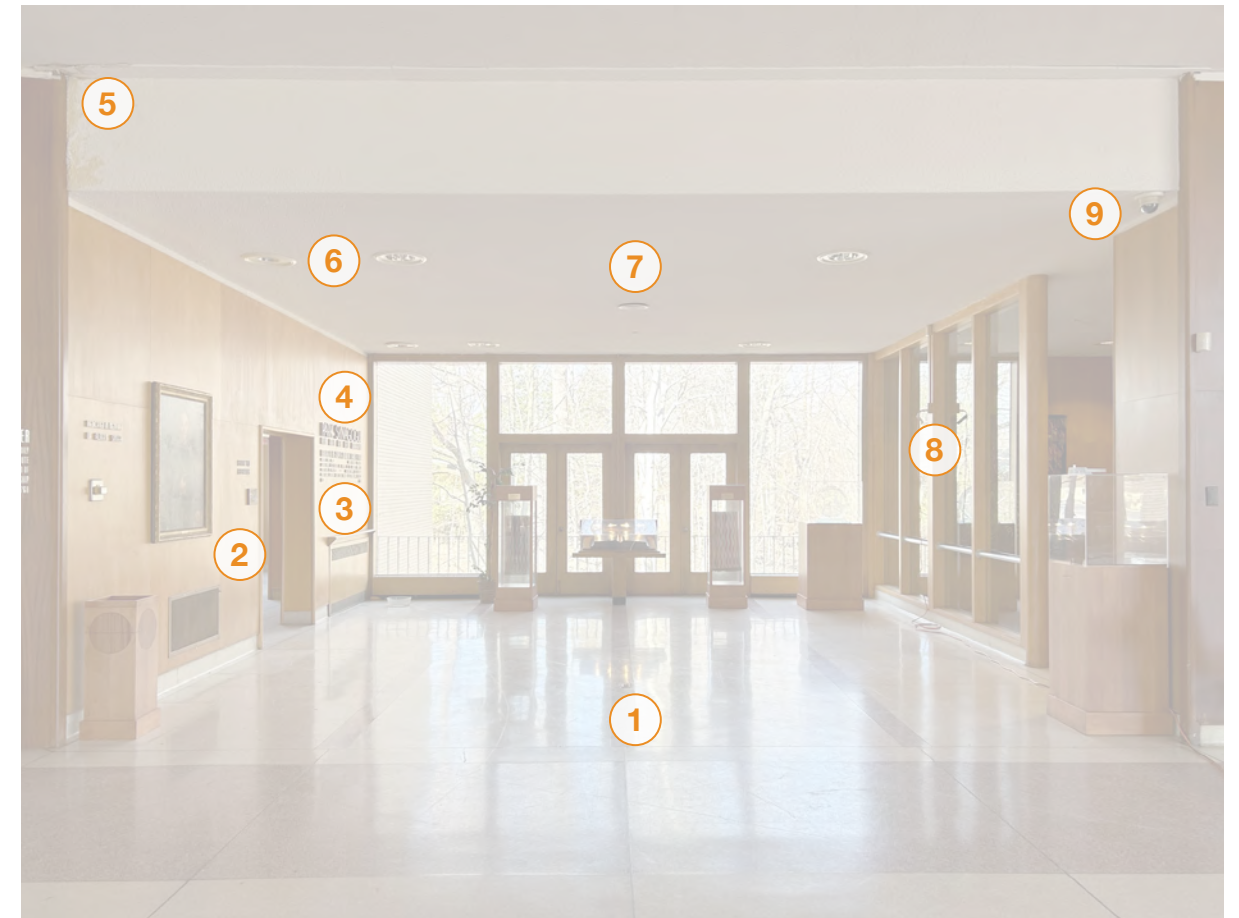
Reference photos of lounge area with enlarged opening to elevator lobby.

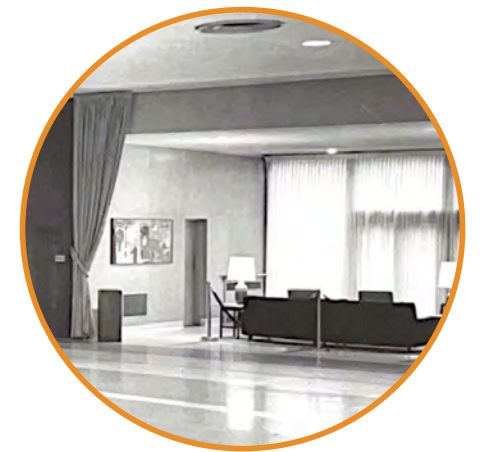
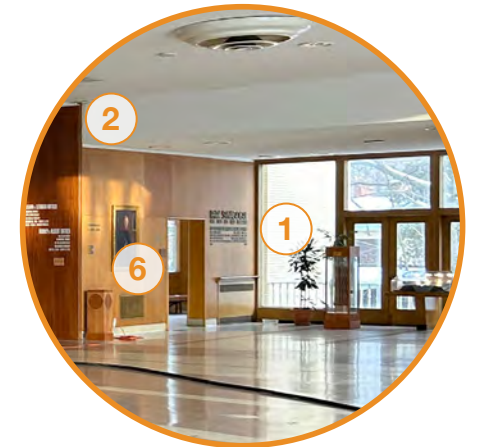
Enlarged detail photos for reference.

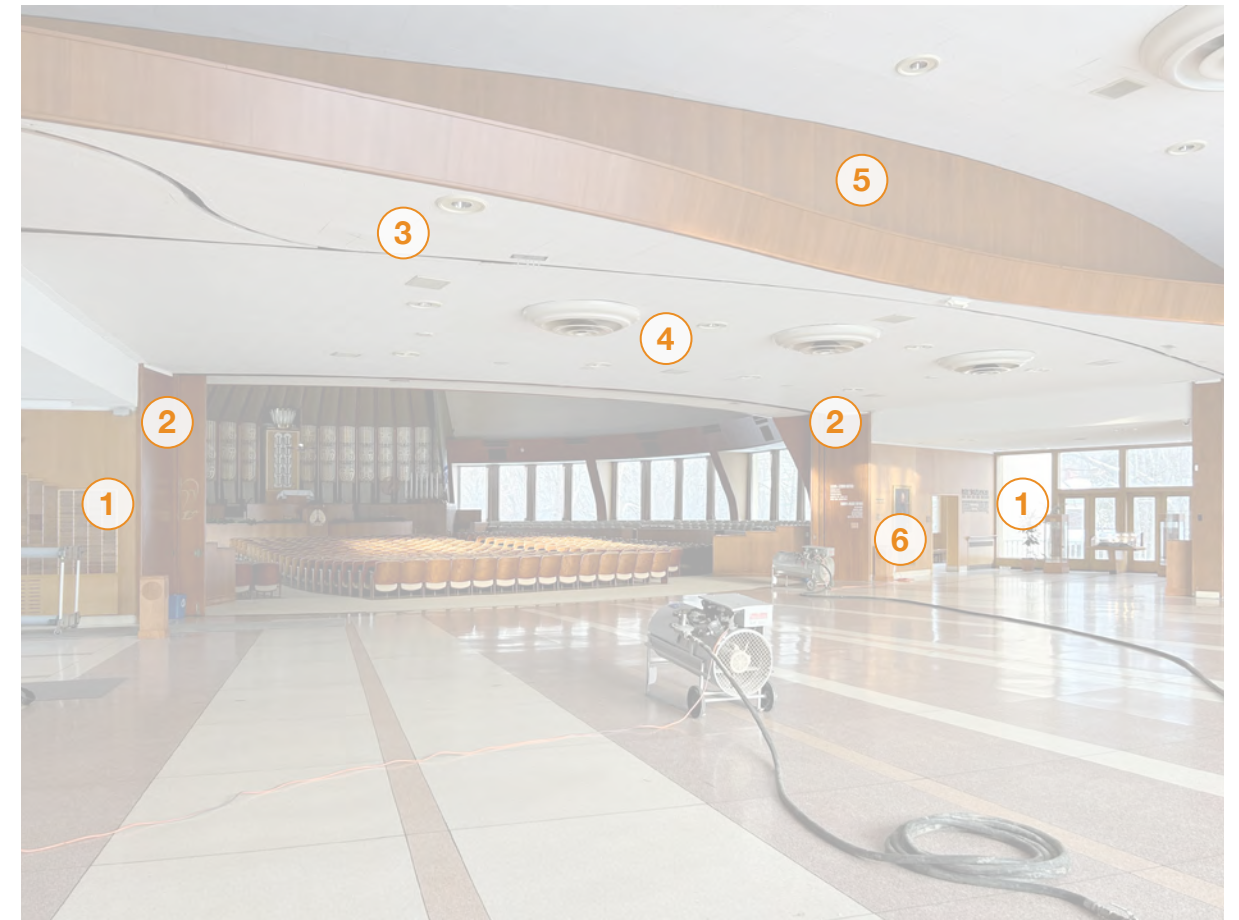
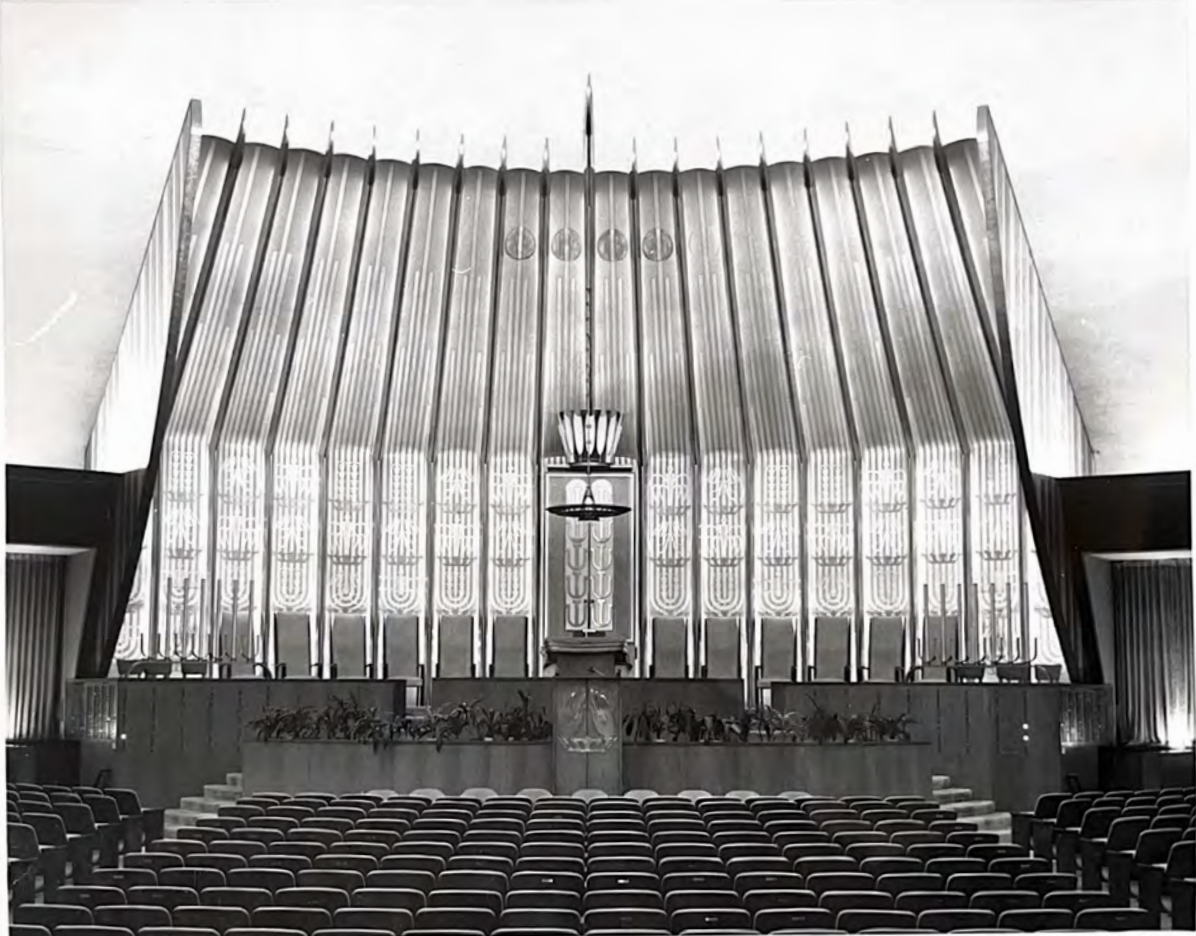
1. Original Signage Moved for Memorial
2. Removal of Curtains
3. Non-Period Lighting Fixtures
4. Enlarged HVAC Diffusers
5. Removal of Speaker [Organ Tone Box]
6. Enlarged Opening to Elevator Lobby

Note: the original ceramic tile artwork shown on the wall of the historic photo has been relocated to the lobby of the administration wing.

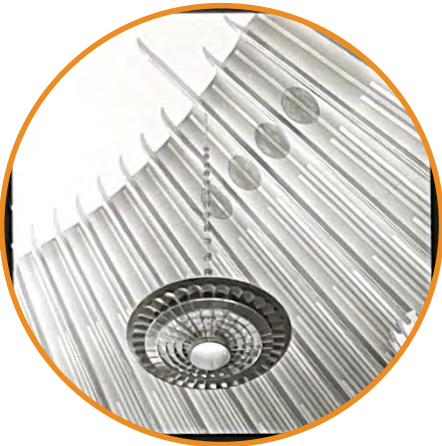
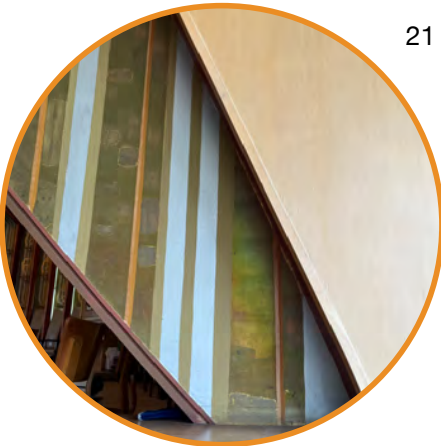
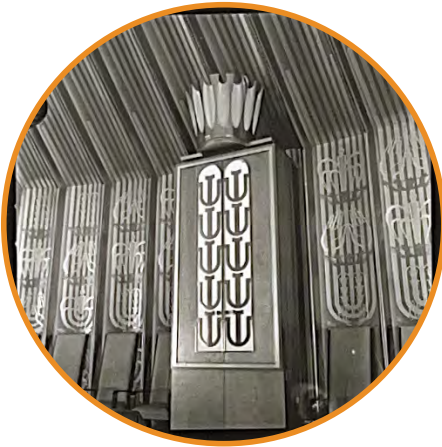
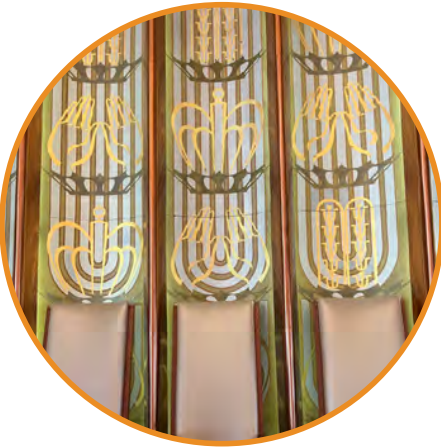
Enlarged historic c1955 and present detail photos for reference.

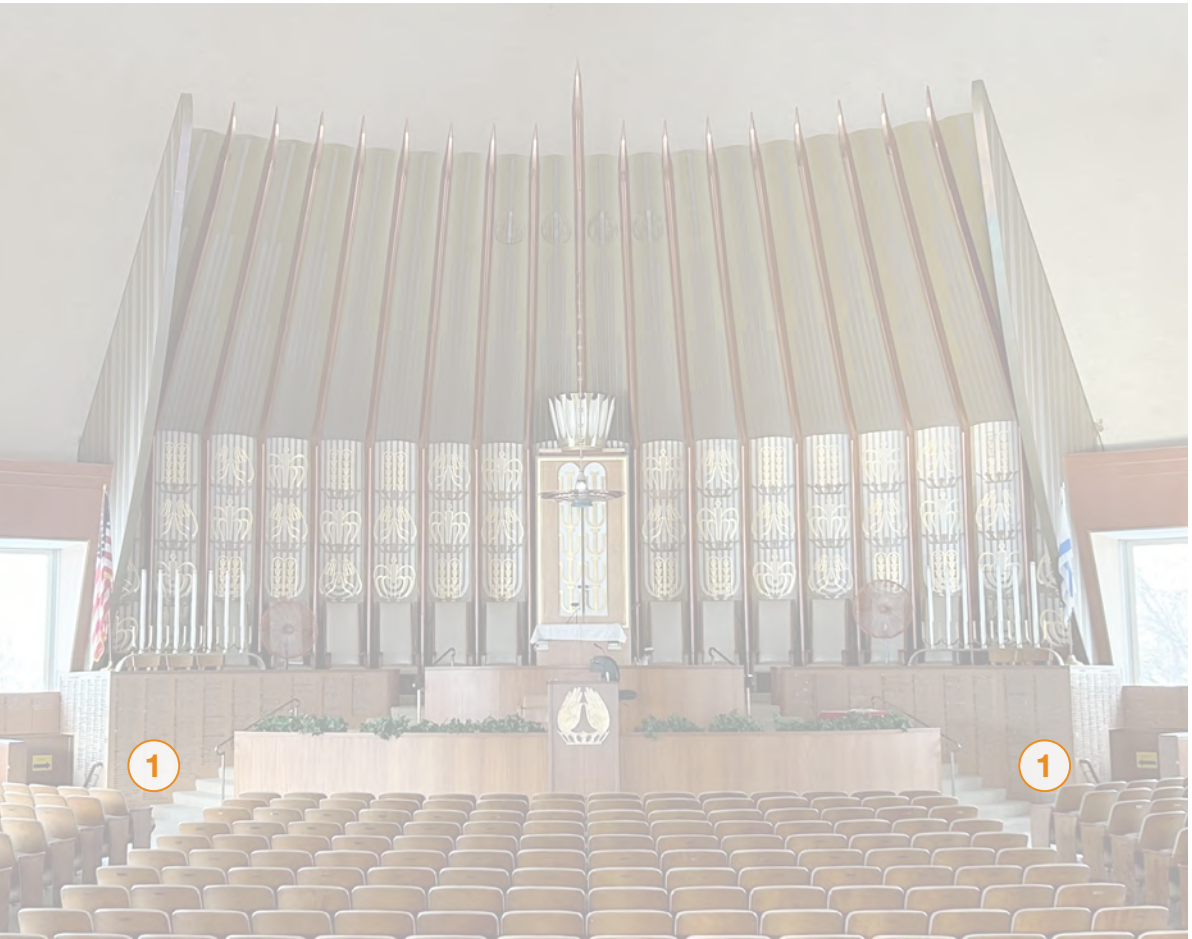
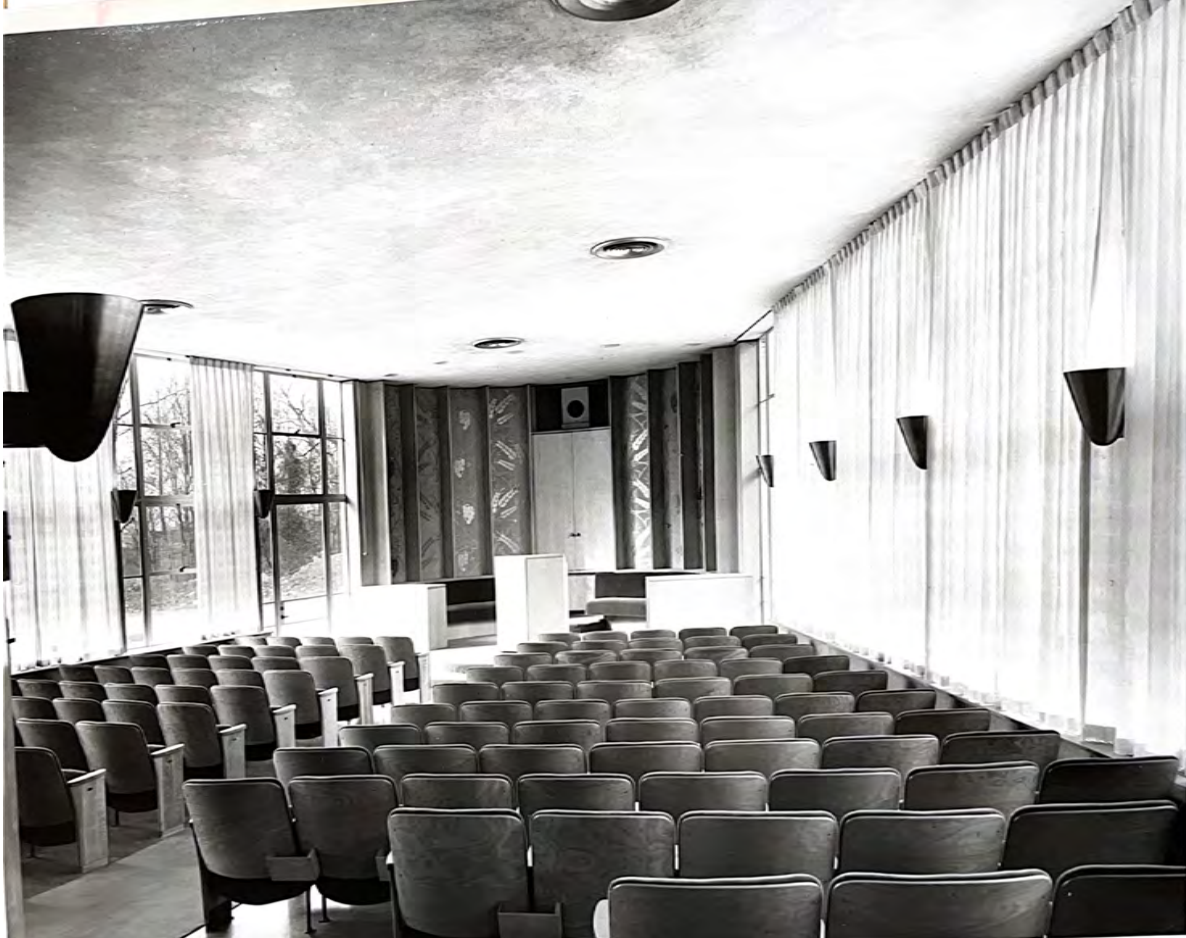
Interior Ark Elevation

1. Expanded List of Names in Memoriam

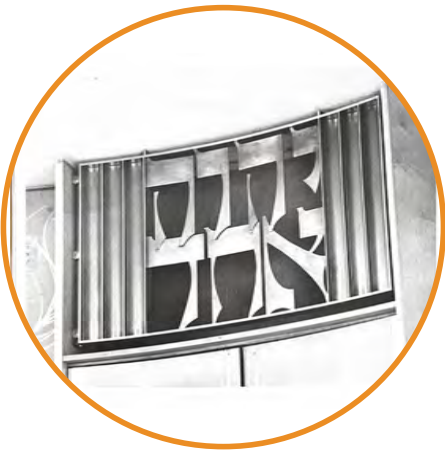
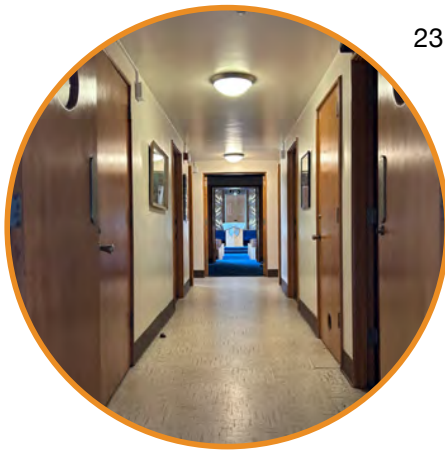
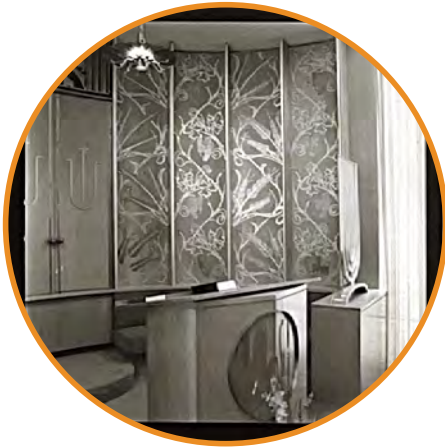
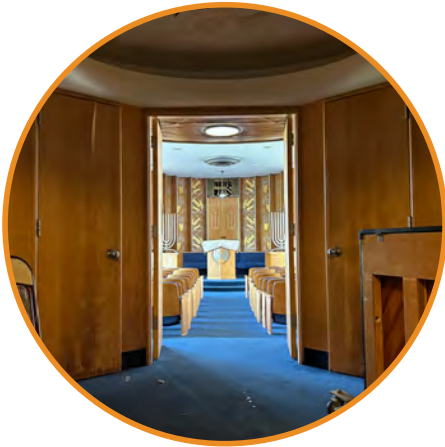
Enlarged historic c1955 and present detail and approach photos for reference.
