Then / Now Photo Comparison

Scanned Photos of Park Synagogue from the Western Reserve Historical Society Archive Compared to Present Day Photos to Identify Alternations over time for the Historic Preservation.

By David Craun, AIA, Cleveland Planning Advisors, LLC, Owner Representative Services

Park Synagogue
Mendelsohn Restoration

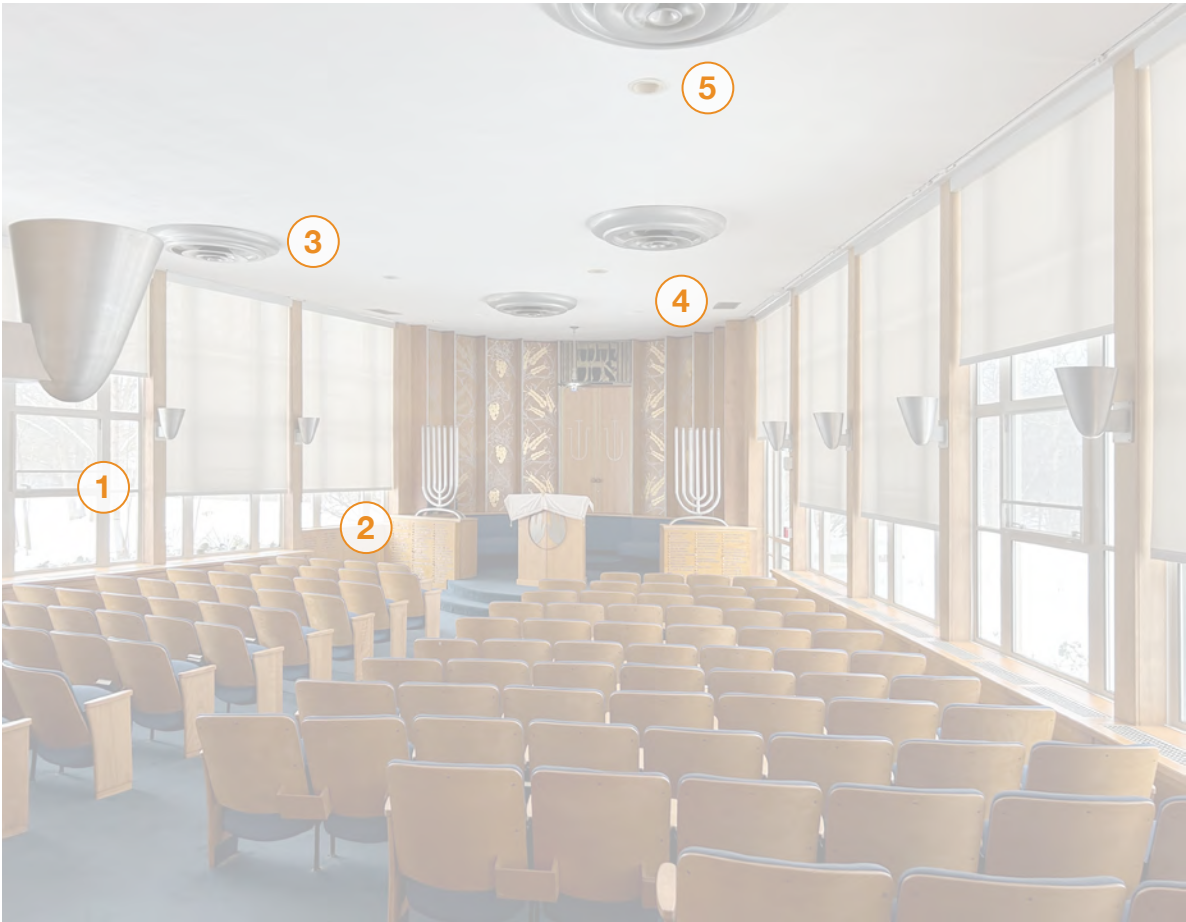
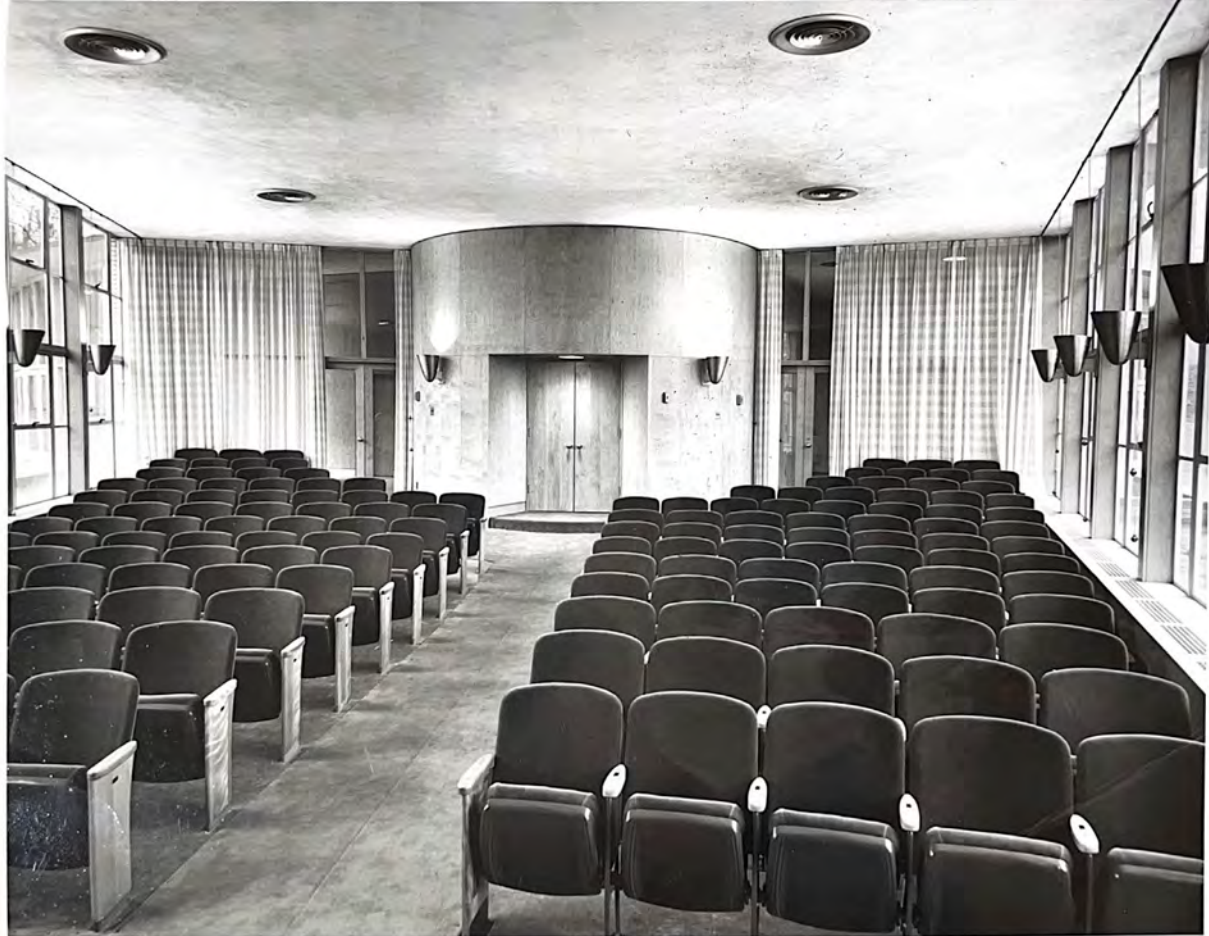
- 1. Non-Period Replacement Windows
- 2. Former Door Closed In
- 3. Enlarged HVAC Diffusers
- 4. Added Return Air Vents
- 5. Added Non-Period Lighting Fixtures

- Decorative Grille Over Ark Speaker
- Decorative Metal *Shin* on Ark Doors
- Decorative Metal Hands on Lectern
- Menorah Candelabras

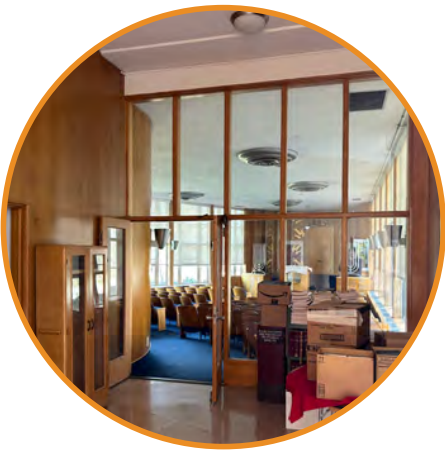
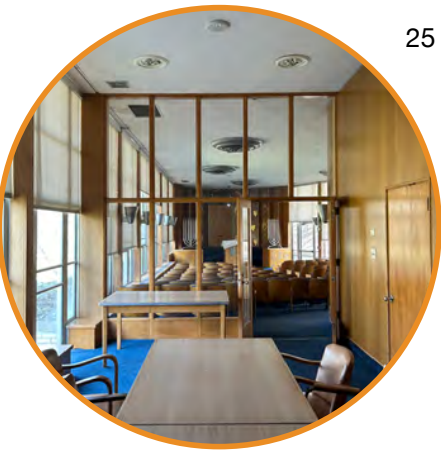
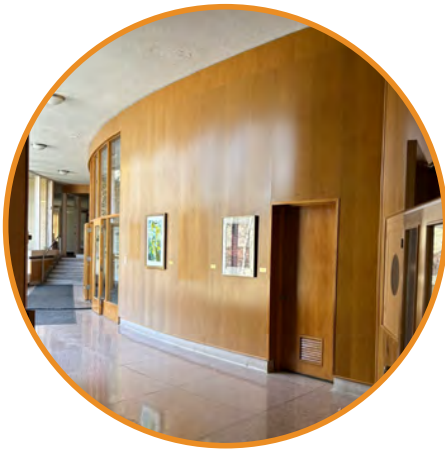
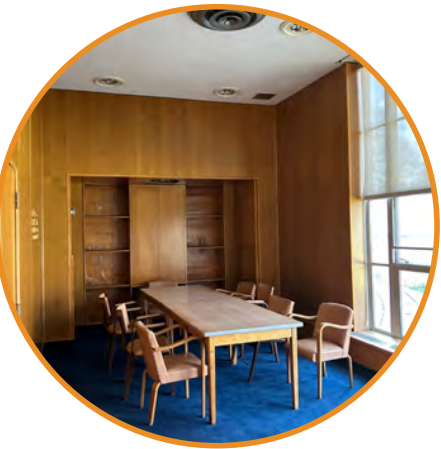
Reference photos included for chapel entries, corridor, and conference room.

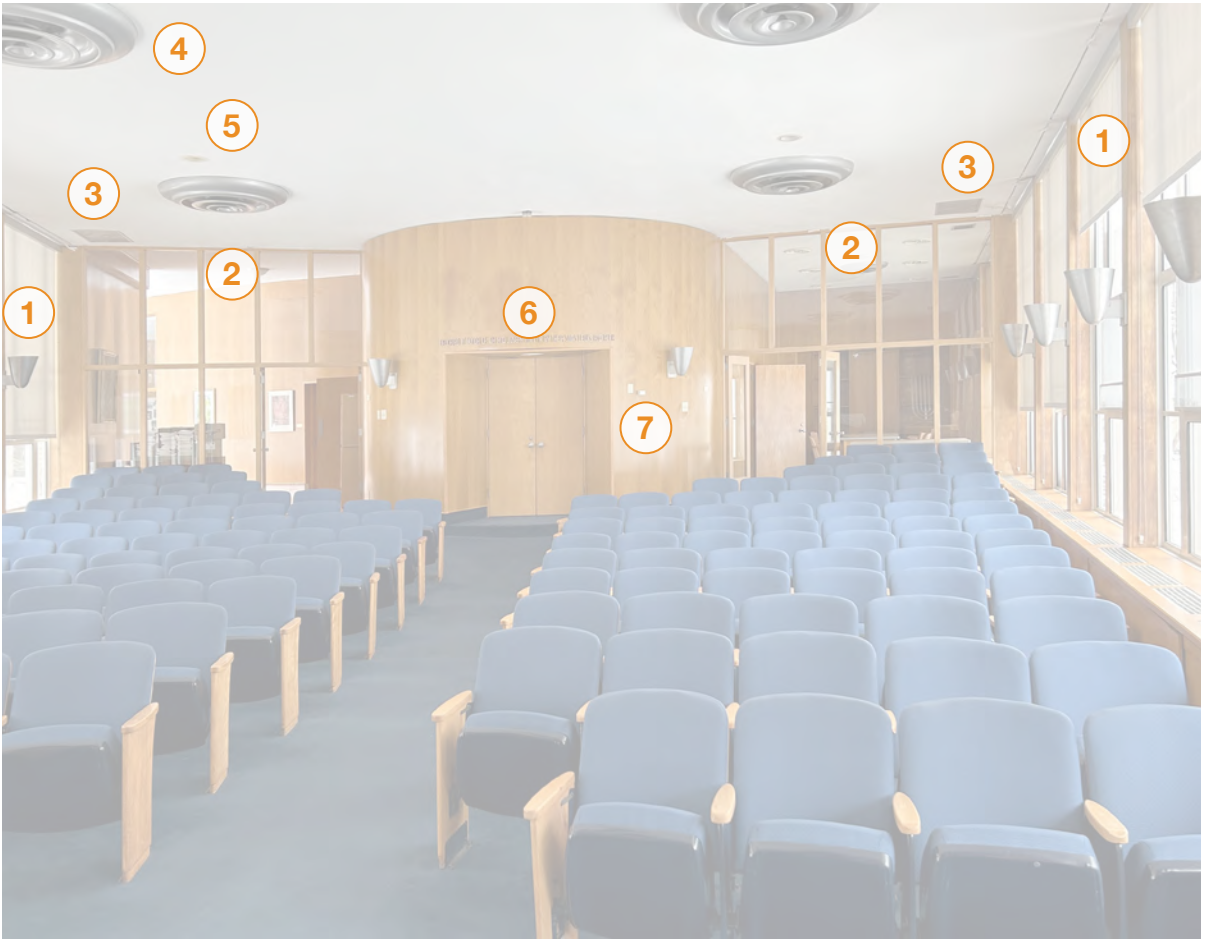
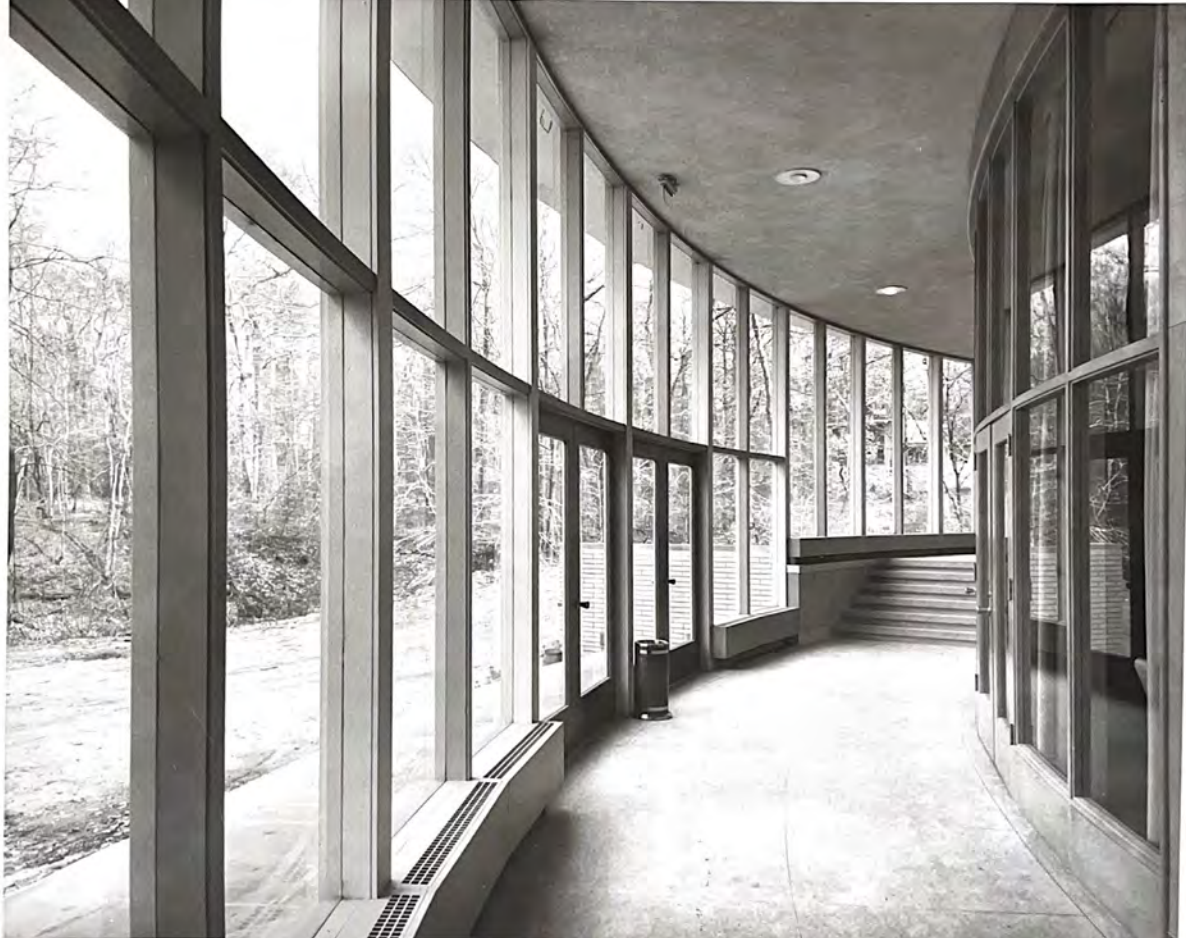
- 1. Added Window Shades
- 2. Removal of Privacy Curtains
- 3. Added Return Air Vents
- 4. Enlarged HVAC Diffusers
- 5. Added Non-Period Lighting Fixtures
- 6. Added Dedication Signage
- 7. Added Wall Switches/Controls

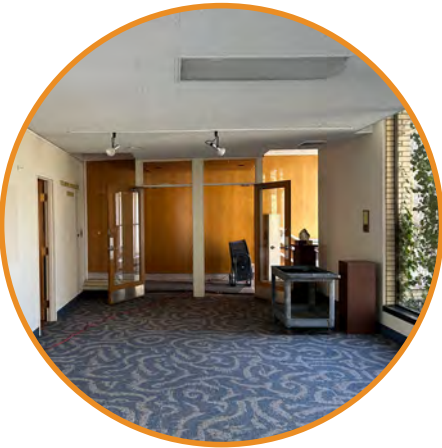
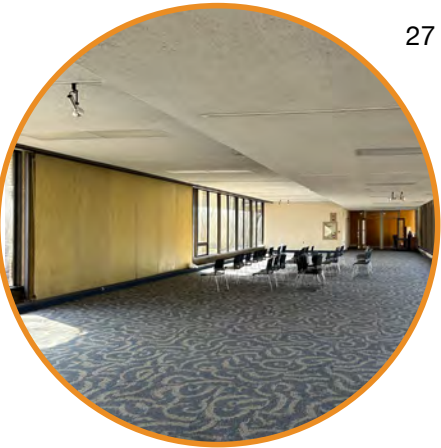
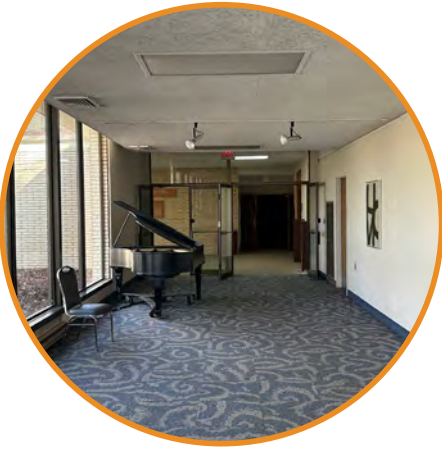
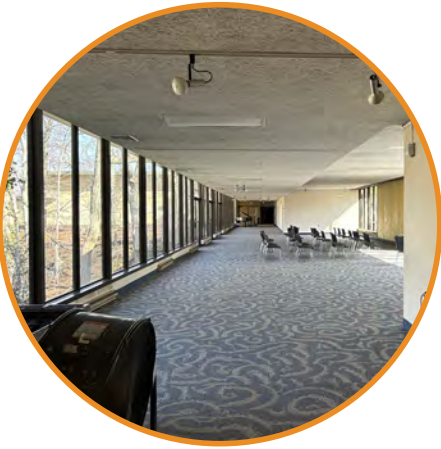
Reference photos included of bridge interior.

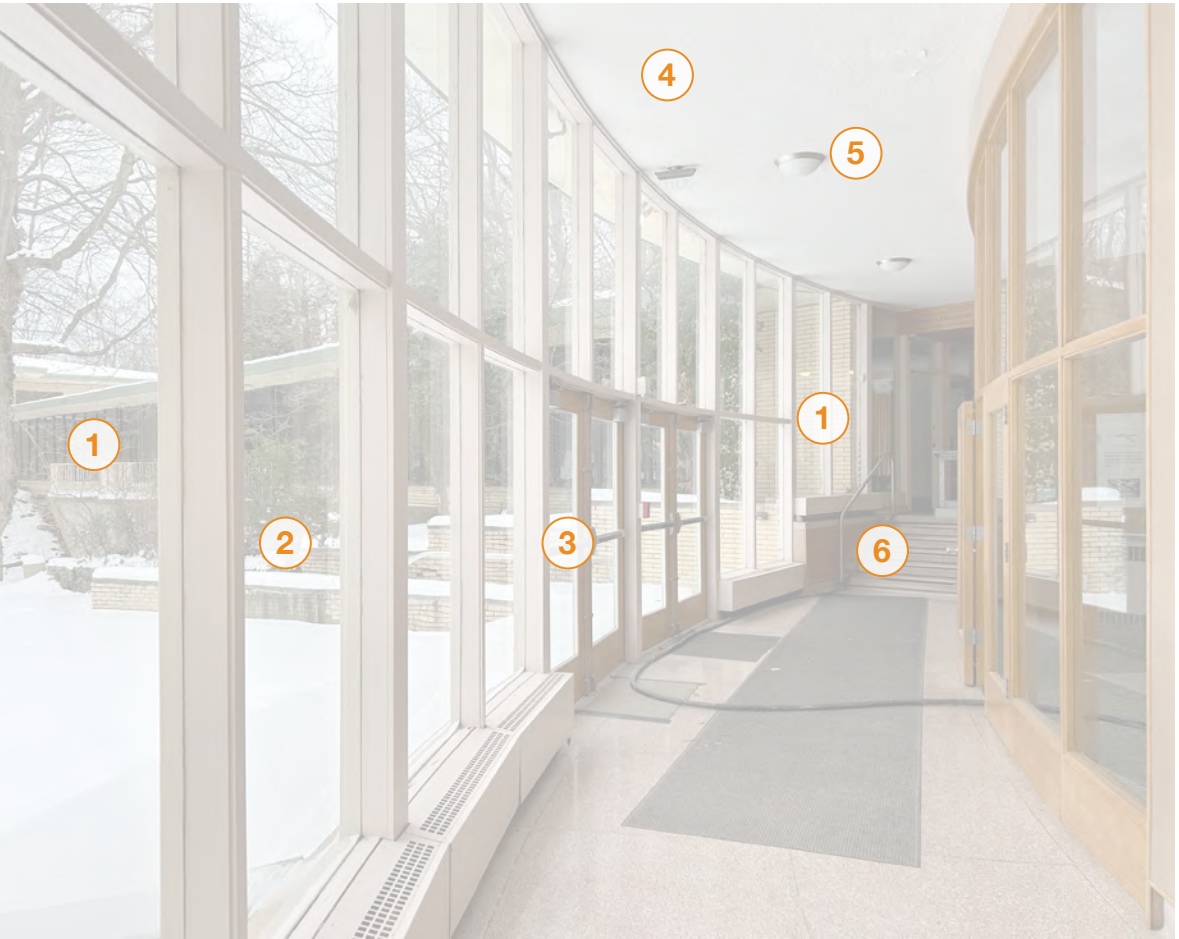
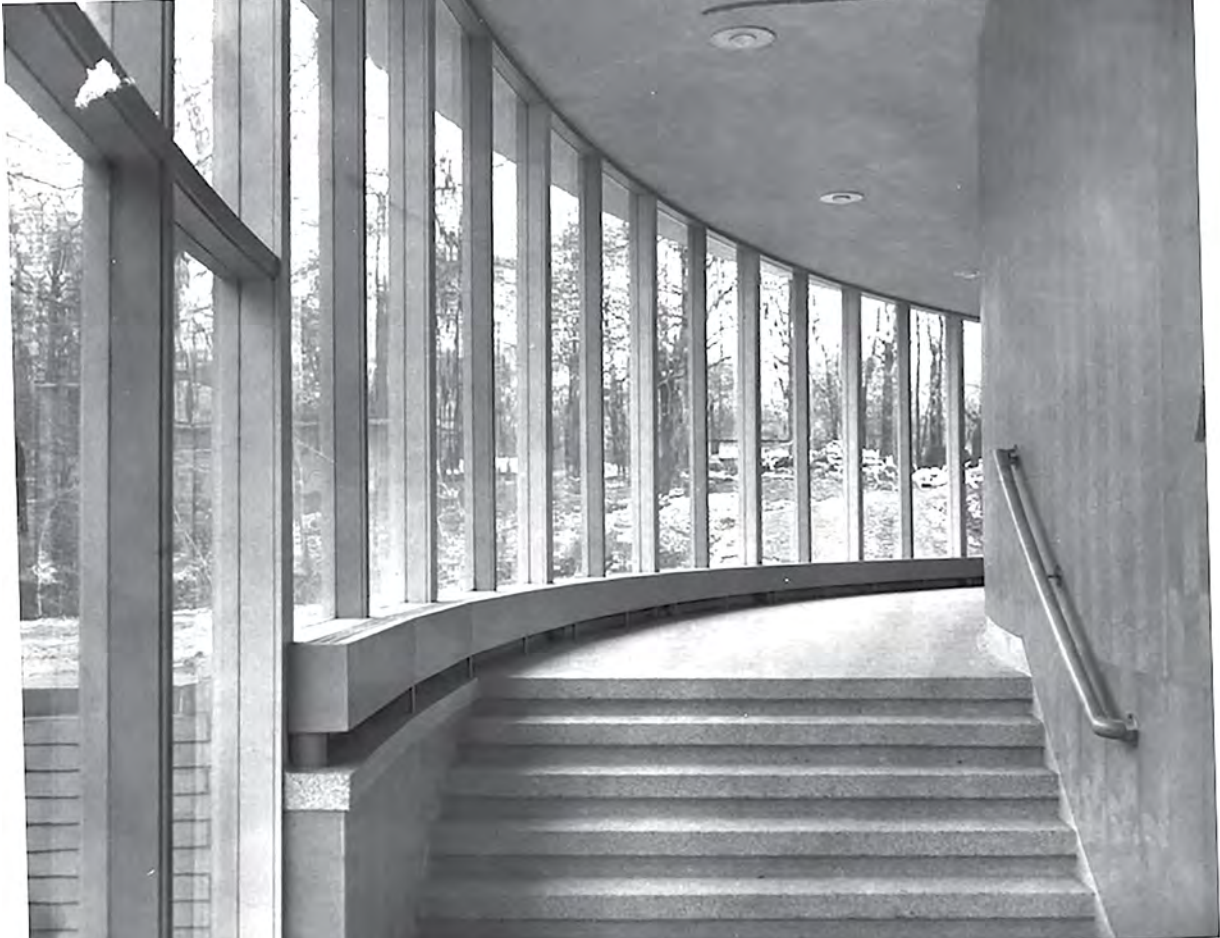
- 1. Bridge Addition*
- 2. Added Site Walls for Ramp
- 3. Panic Hardware on Exit Doors
- 4. Ceiling Painted Lighter Color**
- 5. Non-Period Lighting Fixtures
- 6. Added Stair Handrail

*1968 Bridge and Kangesser Hall Addition.

**Ceiling color appears to have originally matched between exterior and interior.

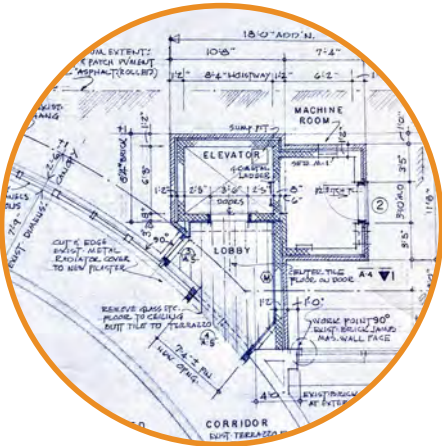
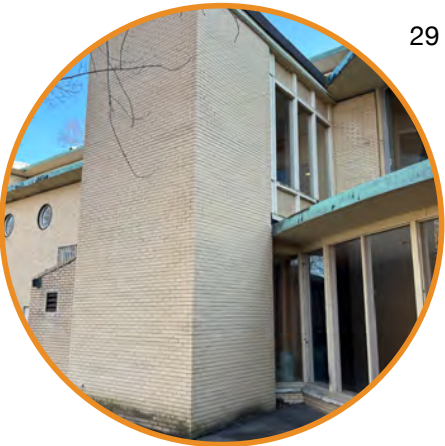
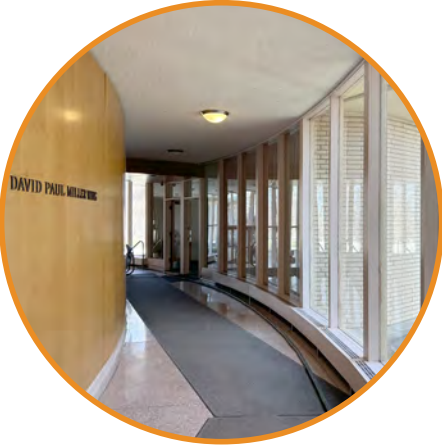
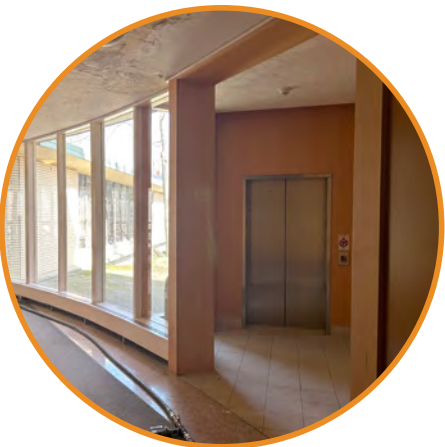
Reference photos/drawing of elevator addition between main and ground floors.

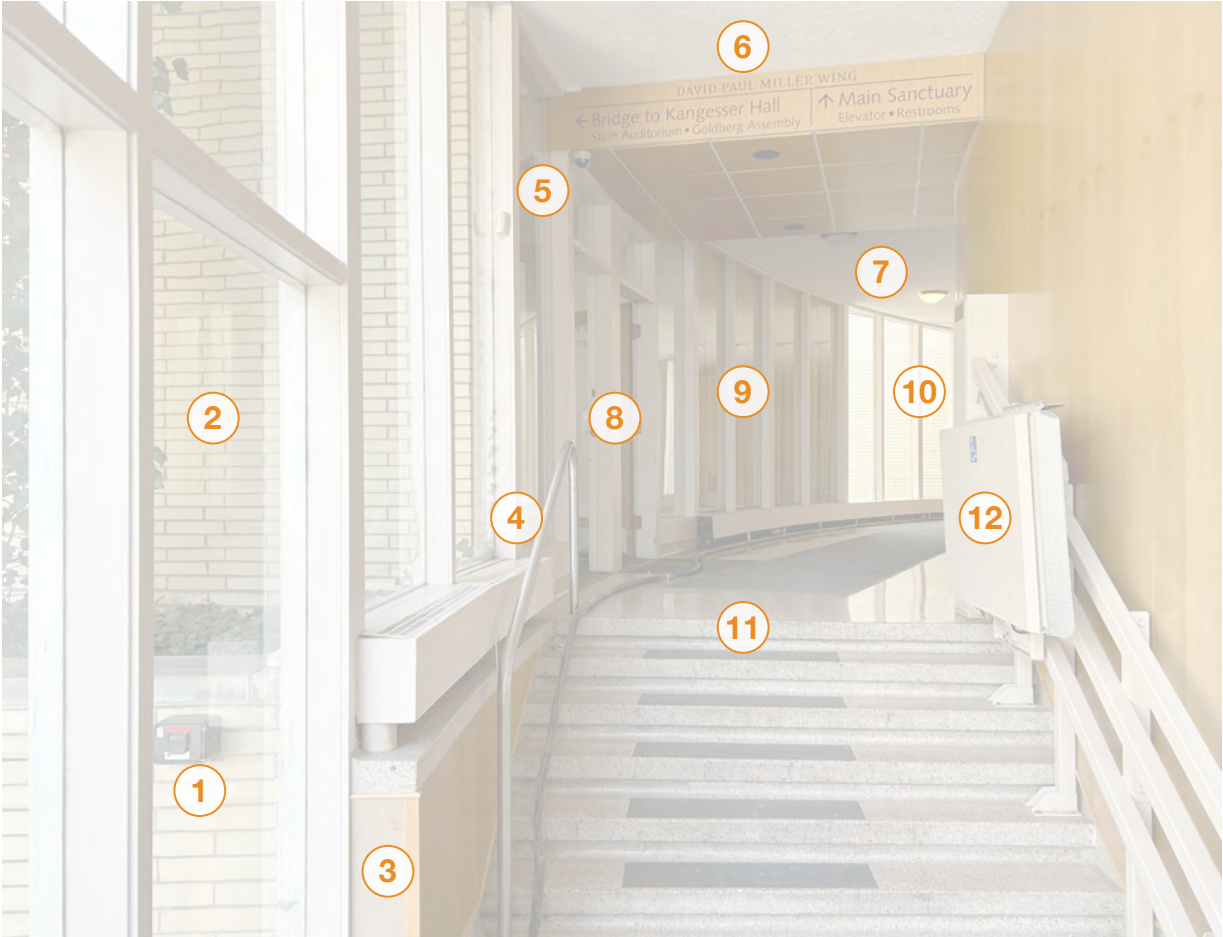
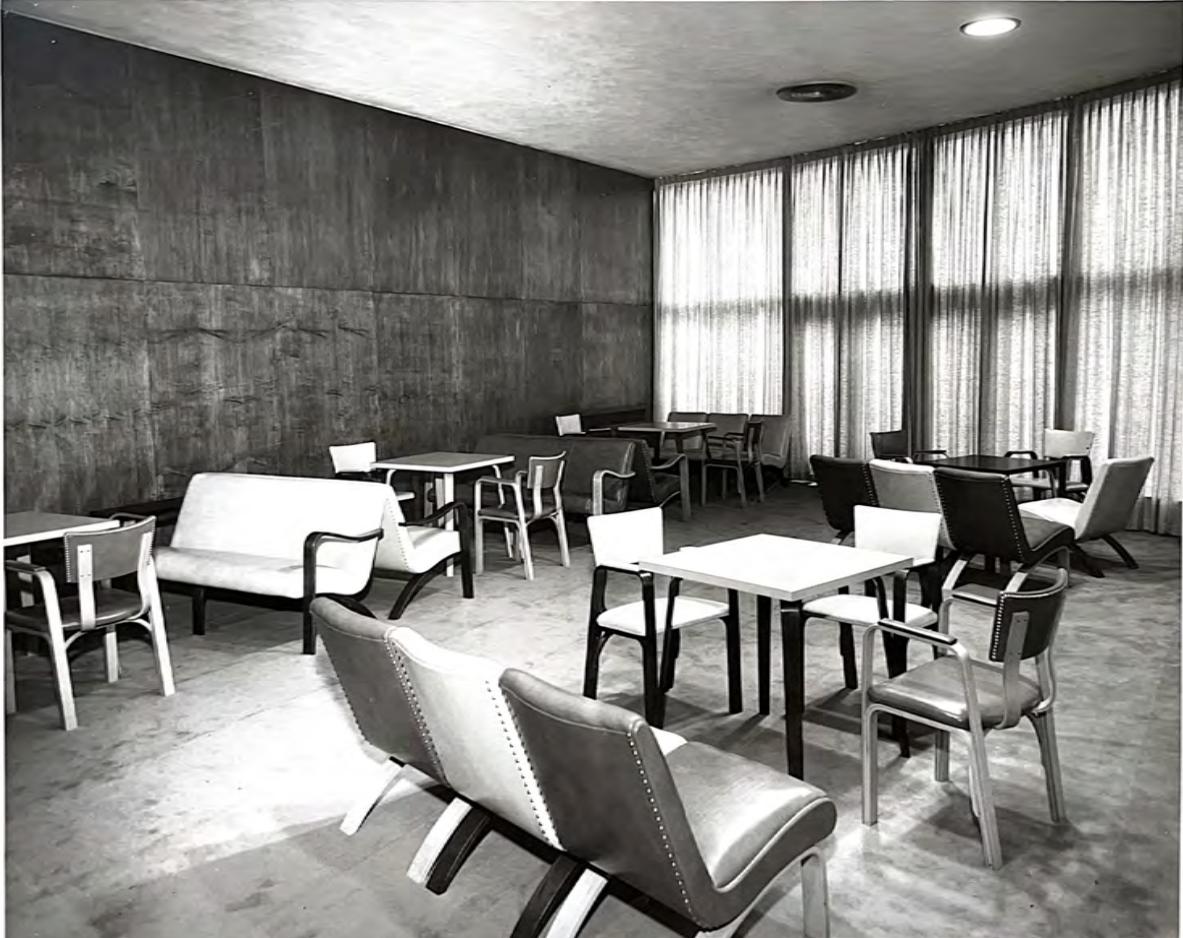
- 1. Knox Box for CHFD
- 2. Bridge Addition*
- 3. Discolored Wood Panel
- 4. Added Handrail
- 5. Motion Detector & Security Camera
- 6. Non-Period Ceiling Signage Feature
- 7. Non-Period Lighting Fixtures
- 8. Window System Altered for Doors
- 9. Curtains of Office in Bridge
- 10. Elevator Addition**
- 11. Slip-Resistant Pads on Stairs
- 12. Handrail Replaced with ADA Lift

*1968 Bridge and Kangesser Hall Addition.

**1998 Elevator Addition

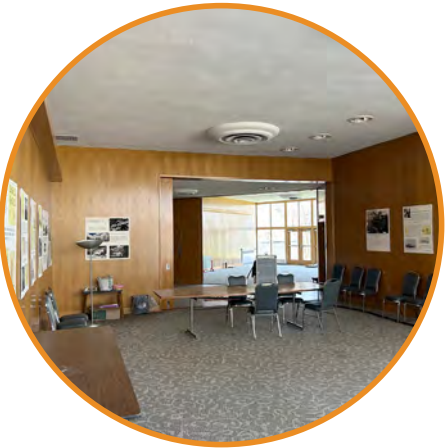
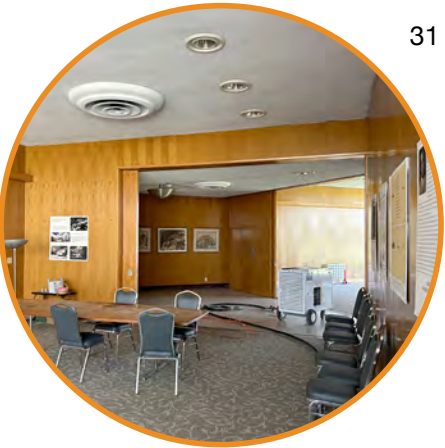
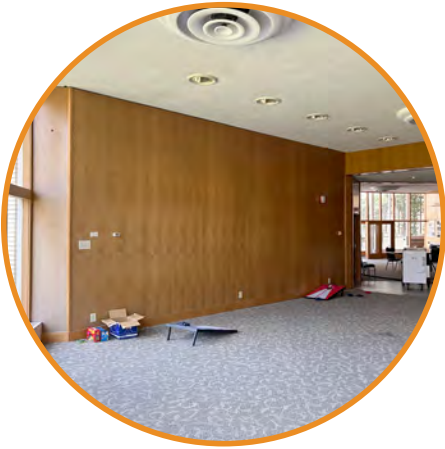
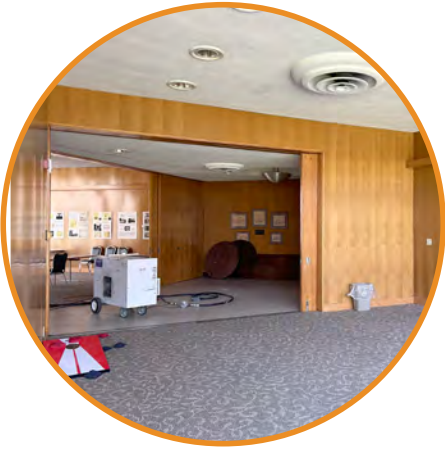
Reference photos/drawings of former
“Mens Club Parlor” & “Sisterhood Parlor”.

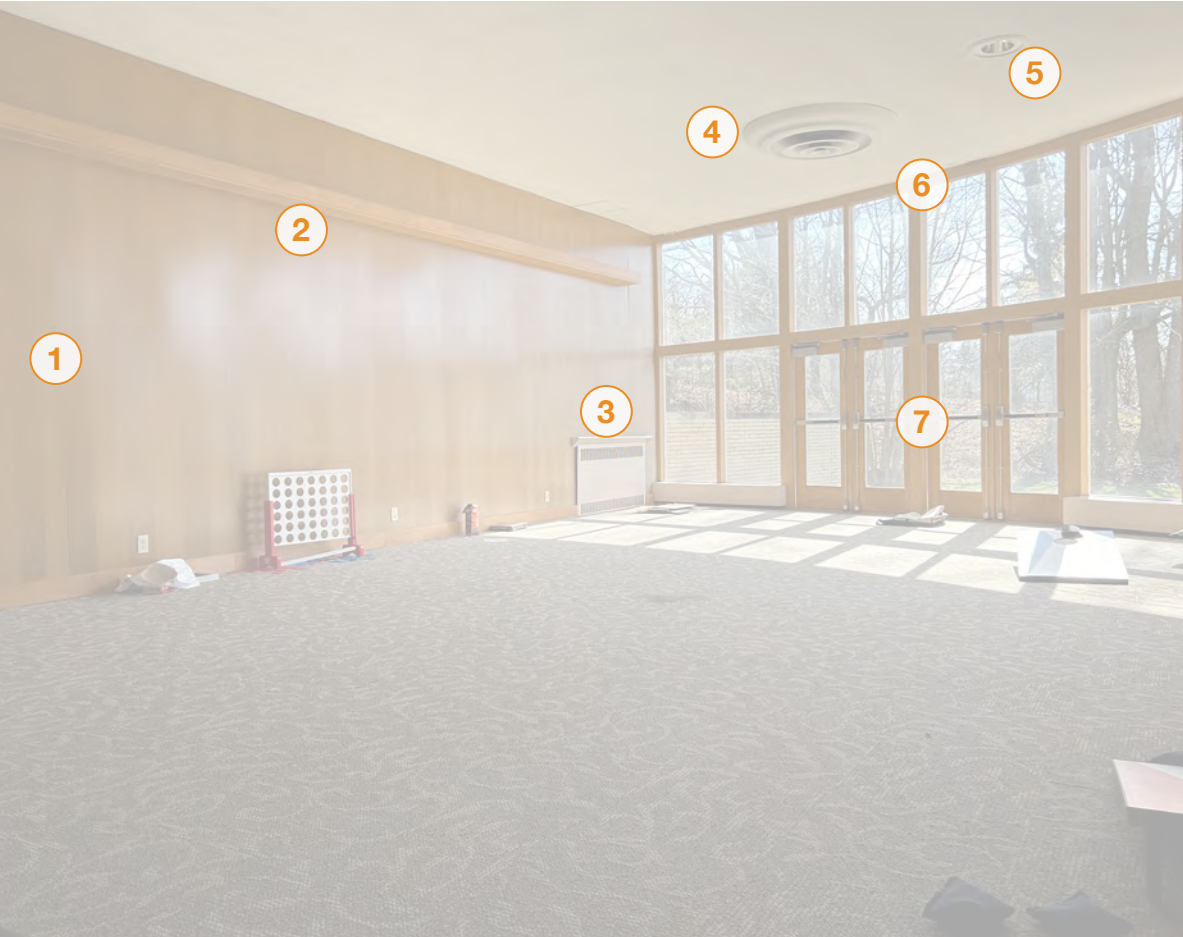
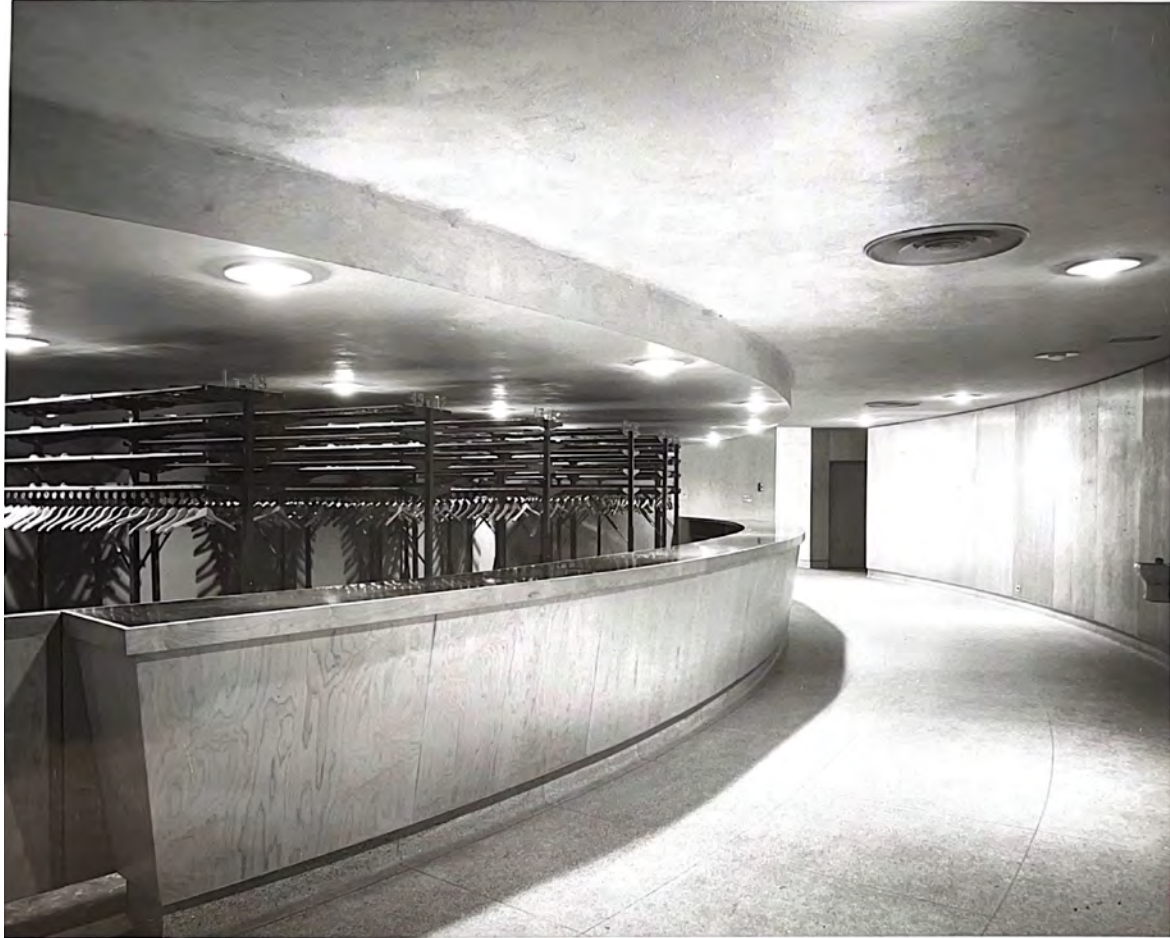
- 1. Replaced Wood Paneling
- 2. Wood Cove Lighting
- 3. Added Hood Over Wall Heater
- 4. Enlarged HVAC Diffusers
- 5. Non-Period Lighting Fixtures
- 6. Removed Curtains
- 7. Panic Door Hardware

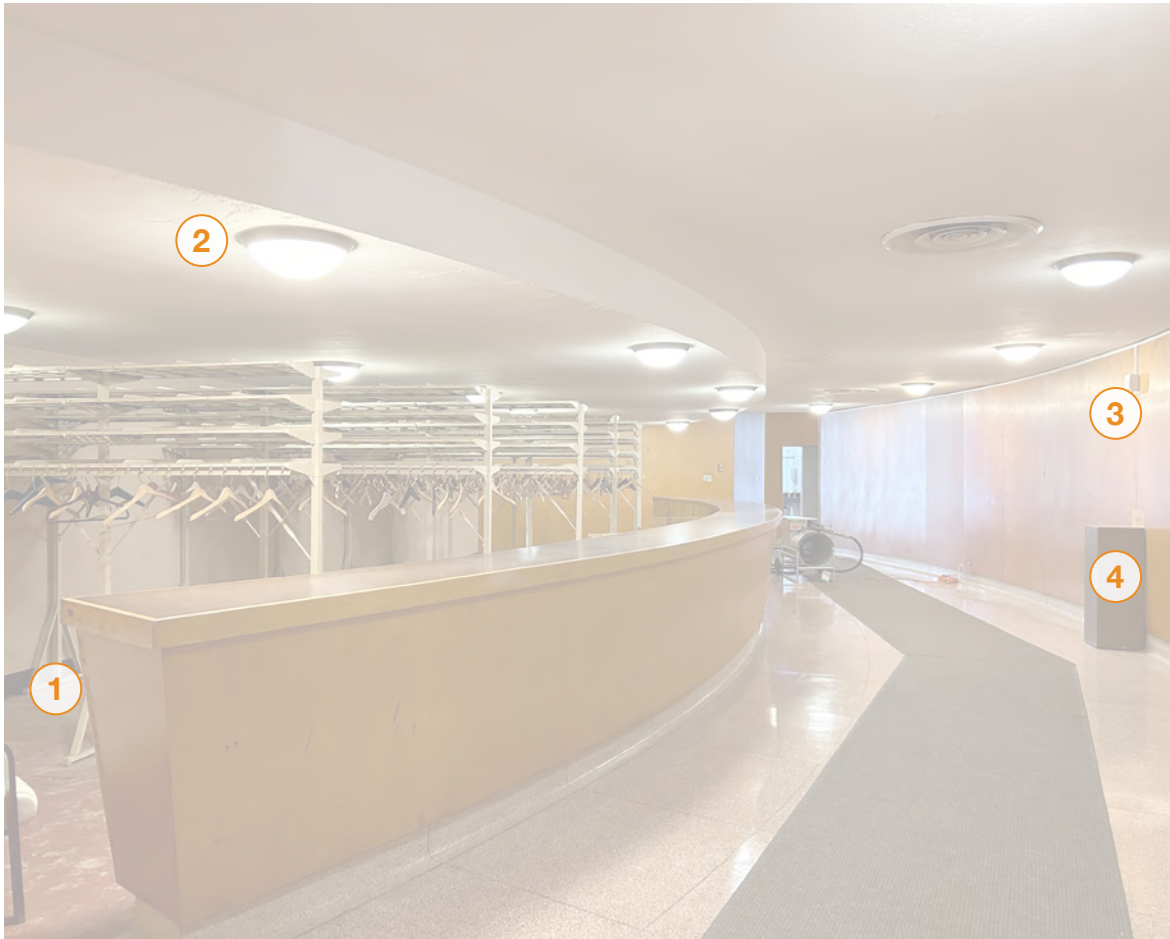
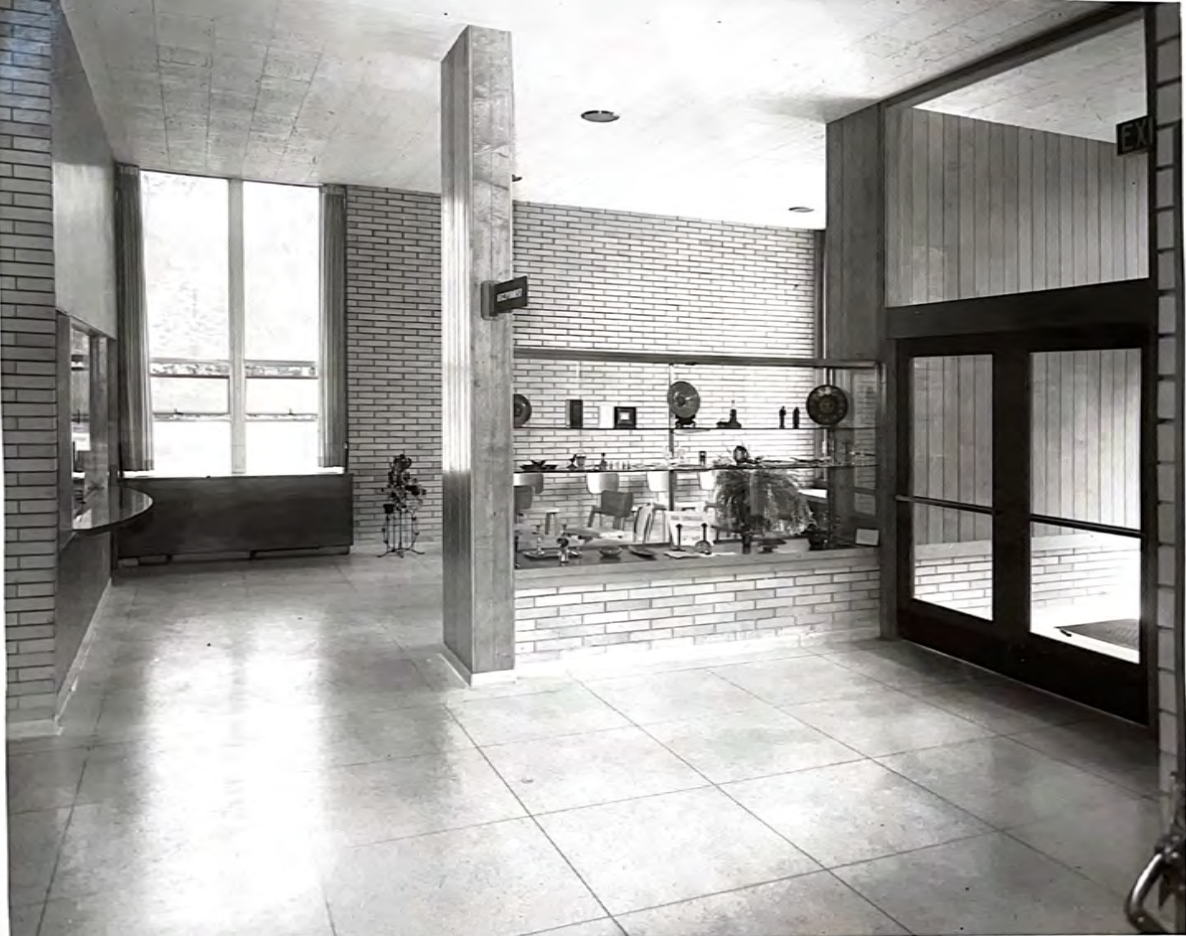
HISTORIC ALTERATIONS

- 1. Removed Millwork Doors
- 2. Non-Period Lighting Fixtures
- 3. Alarm Device with Exposed Conduit
- 4. Removed Drinking Fountain

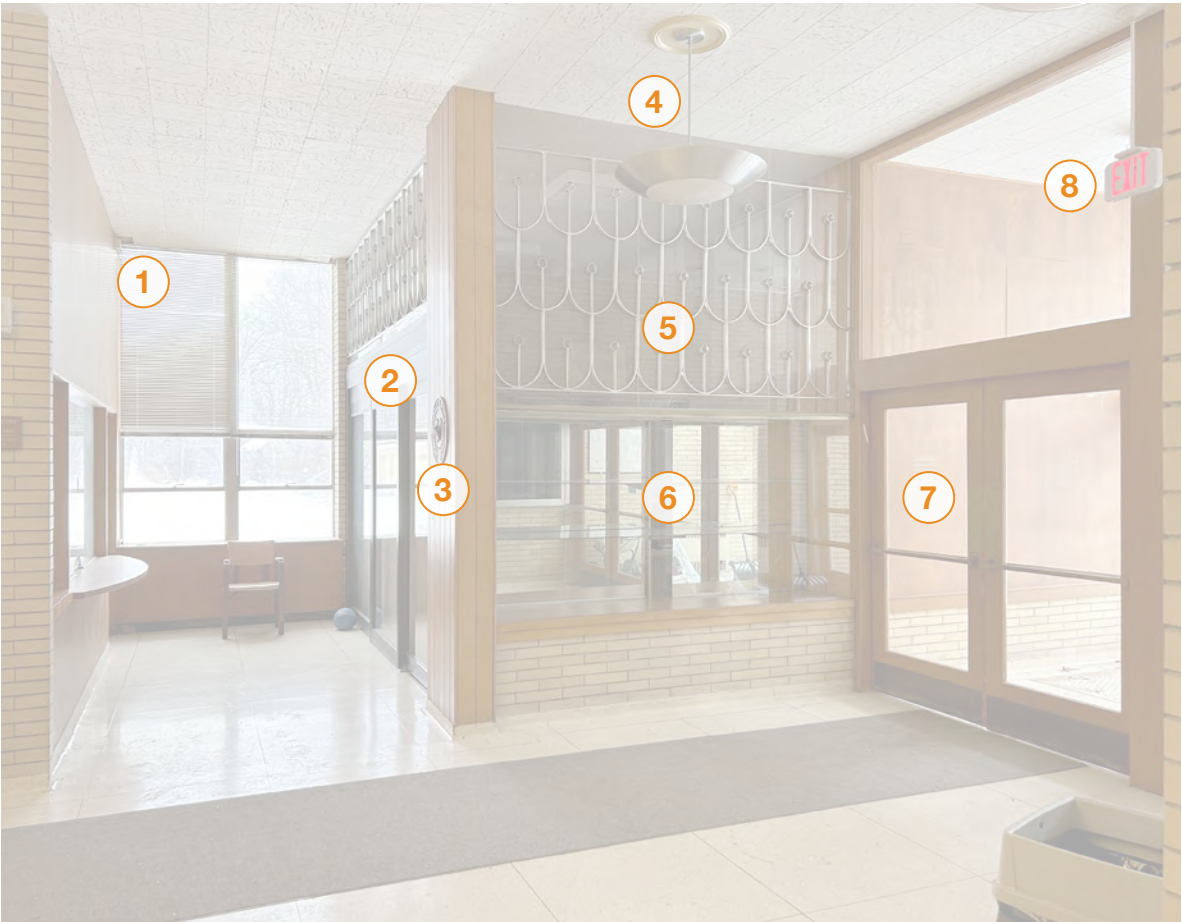
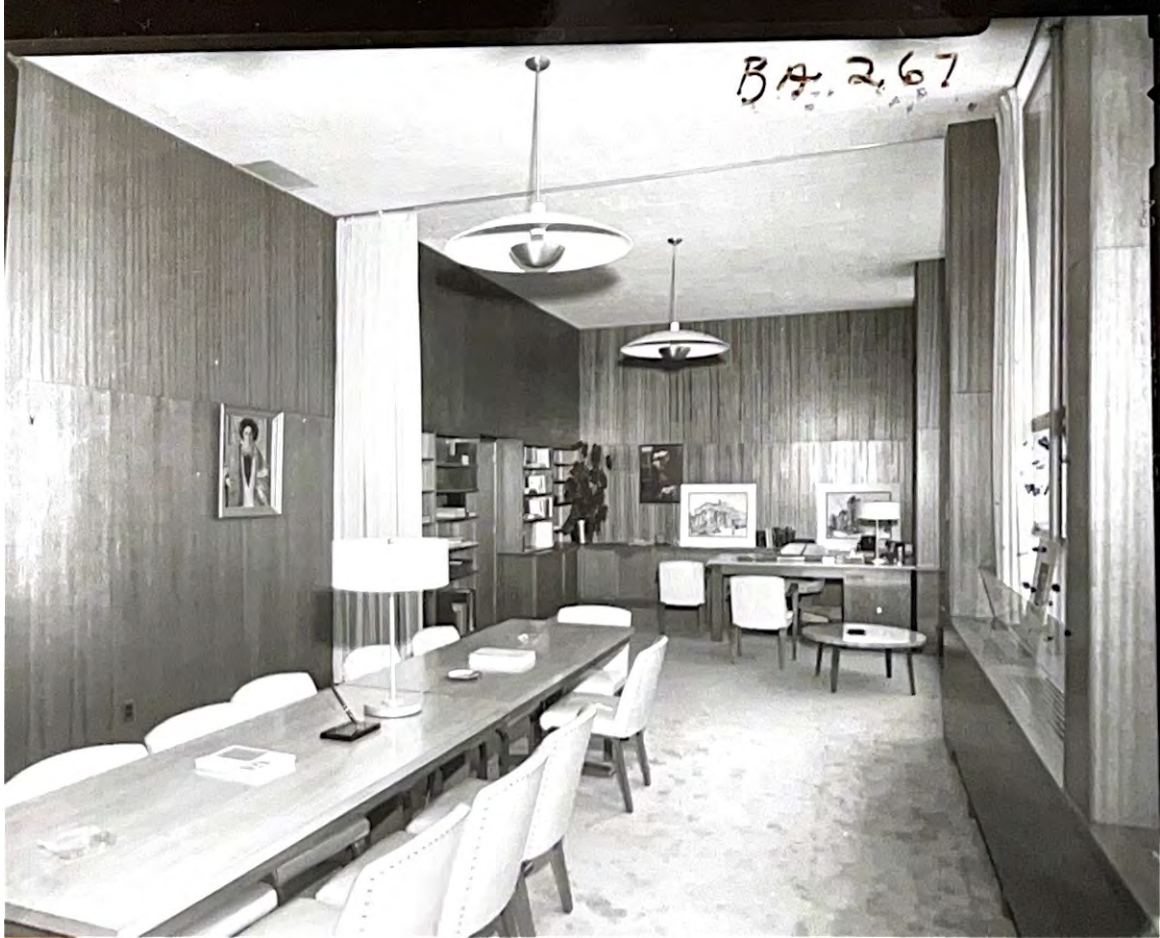
Historic Photo c.1955

HISTORIC ALTERATIONS

- 1. Window Blinds Replaced Curtains
- 2. Added Storefront System
- 3. Added Dedication Plaque
- 4. Non-Period Lighting Fixture
- 5. Added *Shin* Decorative Grill
- 6. Added Mirror Glass at Display
- 7. Replaced Wood Paneling
- 8. Non-Period Exit Sign

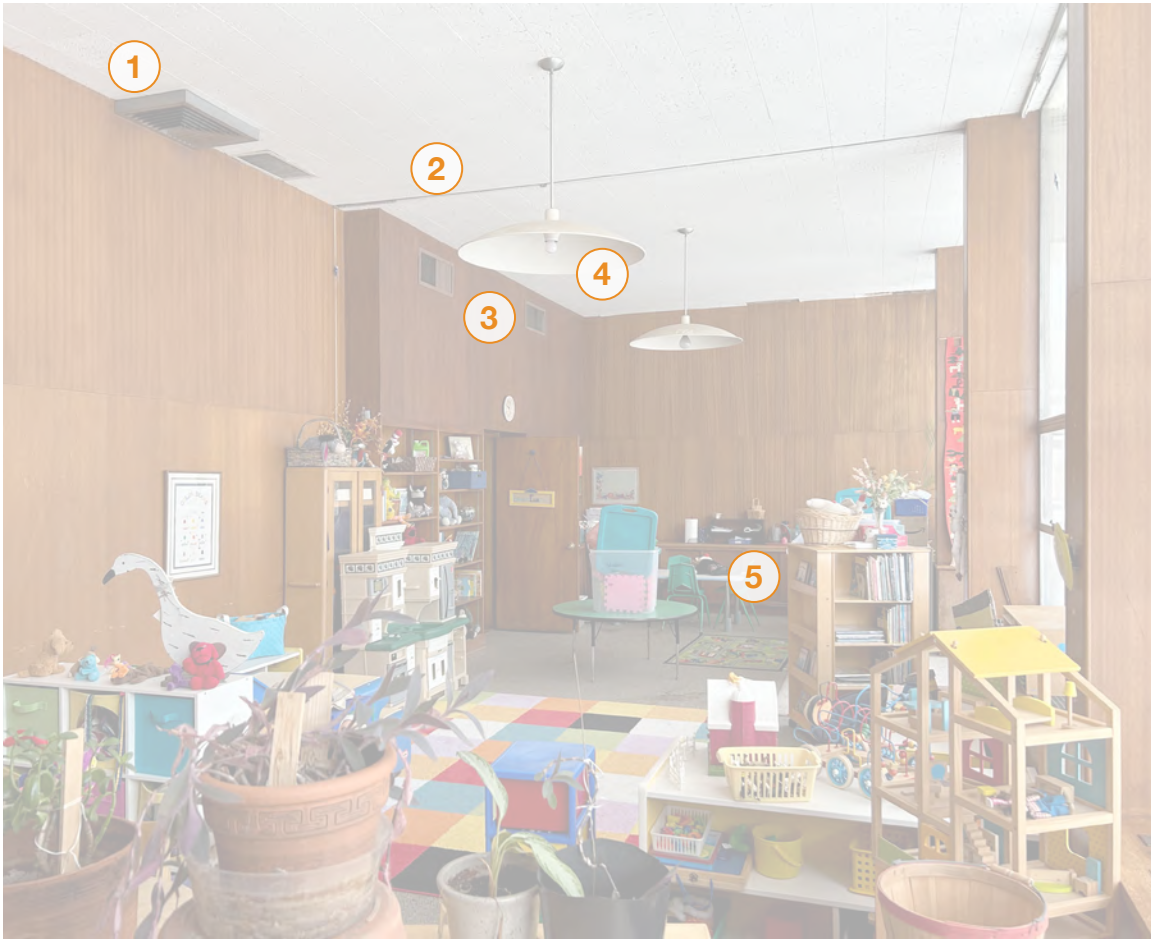
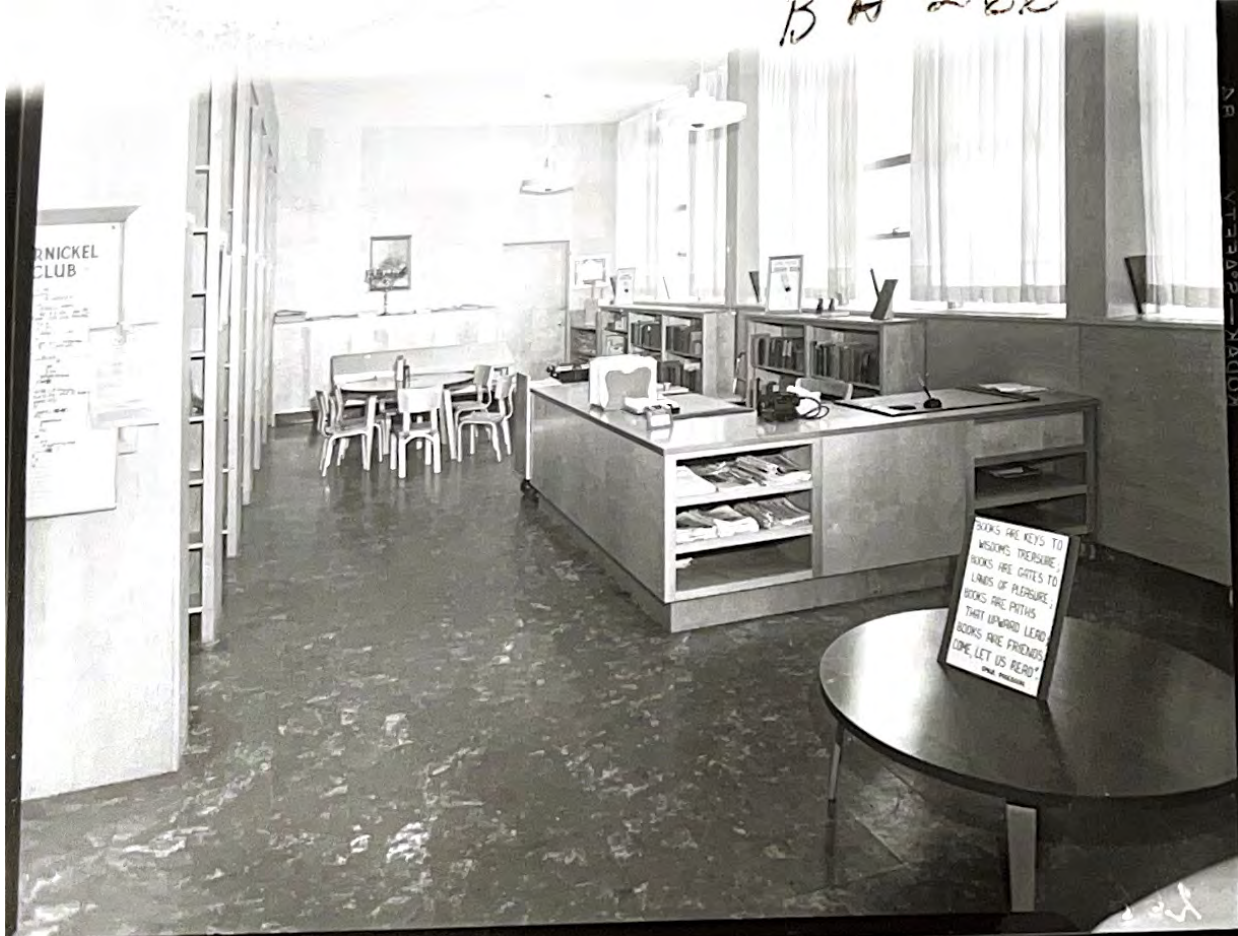
Historic Photo c.1955

HISTORIC ALTERATIONS

- 1. Added HVAC Ceiling Return Air
- 2. Removed Privacy Curtains
- 3. Added HVAC Wall Diffuser
- 4. Removed Lighting Fixture Reflector
- 5. Removed Built-In Desk
