Then / Now Photo Comparison

Scanned Photos of Park Synagogue from the Western Reserve Historical Society Archive Compared to Present Day Photos to Identify Alternations over time for the Historic Preservation.

By David Craun, AIA, Cleveland Planning Advisors, LLC, Owner Representative Services

Park Synagogue
Mendelsohn Restoration

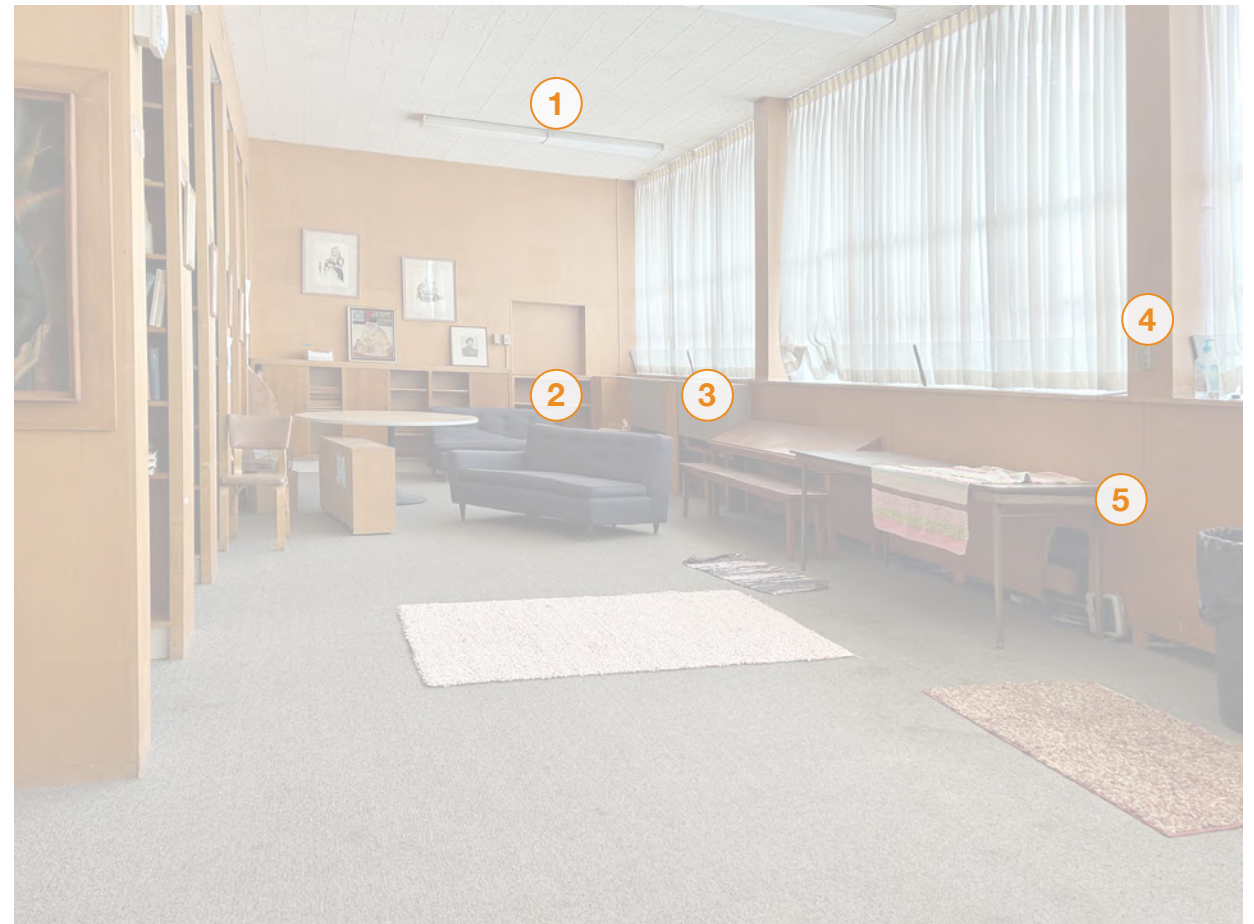
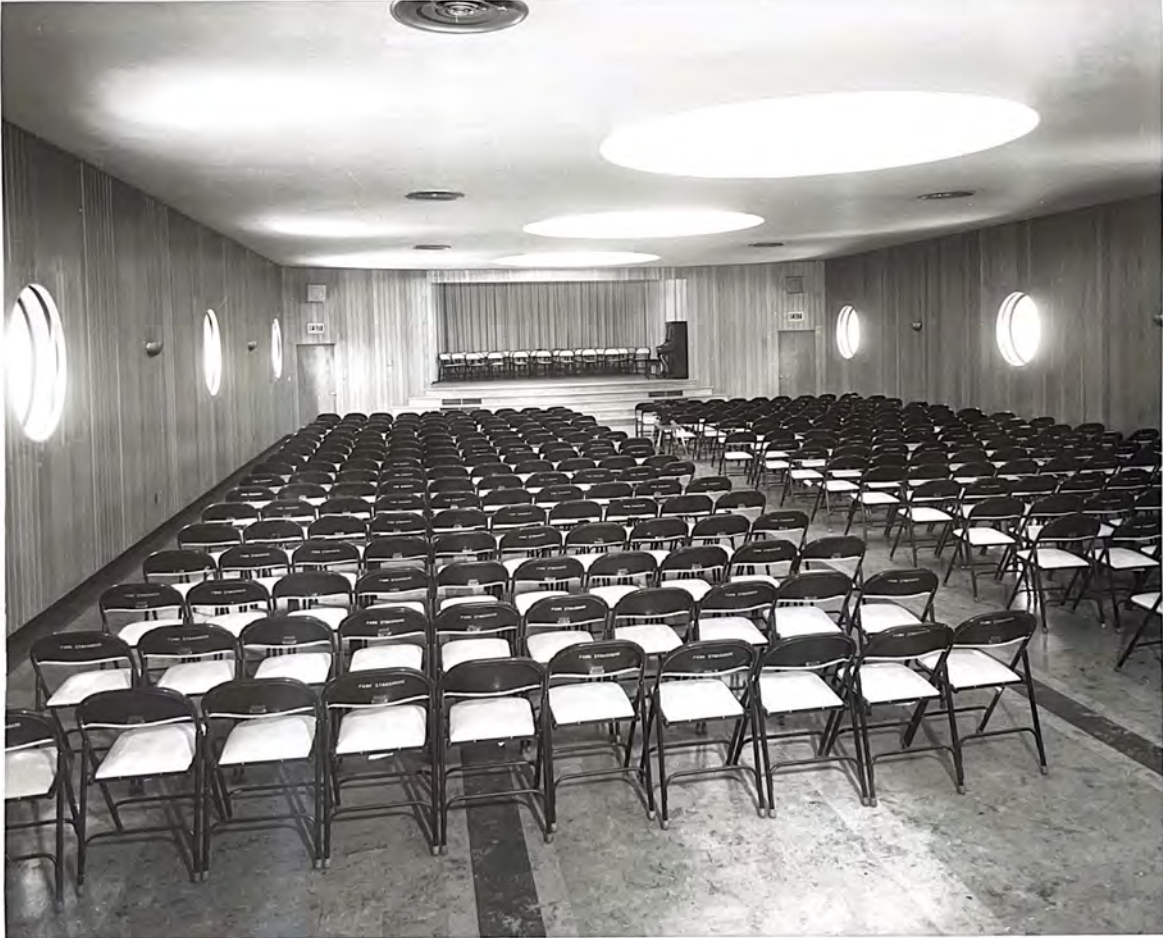
Interior Library View

HISTORIC ALTERATIONS

1. Non-Period Lighting Fixtures
2. Casework Blocking Door
3. Added Radiators
4. Added Electrical Outlets
5. Removed Built-In Desk

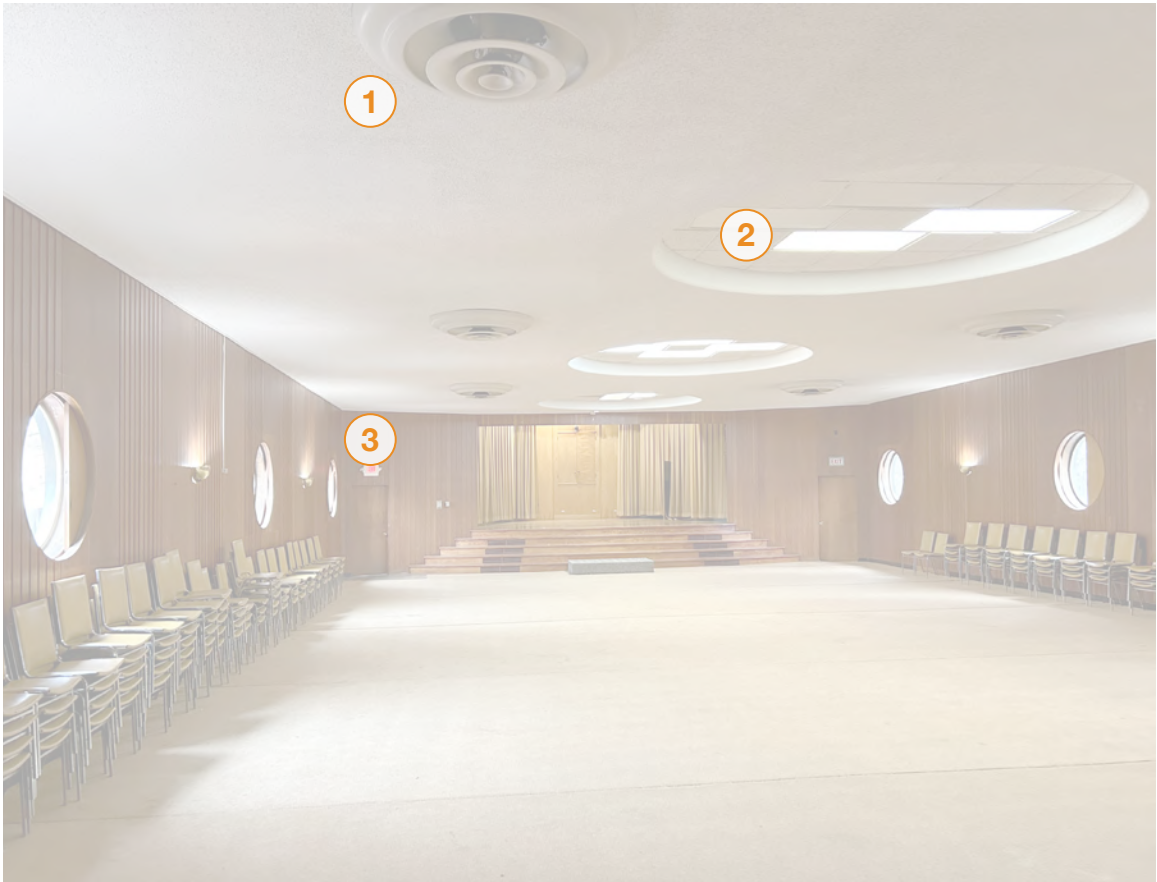
HISTORIC ALTERATIONS

- 1. Enlarged HVAC Diffusers
- 2. Added ACT Ceiling in Lighting Coves
- 3. Removed Wall-Mounted Speakers
